# Preliminary Wetlands Delineation and Functions and Values Assessment

Dalton Highway Mileposts 0 to 9

**PRELIMINARY WETLANDS DELINEATION  
AND  
FUNCTIONS AND VALUES ASSESSMENT  
DALTON HIGHWAY MILEPOSTS 0 TO 9 RECONSTRUCTION**

Department of Transportation and Public Facilities Project No.: 60911  
Federal Project No.: STP-0652(16)

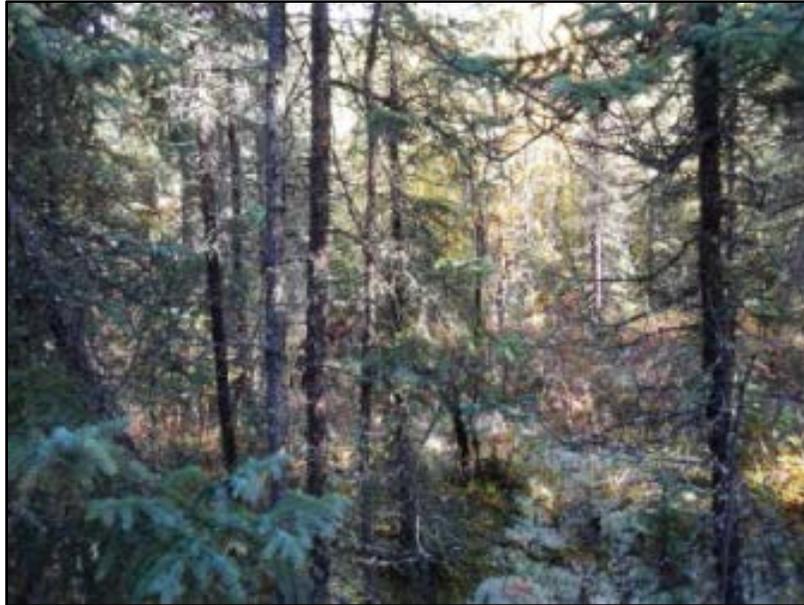
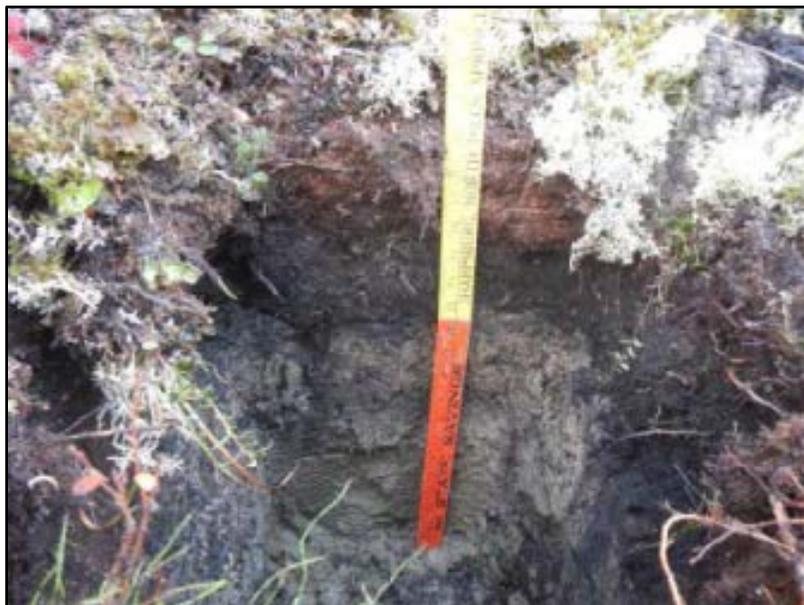
| <b>Site Number:</b> 1<br><b>Date:</b> 09/09/2013 | <b>Notes:</b> | Black spruce ( <i>Picea mariana</i> ) forested wetland with slightly thixotropic mineral soil observed. |

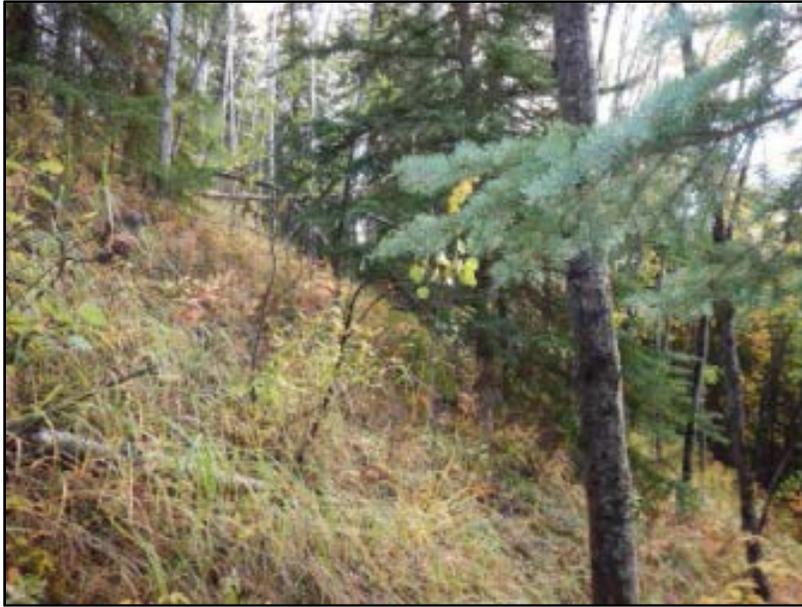
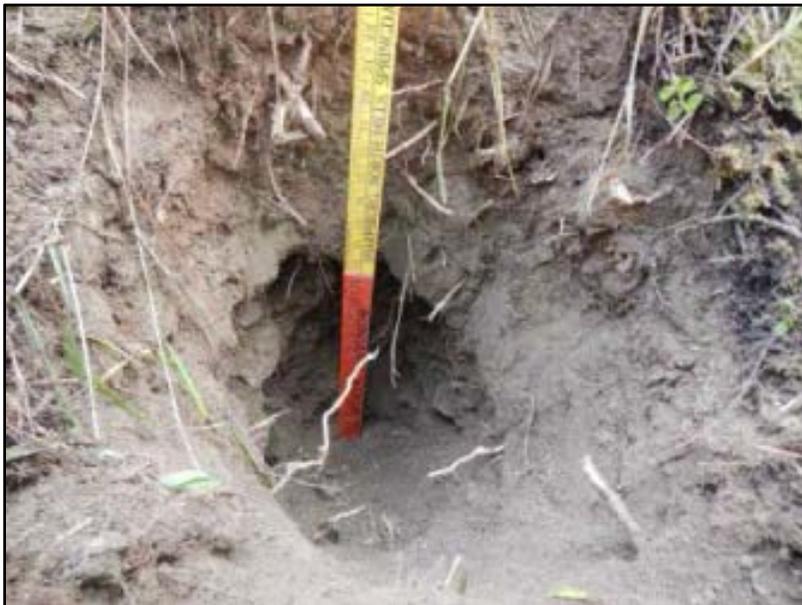
| <b>Site Number: 2<br/>Date: 09/09/2013</b> | <b>Notes:</b> | Steep forested hillside consisting of quaking aspen ( <i>Populus tremuloides</i> ) and white spruce ( <i>Picea glauca</i> ). |

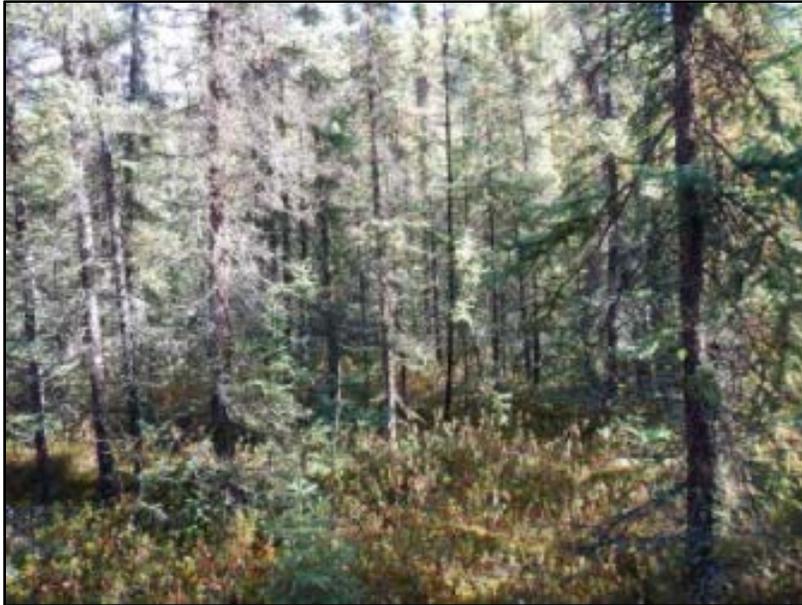
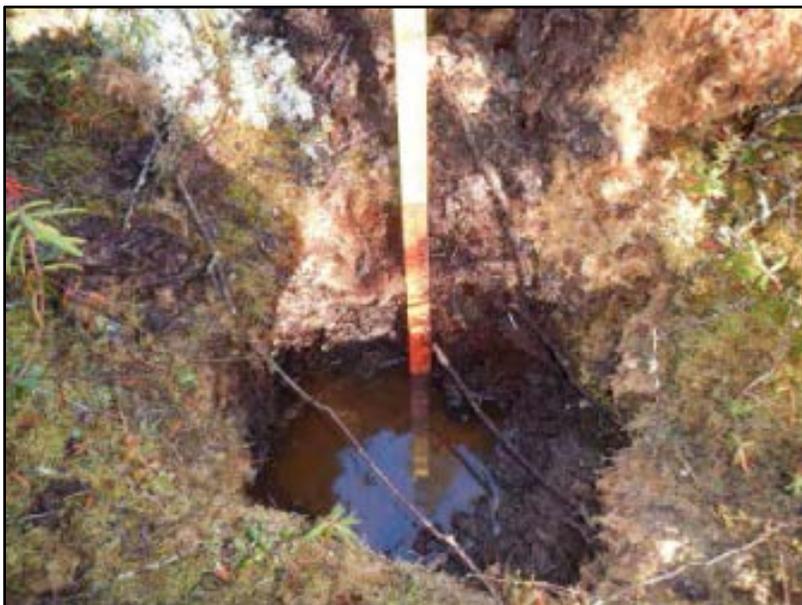
| <b>Site Number:</b> 3<br><b>Date:</b> 09/09/2013 | <b>Notes:</b> | Black spruce ( <i>Picea mariana</i> ) forested wetland with unulating topography. The wetland is situated between the road and the hillside. |

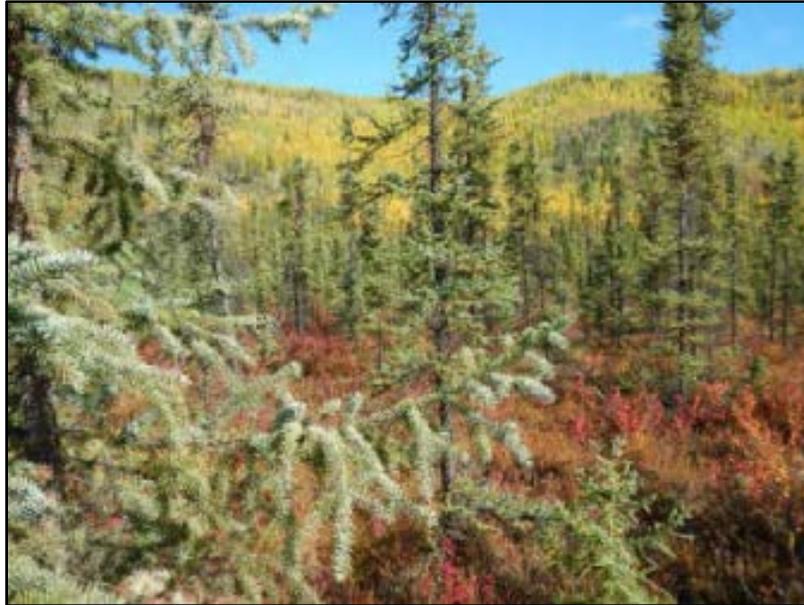
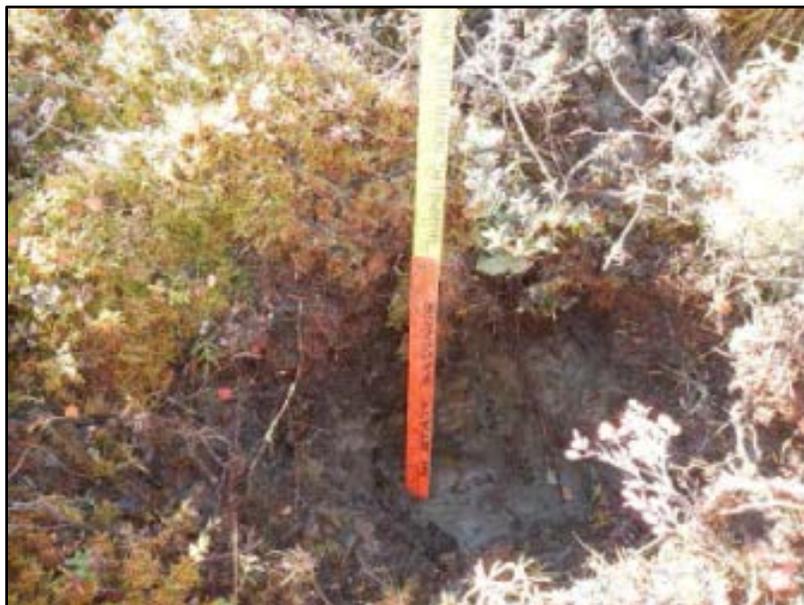
| <b>Site Number: 4</b><br><b>Date: 09/09/2013</b> | <b>Notes:</b> | Scrub shrub wetland dominated by black spruce ( <i>Picea mariana</i> ) and dwarf birch ( <i>Betula nana</i> ). Surface water was observed between tussocks. |

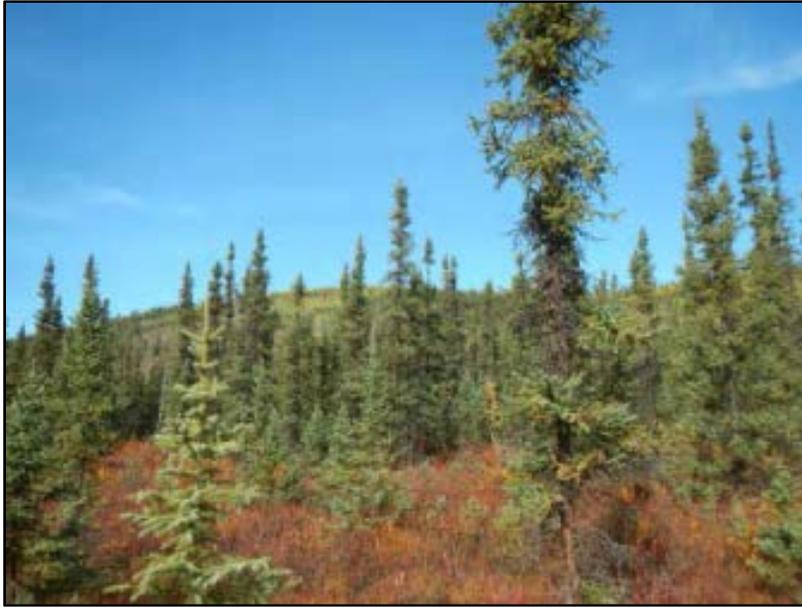
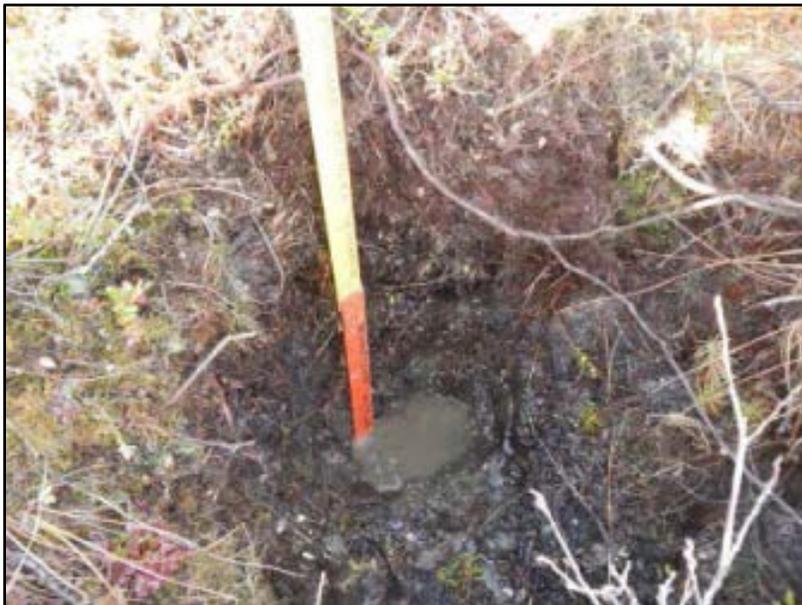
| <b>Site Number:</b> 5<br><b>Date:</b> 09/09/2013 | <b>Notes:</b> | Black spruce ( <i>Picea mariana</i> ) and northern mountain cranberry ( <i>Vaccinium vitis-idaea</i> ) dominated scrub shrub wetland with an atv trail present approximately 500 feet west of the sample point. |

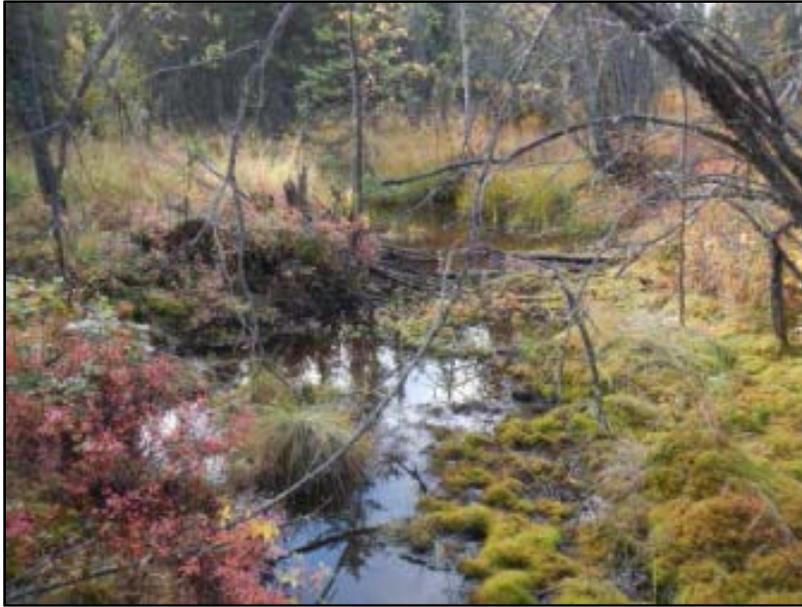
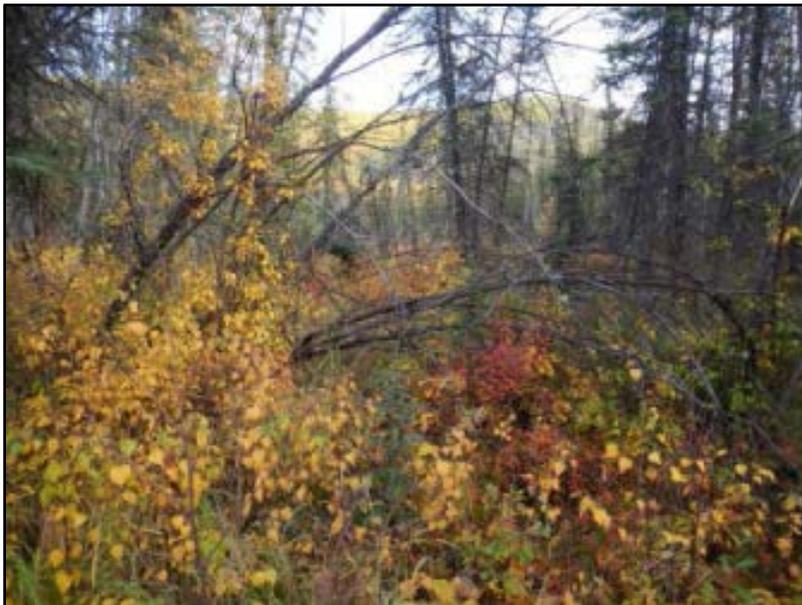
| <b>Site Number:</b> 6<br><b>Date:</b> 09/09/2013 | <b>Notes:</b> Surface water observed near sample point number 5. | |

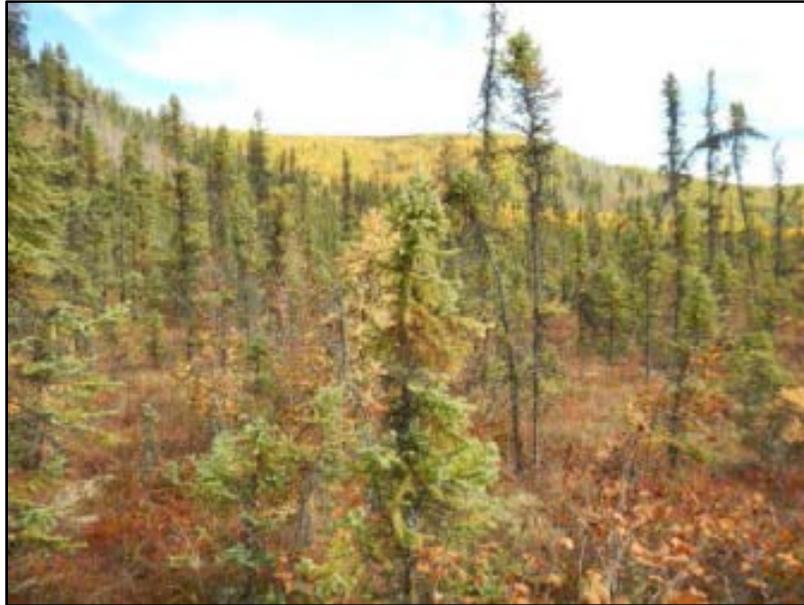
| <b>Site Number:</b> 7<br><b>Date:</b> 09/09/2013 | <b>Notes:</b> | Scrub shrub wetland with hummocks at bottom of slope consisting largely of black spruce ( <i>Picea mariana</i> ) and marsh labrador tea ( <i>Rhododendron tomentosum</i> ). |

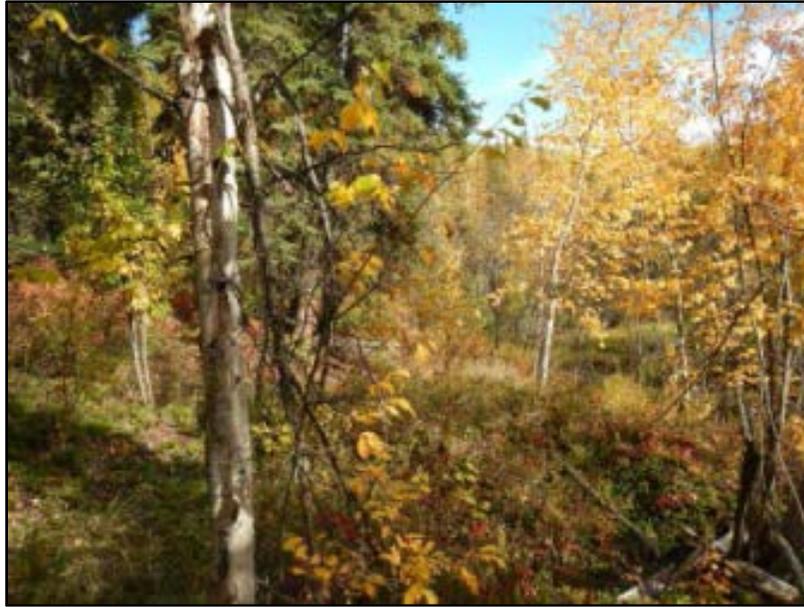
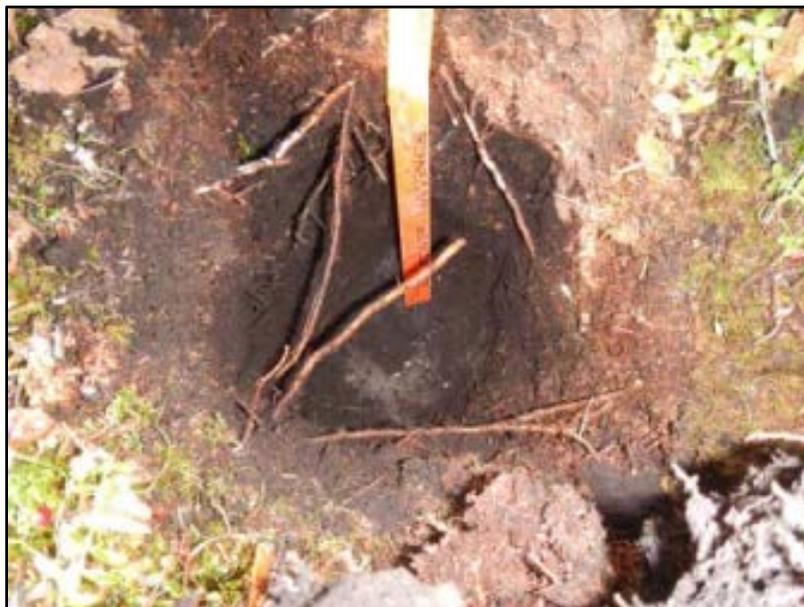
| <b>Site Number: 8</b><br><b>Date: 09/09/2013</b> | <b>Notes:</b> | White spruce ( <i>Picea glauca</i> ), resin birch ( <i>Betula neoalaskana</i> ), prickly rose ( <i>Rosa acicularis</i> ) and <i>Salix</i> upland. |

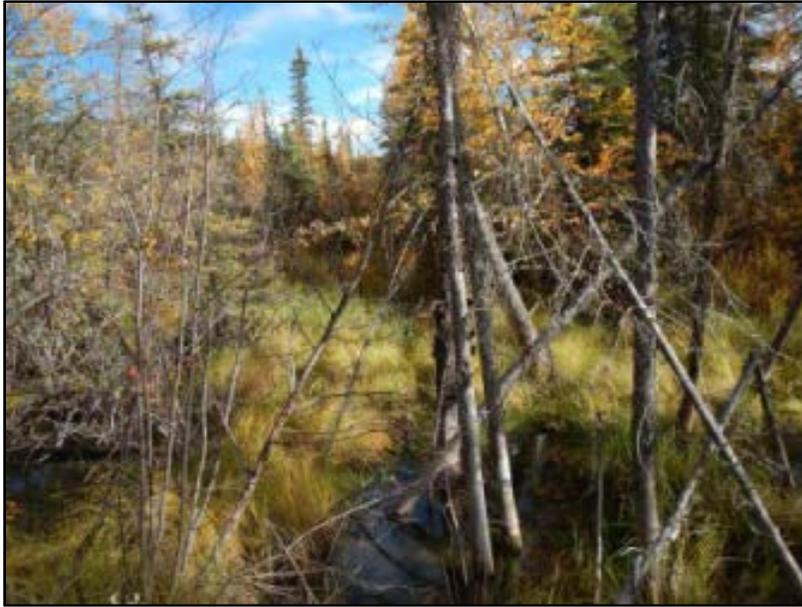
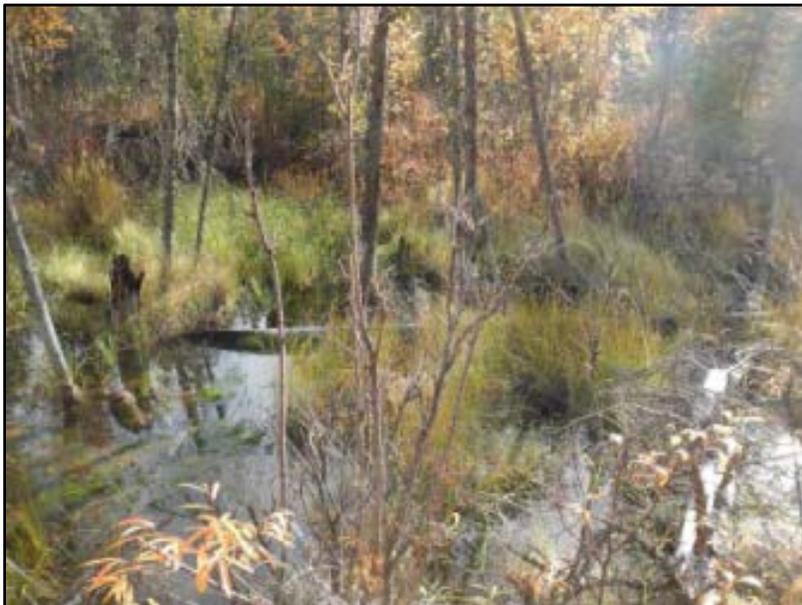
| <b>Site Number: 9<br/>Date: 09/09/2013</b> | <b>Notes:</b> Surface water present downslope of sample point 8. | |

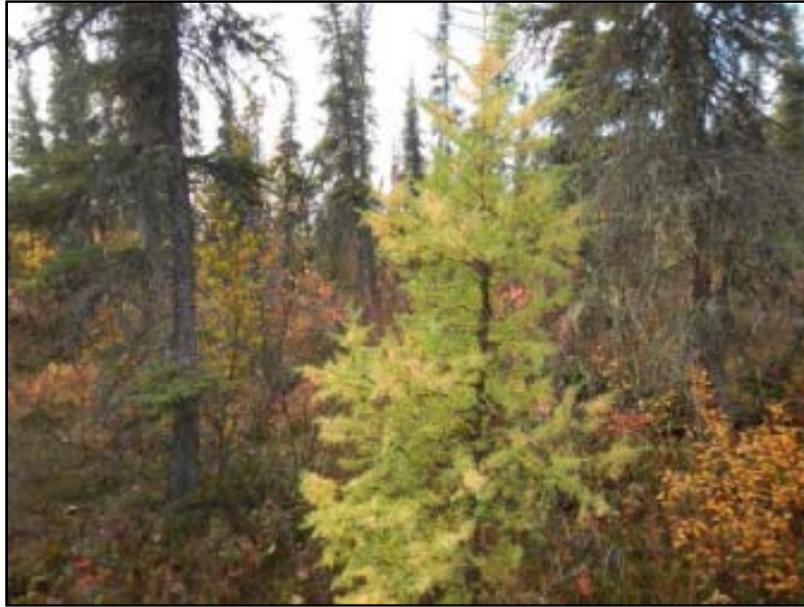
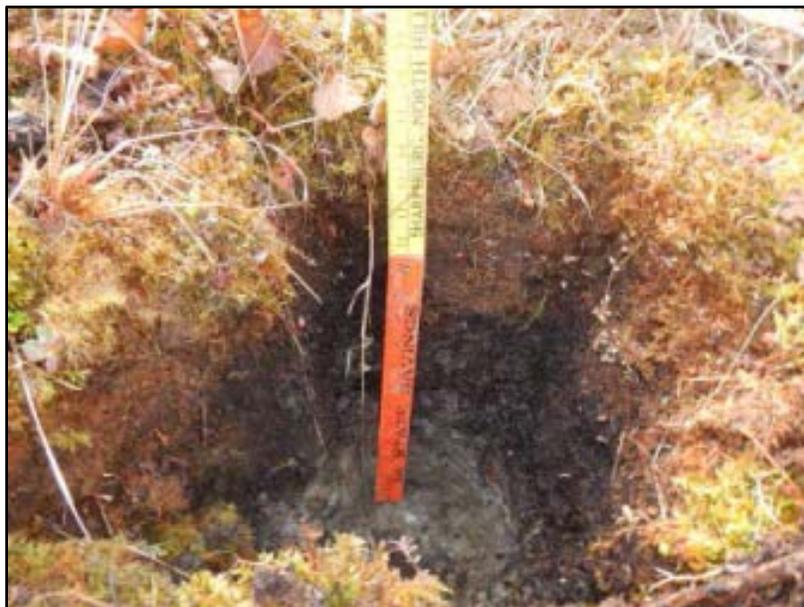
| <b>Site Number:</b> 10<br><b>Date:</b> 09/09/2013 | <b>Notes:</b> | Black spruce ( <i>Picea mariana</i> ) scrub shrub wetland at bottom of toe slope with moderate hummocks. |

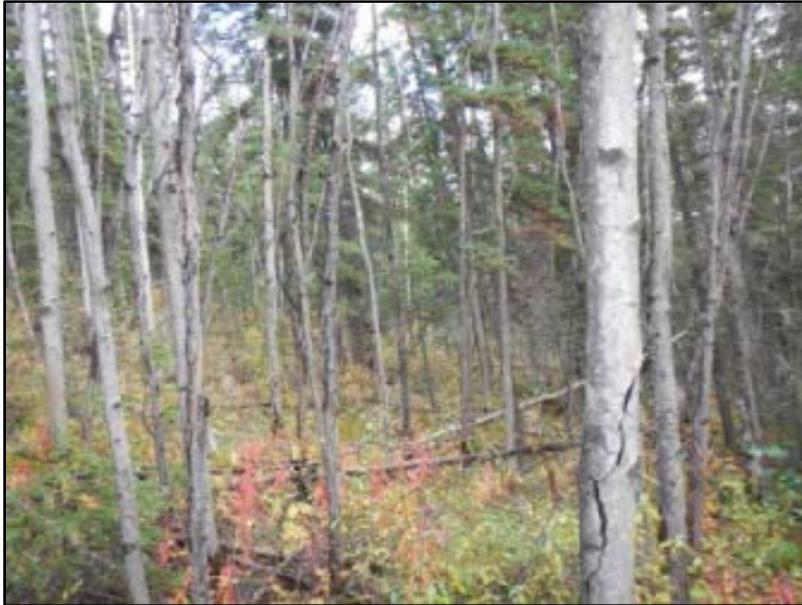
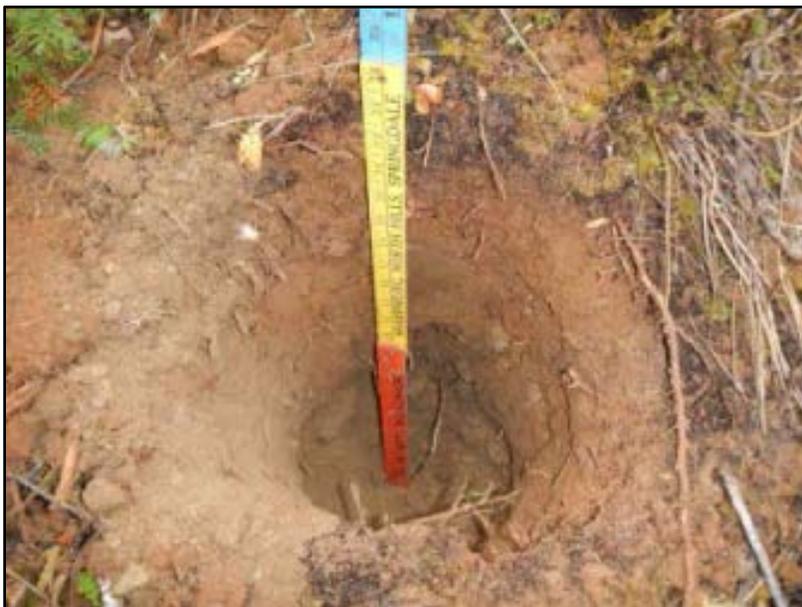
| <b>Site Number:</b> 11<br><b>Date:</b> 09/09/2013 | <b>Notes:</b> | Steep, well drained hillside with white spruce ( <i>Picea glauca</i> ) and quaking aspen ( <i>Populus tremuloides</i> ). |

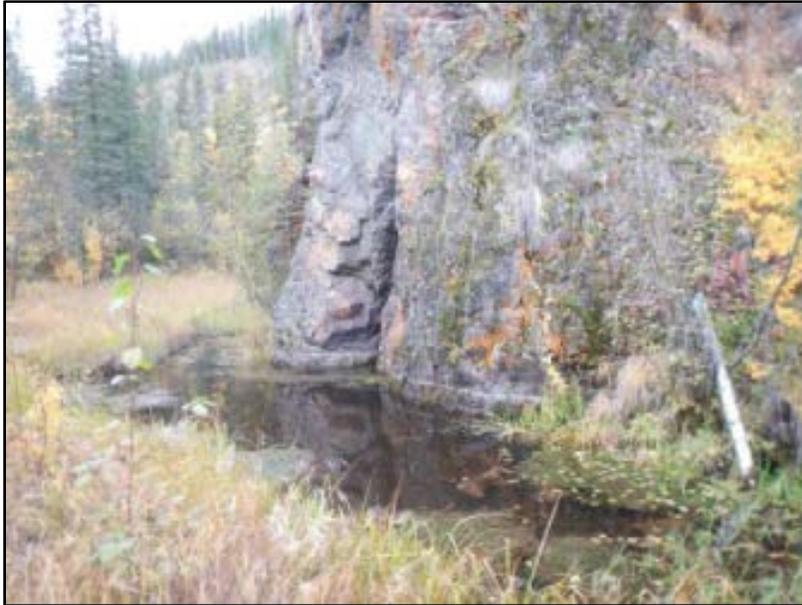
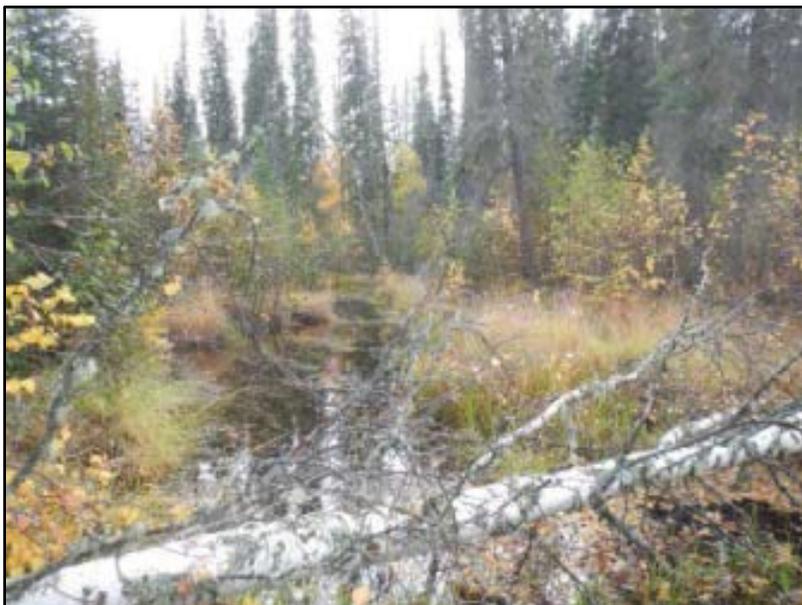
| <b>Site Number: 11<br/>Date: 09/09/2013</b> | <b>Notes:</b> Riverine area present between sample point 11 and 12. | |

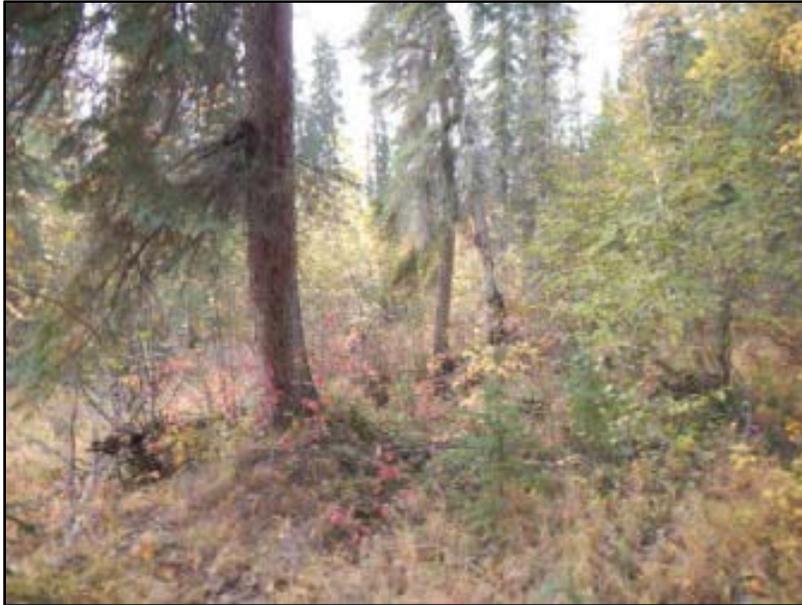
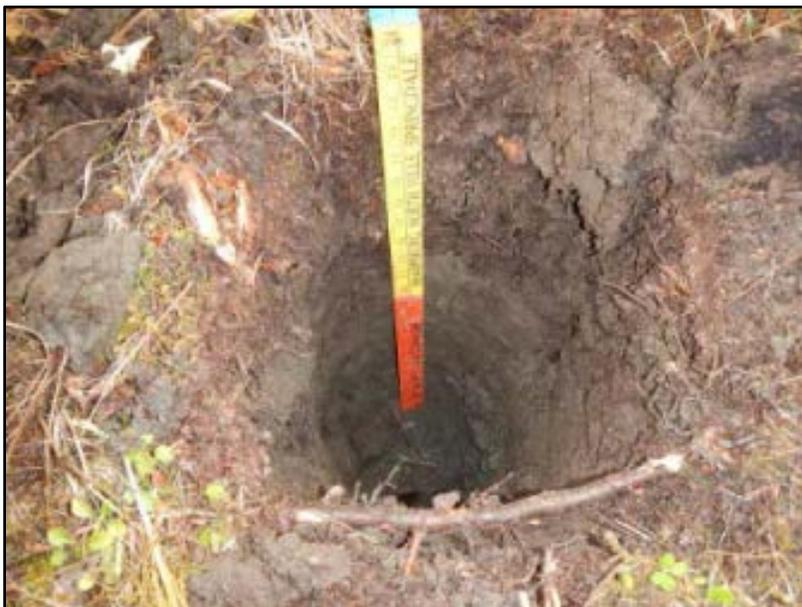
| <b>Site Number:</b> 12<br><b>Date:</b> 09/09/2013 | <b>Notes:</b> | White spruce ( <i>Picea glauca</i> ), resin birch ( <i>Betula neoalaskana</i> ) and green alder ( <i>Alnus viridis</i> ) upland with creek floodplain water surrounding plot. |

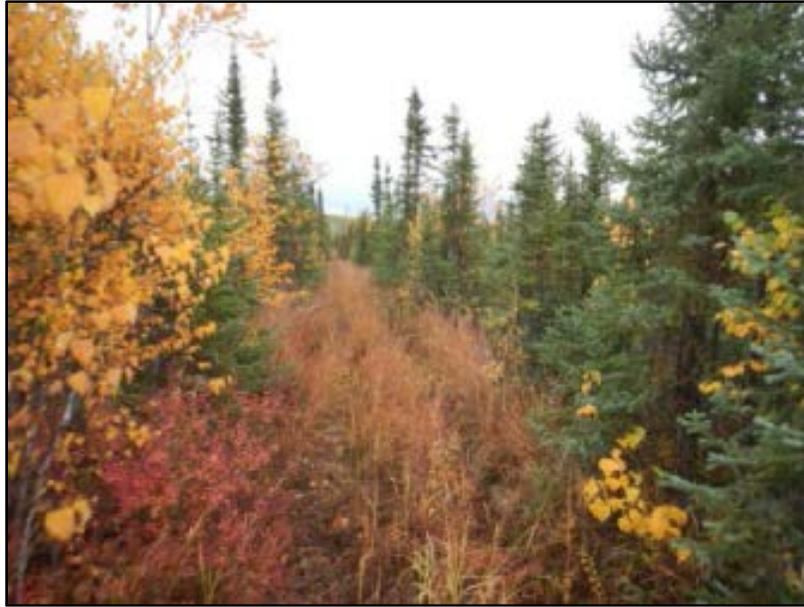
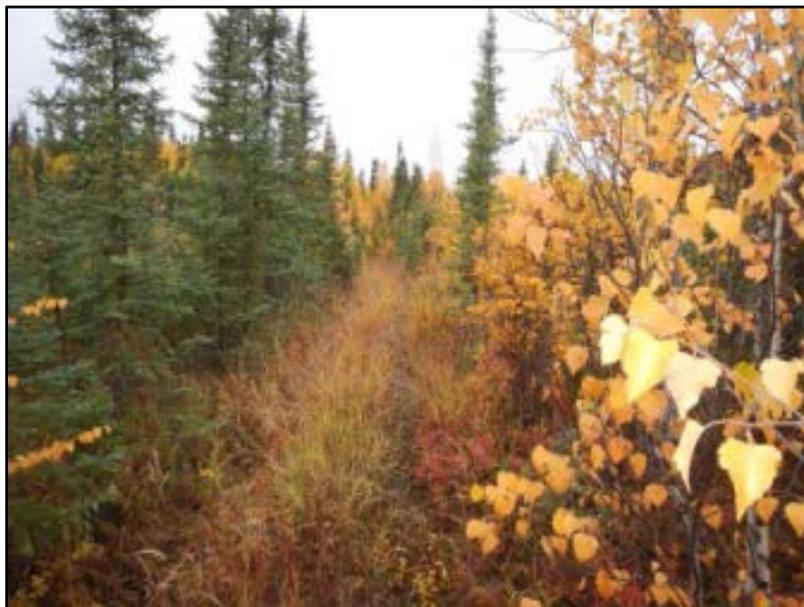
| <b>Site Number: 12<br/>Date: 09/09/2013</b> | <b>Notes:</b> ATV trail between sample point 12 and sample point 13. | |

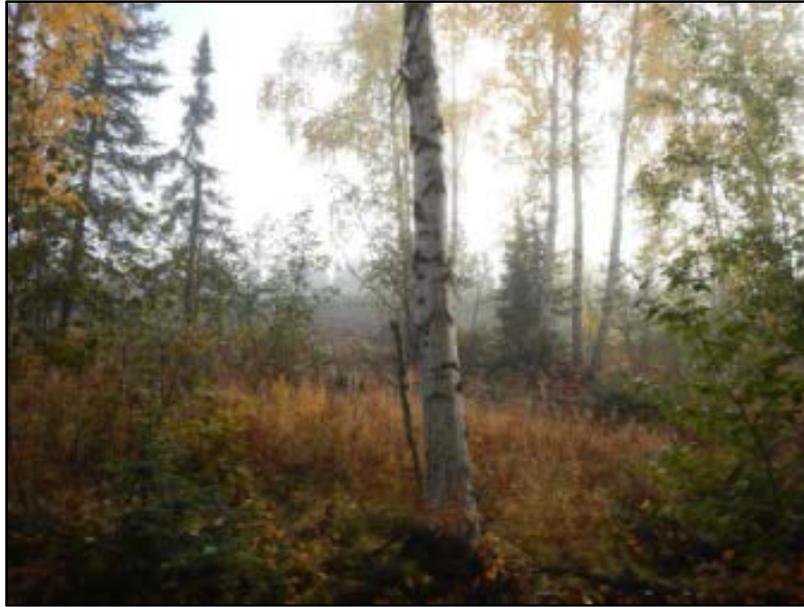
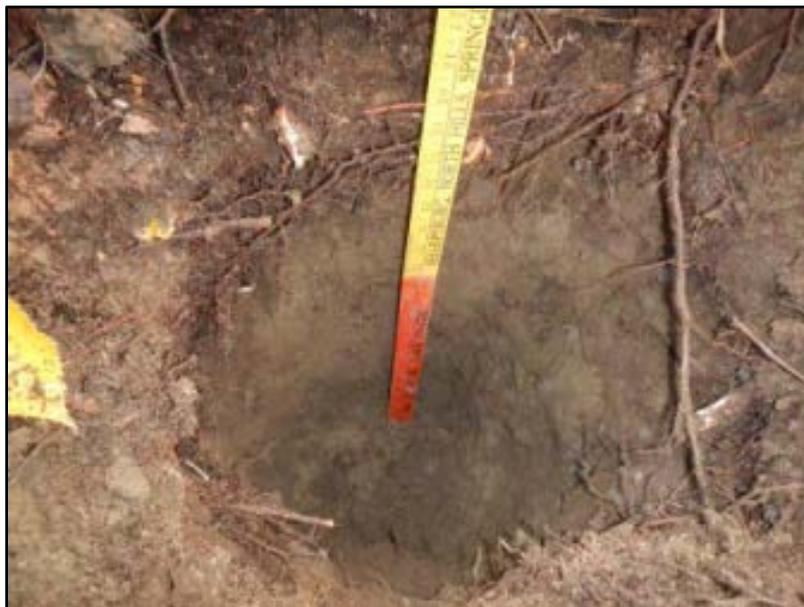
| <b>Site Number:</b> 13<br><b>Date:</b> 09/10/2013 | <b>Notes:</b> | Resin birch ( <i>Betula neoalaskana</i> ), green alder ( <i>Alnus viridis</i> ) and prickly rose ( <i>Rosa acicularis</i> ) hillside. |

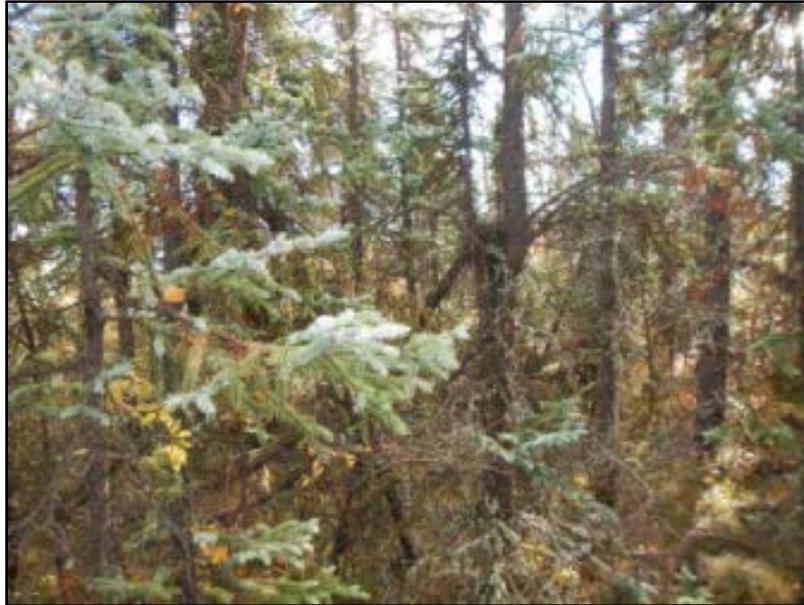
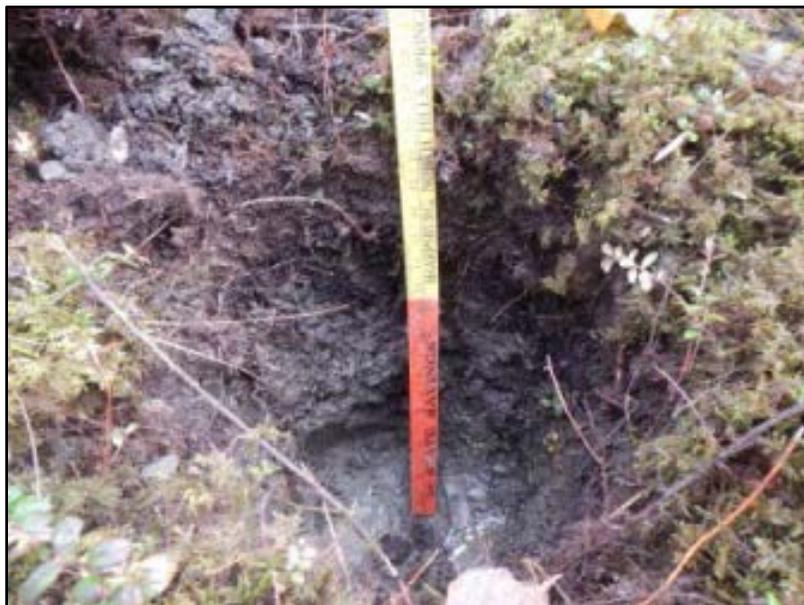
| <b>Site Number:</b> 14<br><b>Date:</b> 09/10/2013 | <b>Notes:</b> | Scrub shrub wetland dominated by black spruce ( <i>Picea mariana</i> ) in the tree and shrub layer. |

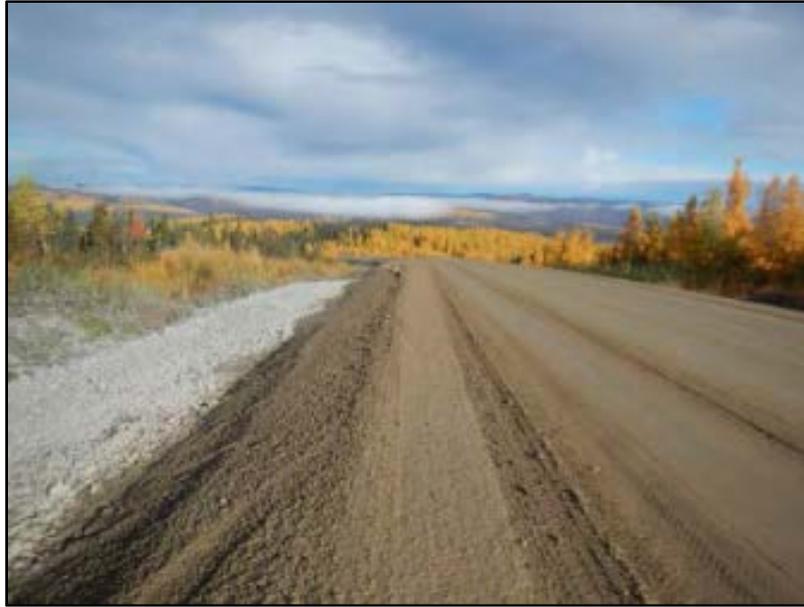
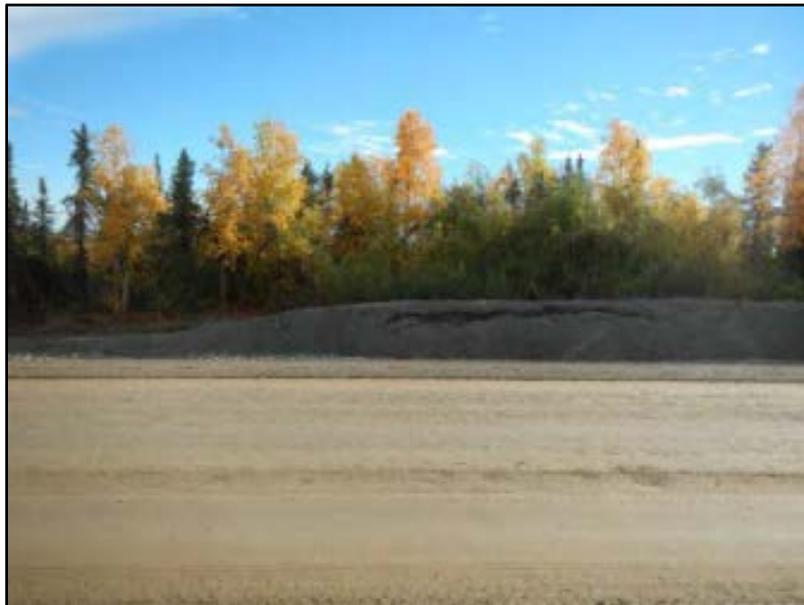
| <b>Site Number:</b> 14<br><b>Date:</b> 09/10/2013 | <b>Notes:</b> Dalton highway observed between sample points 14 and 15. | |

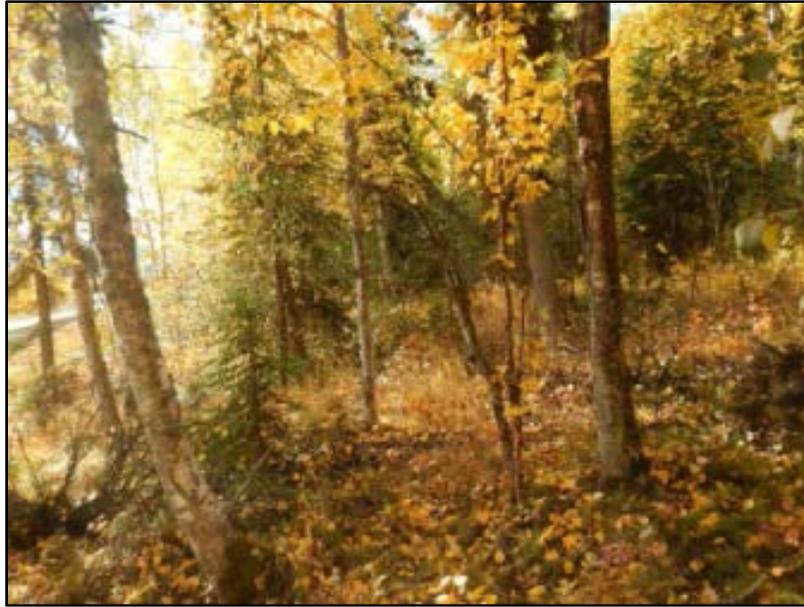
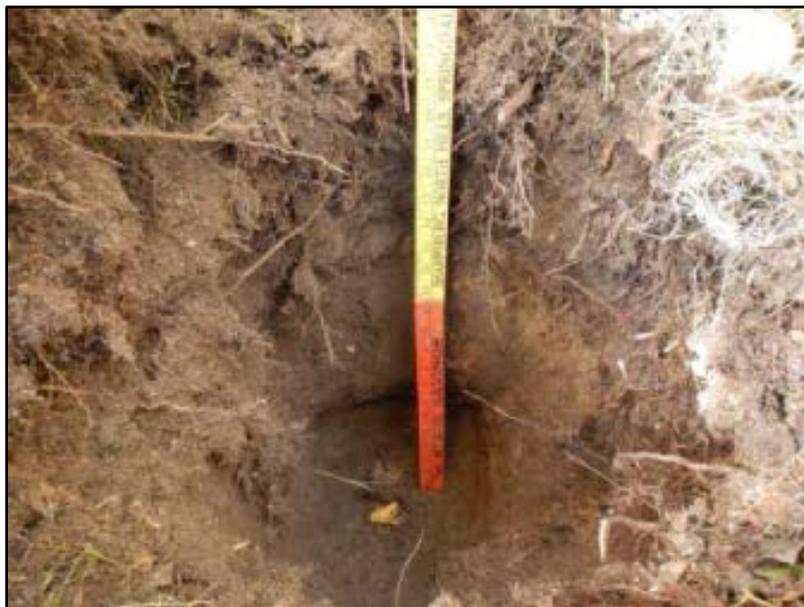
| <b>Site Number:</b> 15<br><b>Date:</b> 09/10/2013 | <b>Notes:</b> | Upland point with resin birch ( <i>Betula neoalaskana</i> ) and white spruce ( <i>Picea glauca</i> ). Two small dry seasonal channels located near sample plot. |

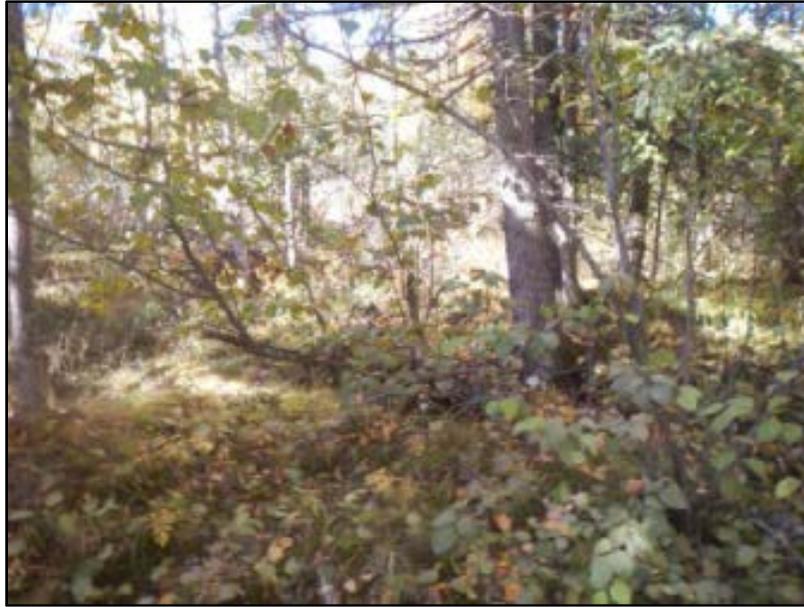
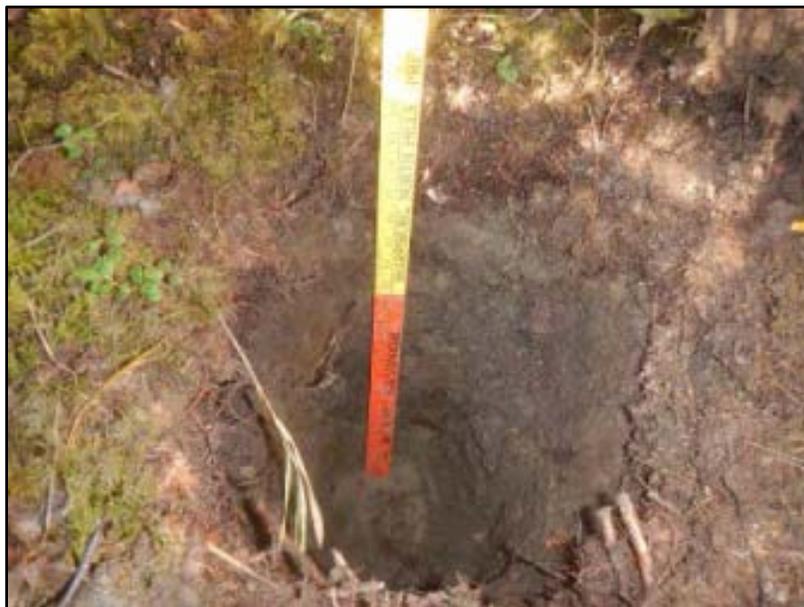
| <b>Site Number: 16<br/>Date: 09/10/2013</b> | <b>Notes:</b> Hillside consisting of mostly resin birch ( <i>Betula neoalaskana</i> ) and green alder ( <i>Alnus viridis</i> ). Sample point located approximately 50 feet away from road clearing. | |

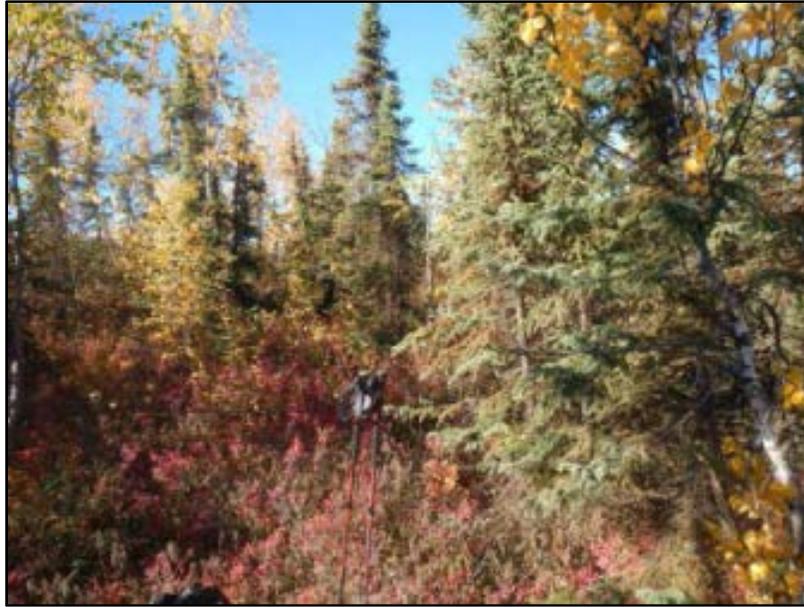
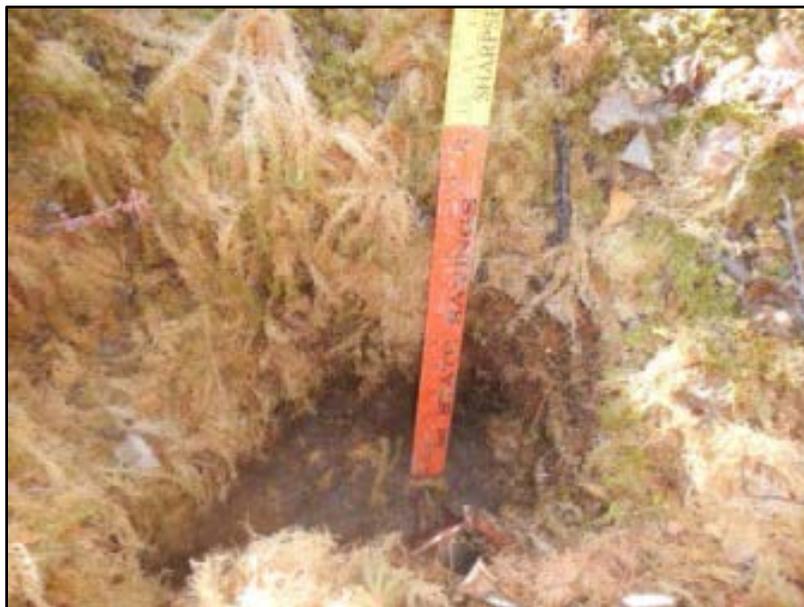
| <b>Site Number:</b> 17<br><b>Date:</b> 09/10/2013 | <b>Notes:</b> | Black spruce ( <i>Picea mariana</i> ), blueberry ( <i>Vaccinium uliginosum</i> ), and resin birch ( <i>Betula neoalaskana</i> ) scrub shrub wetland. Many of the black spruce and resin birch are stunted. Road is about 60 feet upslope of point. |

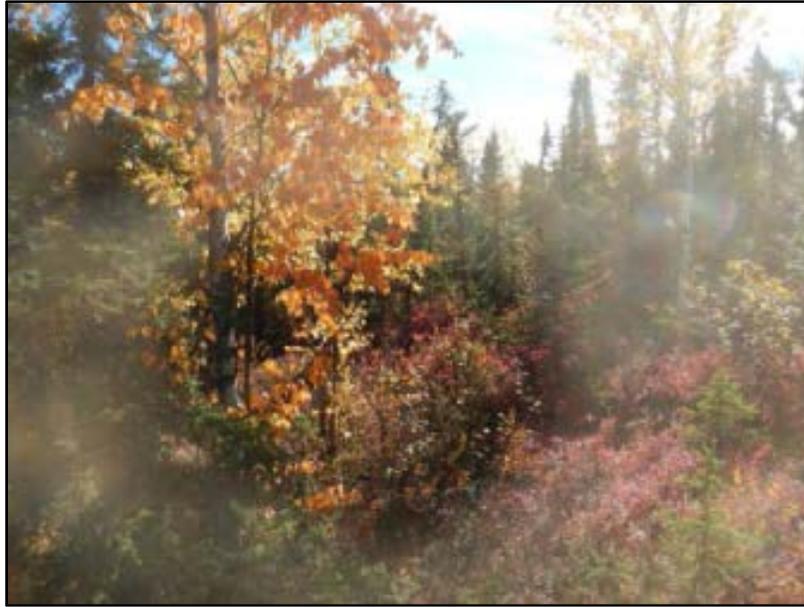
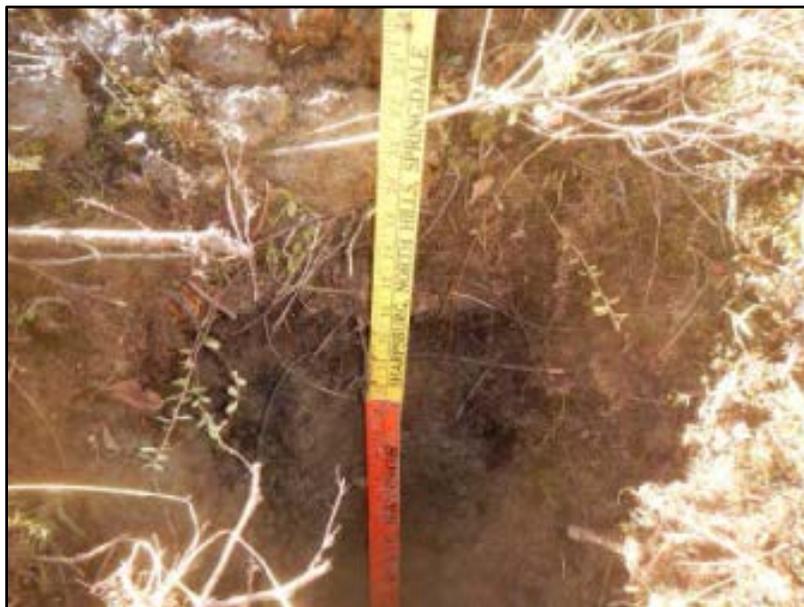
| <b>Site Number:</b> 18<br><b>Date:</b> 09/10/2013 | <b>Notes:</b> | Most trees in plot under 15 feet tall. Tree layer of resin birch ( <i>Betula neoalaskana</i> ) with shrub layer dominated by black spruce ( <i>Picea mariana</i> ) and blueberry ( <i>Vaccinium uliginosum</i> ). |

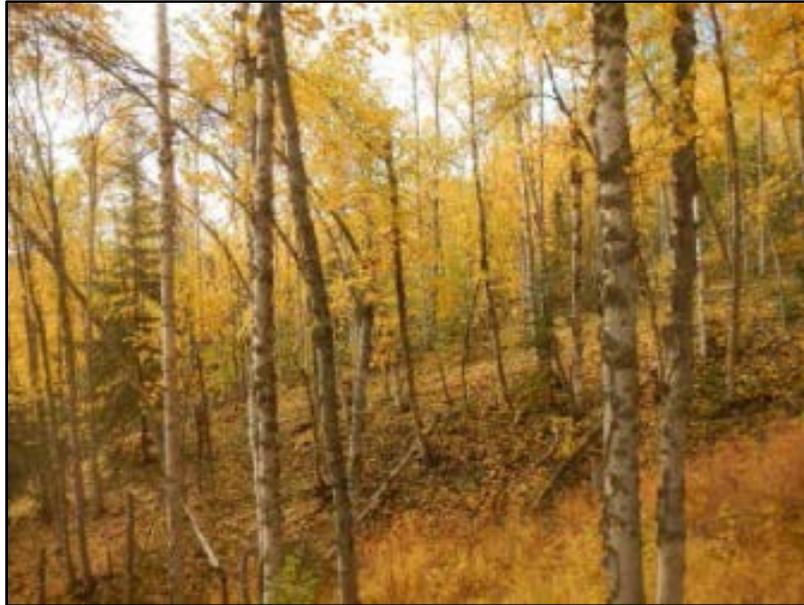
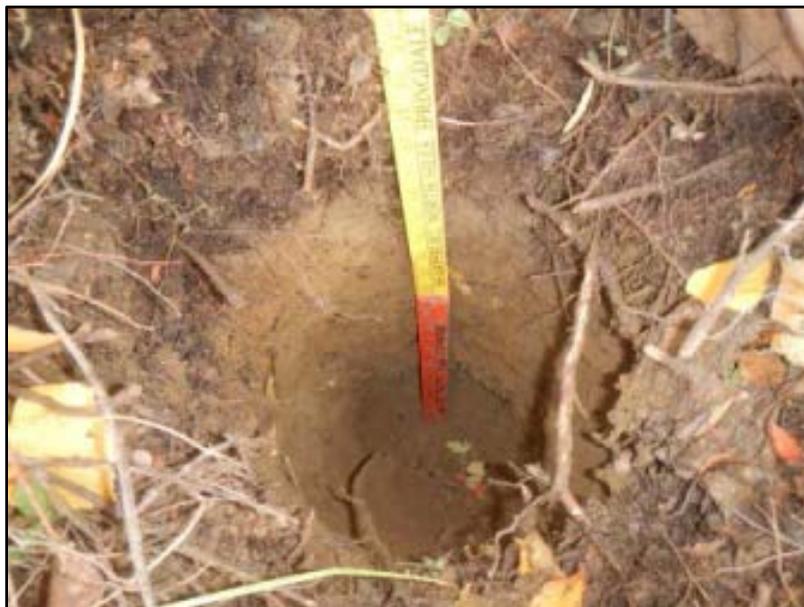
| <b>Site Number:</b> 19<br><b>Date:</b> 09/10/2013 | <b>Notes:</b> | Upland point dominated by resin birch ( <i>Betula neolaskana</i> ). Sample point located approximately 40 feet downslope of disturbed road clearing. |

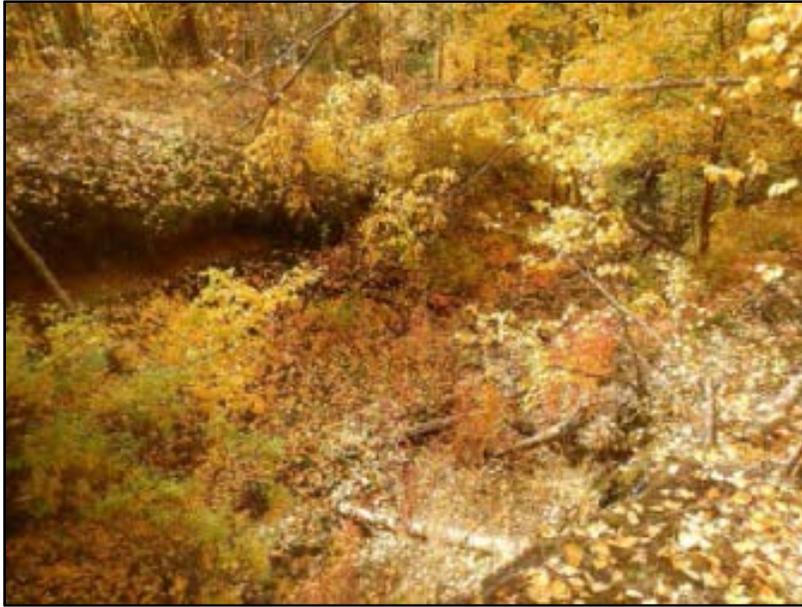
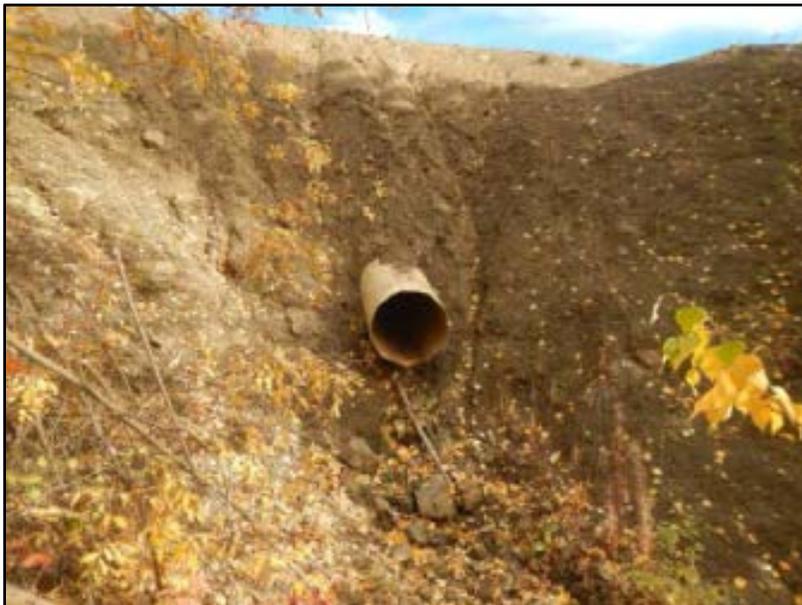
| <b>Site Number: 19<br/>Date: 09/10/2013</b> | <b>Notes:</b> Large culvert drainage from roadway upslope of sample point 19. | |
