# Preliminary Wetlands Delineation and Functions and Values Assessment

Dalton Highway Mileposts 0 to 9

**PRELIMINARY WETLANDS DELINEATION  
AND  
FUNCTIONS AND VALUES ASSESSMENT  
DALTON HIGHWAY MILEPOSTS 0 TO 9 RECONSTRUCTION**

Department of Transportation and Public Facilities Project No.: 60911  
Federal Project No.: STP-0652(16)

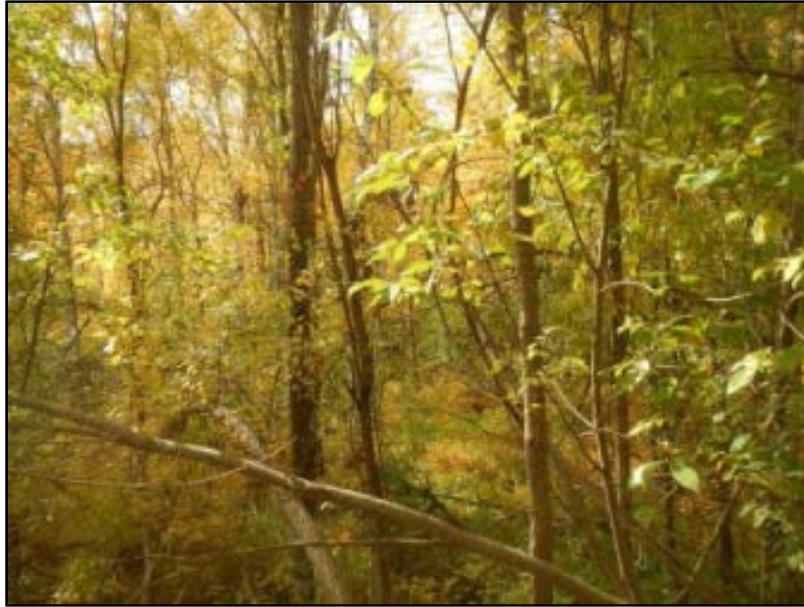
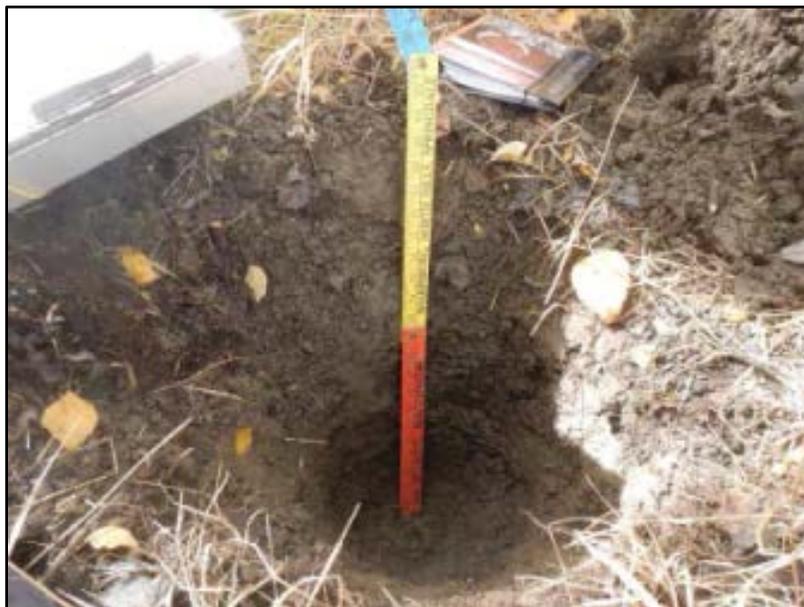
| <b>Site Number:</b> 20<br><b>Date:</b> 09/10/2013 | <b>Notes:</b> | Upland point dominated by tealeaf willow ( <i>Salix pulchra</i> ). Sample point near roadside disturbance with roadway runoff dispersing into forested area. |

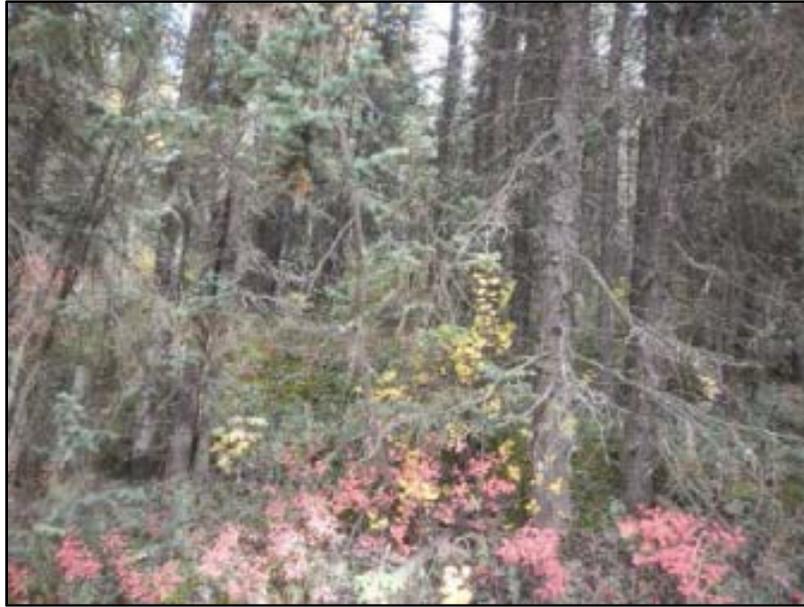
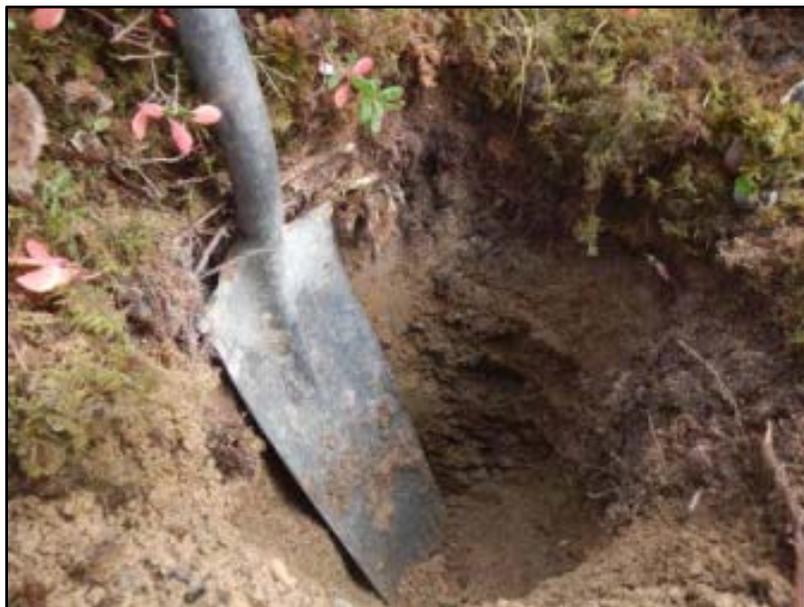
| <b>Site Number:</b> 21<br><b>Date:</b> 09/10/2013 | <b>Notes:</b> Well drained forested hillside consisting of primarily black spruce ( <i>Picea mariana</i> ) in the tree and shrub layer. | |

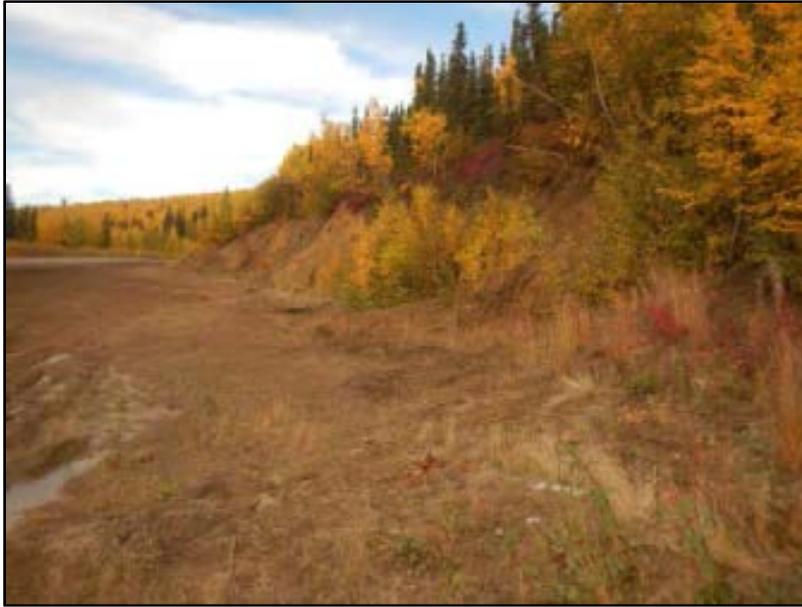
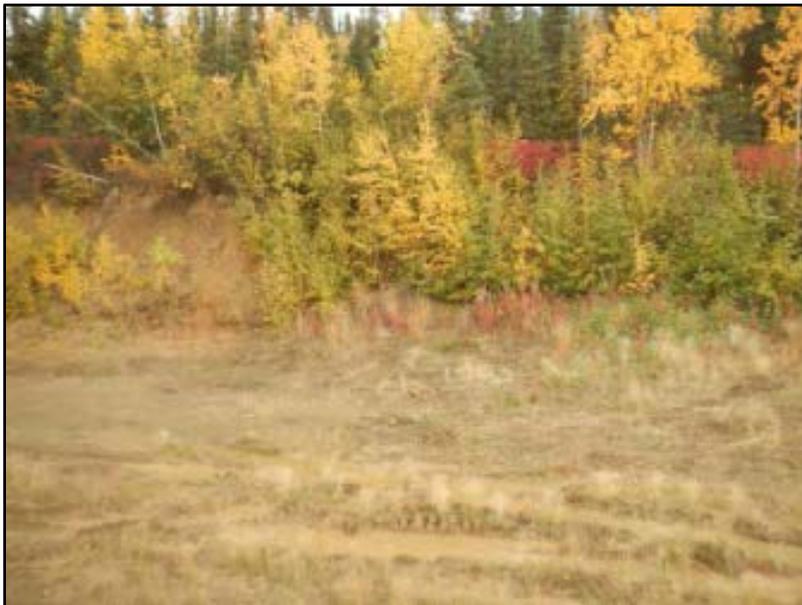
| <b>Site Number: 21<br/>Date: 09/10/2013</b> | <b>Notes:</b> Gravel borrow pit downslope of sample point 21. | |

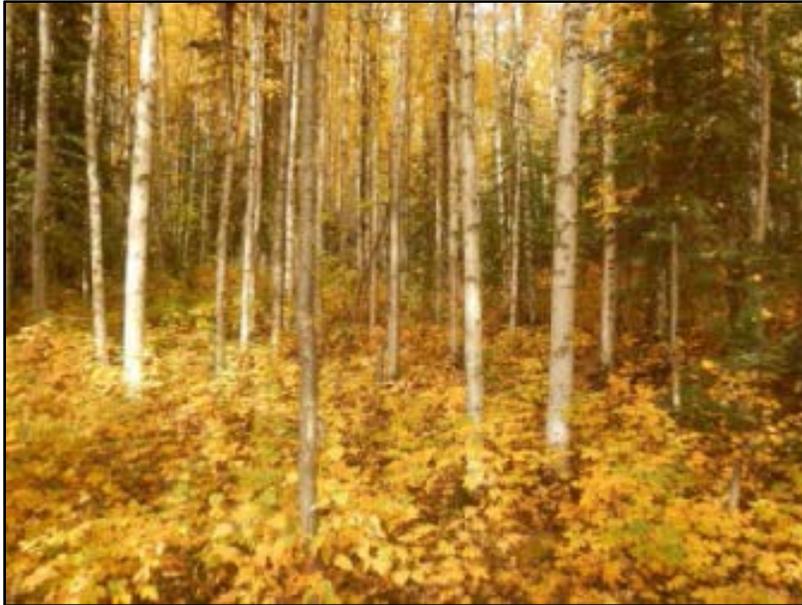
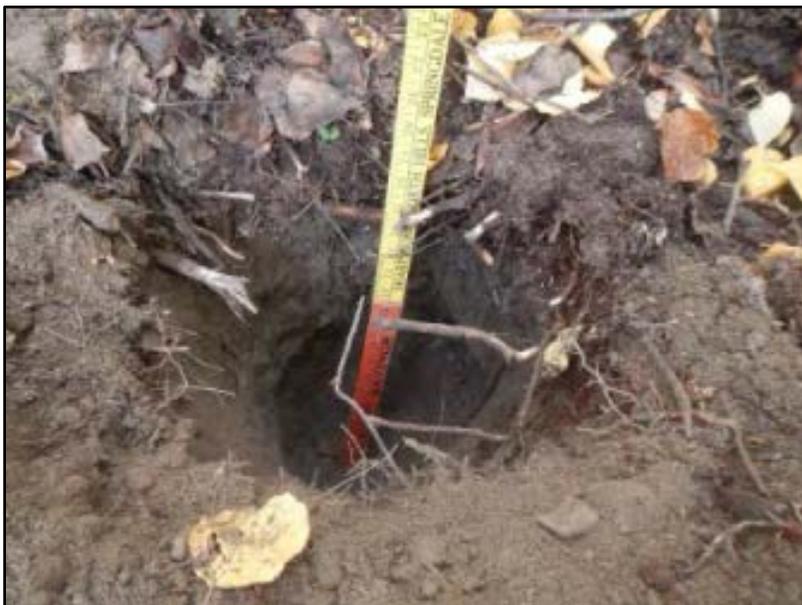
| <b>Site Number:</b> 22<br><b>Date:</b> 09/10/2013 | <b>Notes:</b> | Dry resin birch ( <i>Betula neoalaskana</i> ) forest with unglulating topography. Shrub layer consisted largely of squashberry ( <i>Viburnum edule</i> ). Road present approximately 100 feet below sample point. |

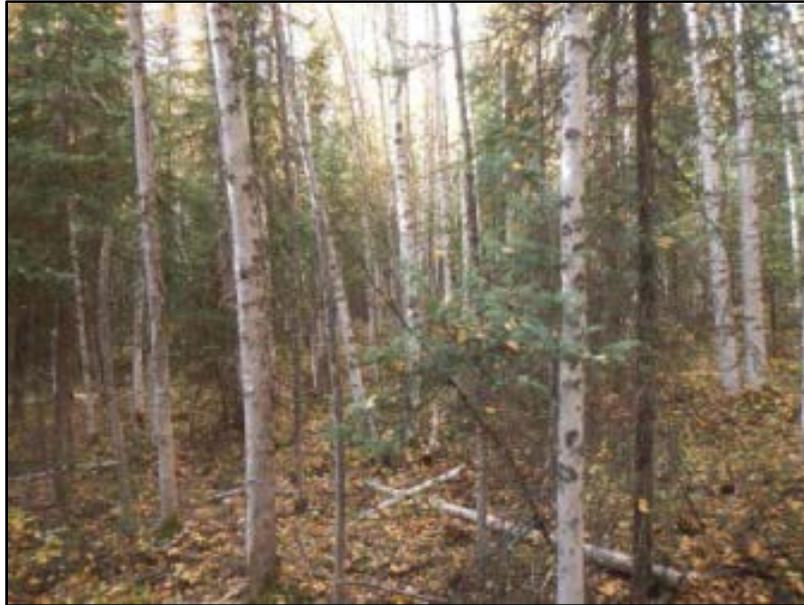
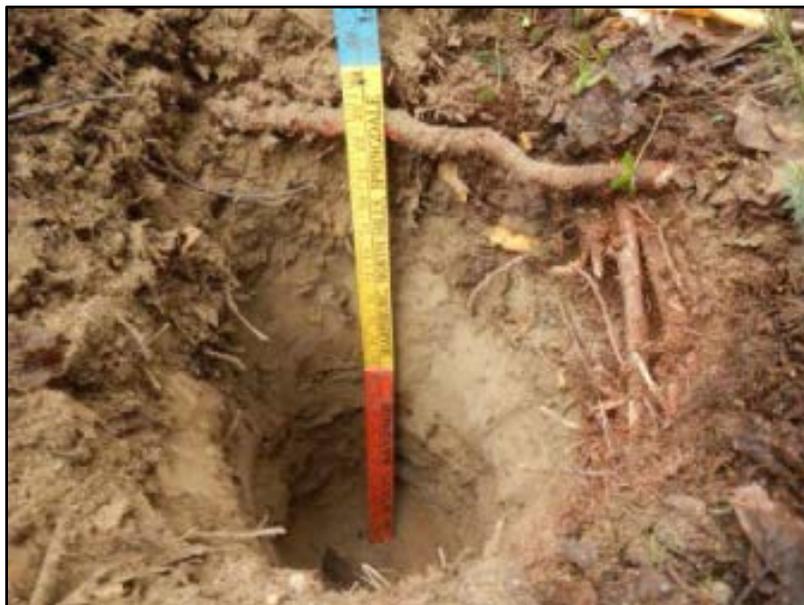
| <b>Site Number:</b> 23<br><b>Date:</b> 09/10/2013 | <b>Notes:</b> Upland point consisting of resin birch ( <i>Betula neoalaskana</i> ), white spruce ( <i>Picea glauca</i> ) and prickly rose ( <i>Rosa acicularis</i> ). Lots of leaf litter present. | |

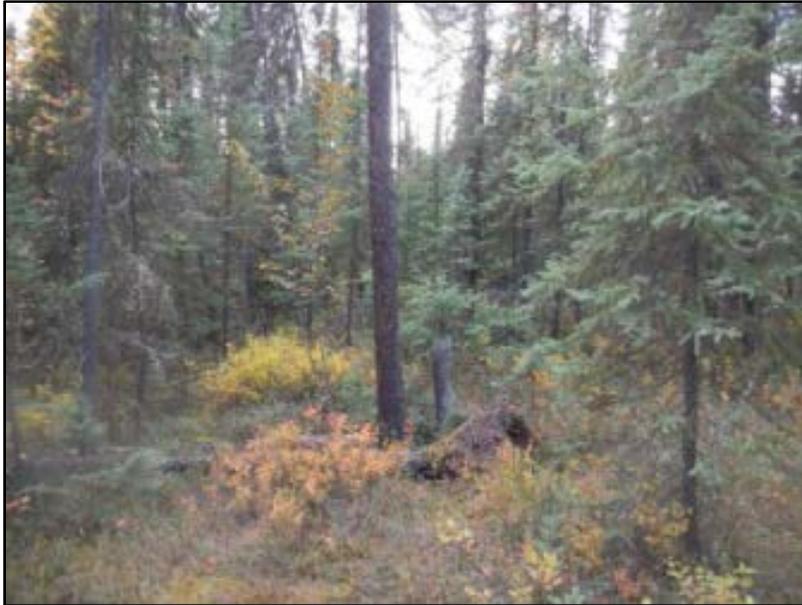
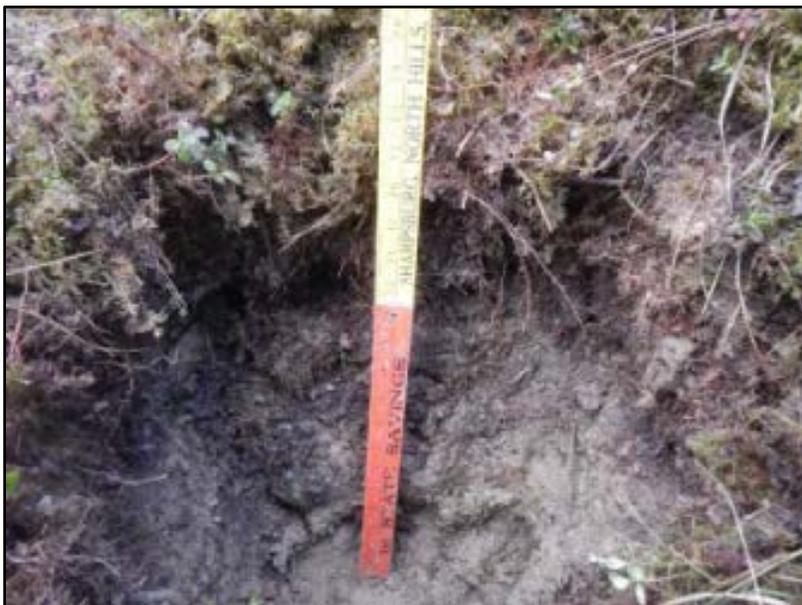
| <b>Site Number:</b> 24<br><b>Date:</b> 09/10/2013 | <b>Notes:</b> | Black spruce ( <i>Picea mariana</i> ) forested wetland with hummocks. Road is approximately 100 feet downslope of the sample point. |

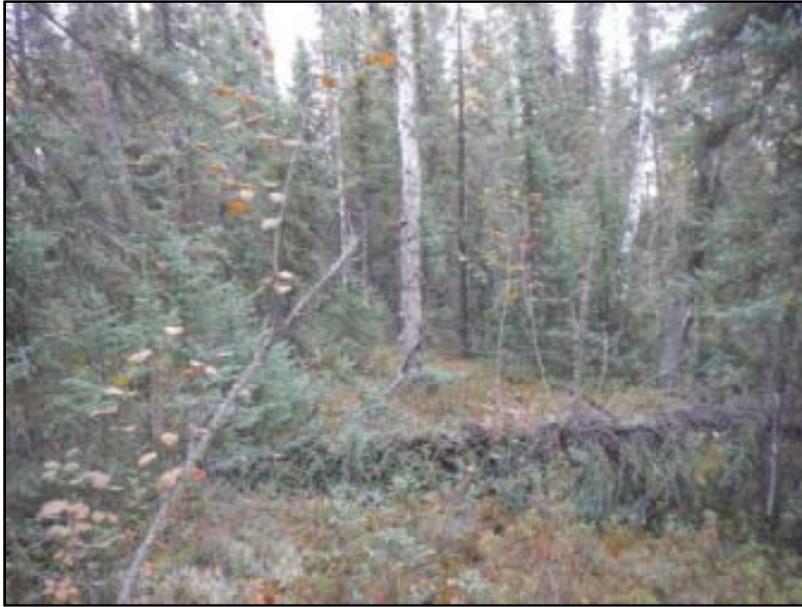
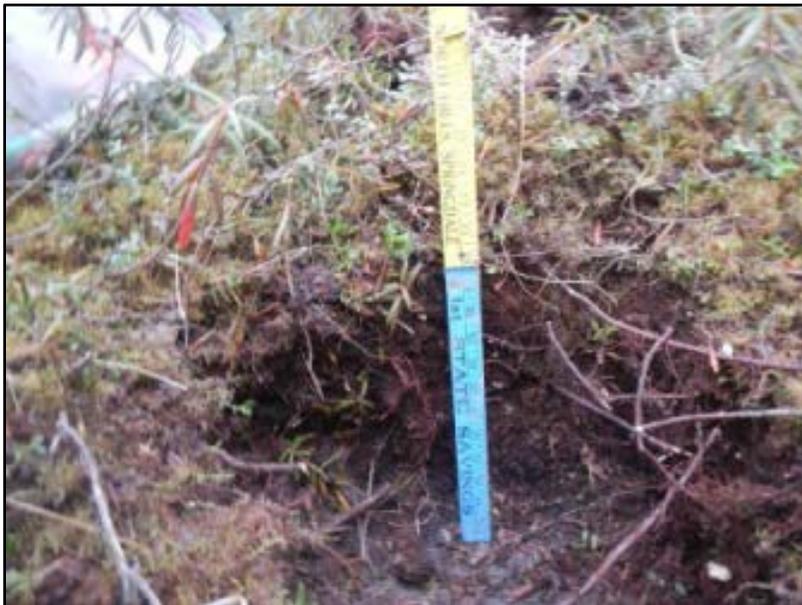
| <b>Site Number: 25<br/>Date: 09/10/2013</b> | <b>Notes:</b> Predominantly Black spruce ( <i>Picea mariana</i> ) forested hillside. | |

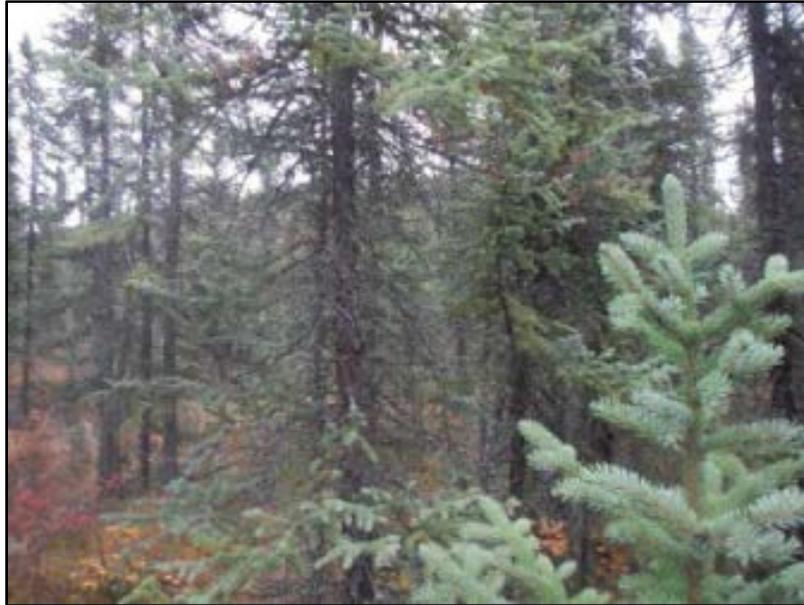
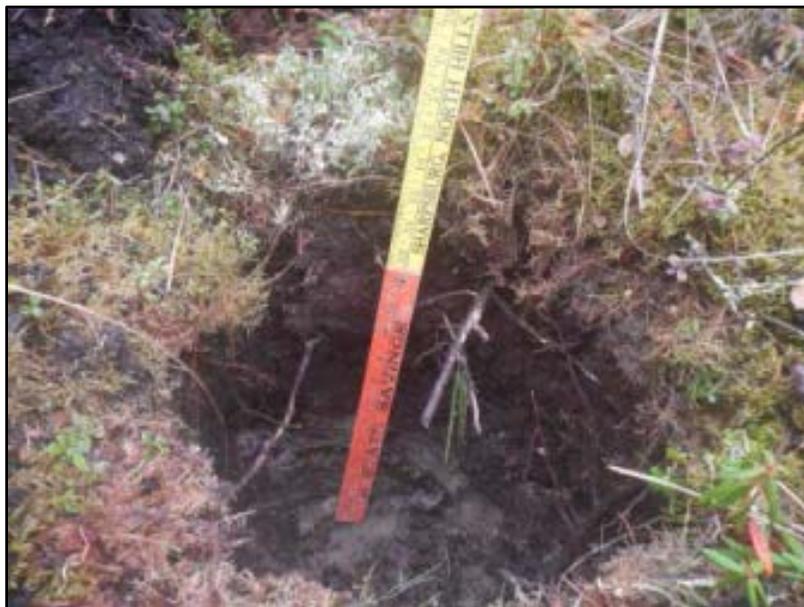
| <b>Site Number:</b> 26<br><b>Date:</b> 09/11/2013 | <b>Notes:</b> | Toe slope with black spruce ( <i>Picea mariana</i> ) and Barclay's willow ( <i>Salix barclayi</i> ). Large hummocks present at sample point and willows browsed by moose. |

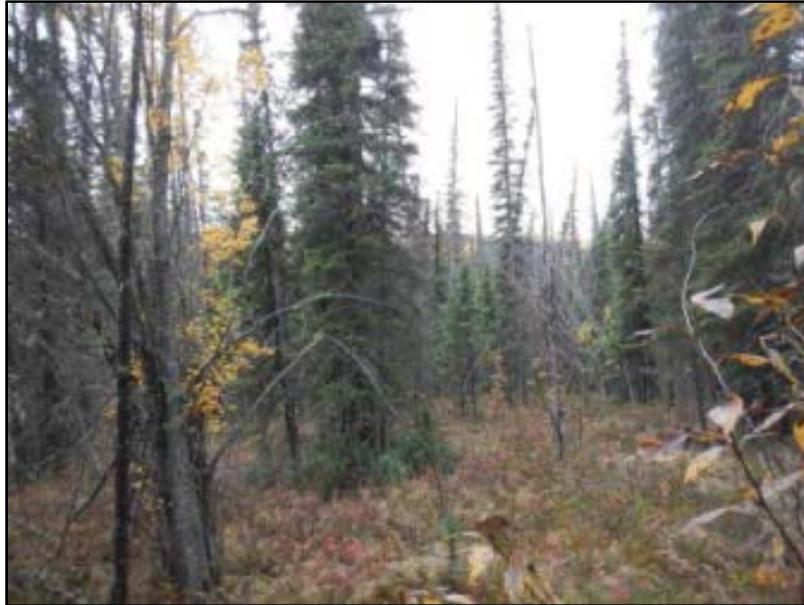
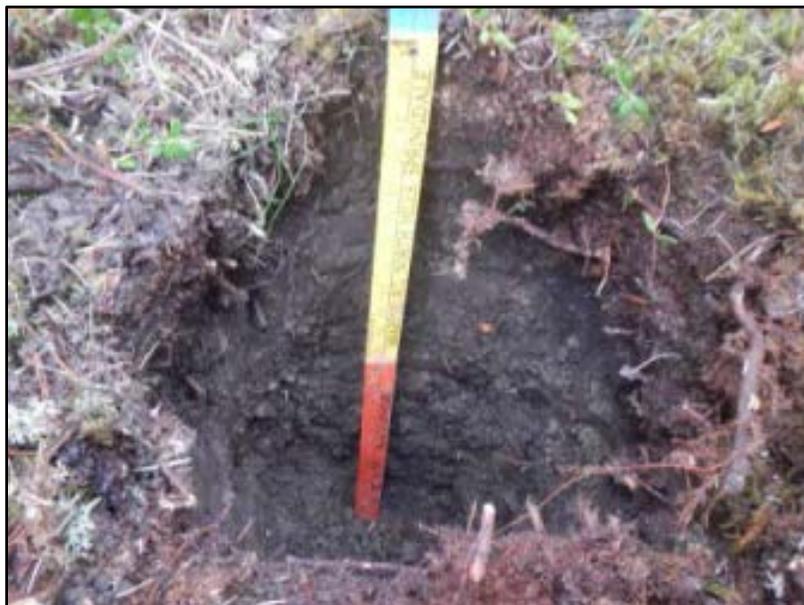
| <b>Site Number:</b> 27<br><b>Date:</b> 09/11/2013 | <b>Notes:</b> | Black spruce ( <i>Picea mariana</i> ) woodland with open pockets of shrubs. |

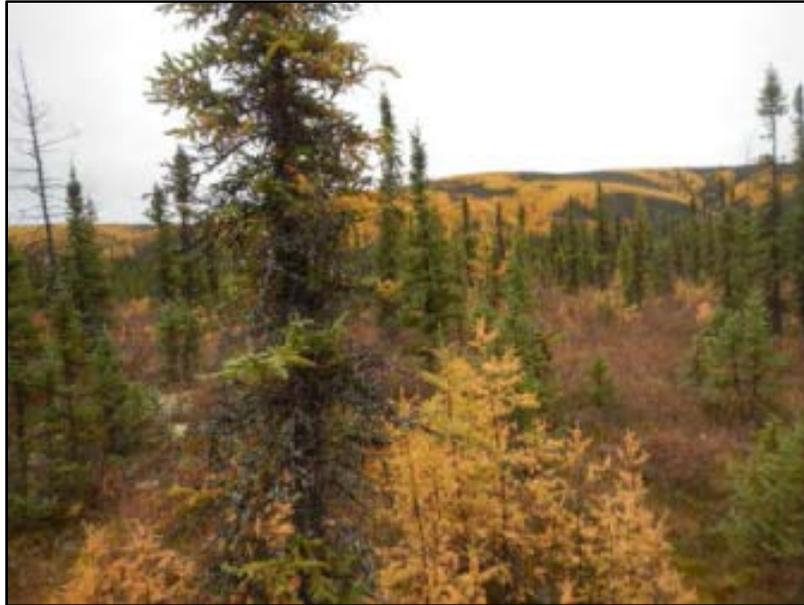
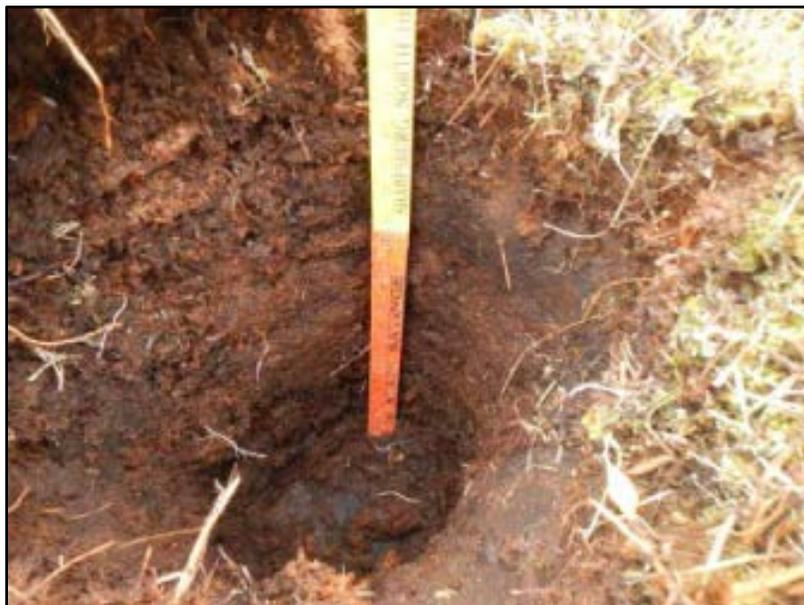
| <b>Site Number:</b> 28<br><b>Date:</b> 09/11/2013 | <b>Notes:</b> | Broad flood plain with sparsely dispersed black spruce ( <i>Picea mariana</i> ) below steep slope from upland area. Stunted trees present within the sample plot. |

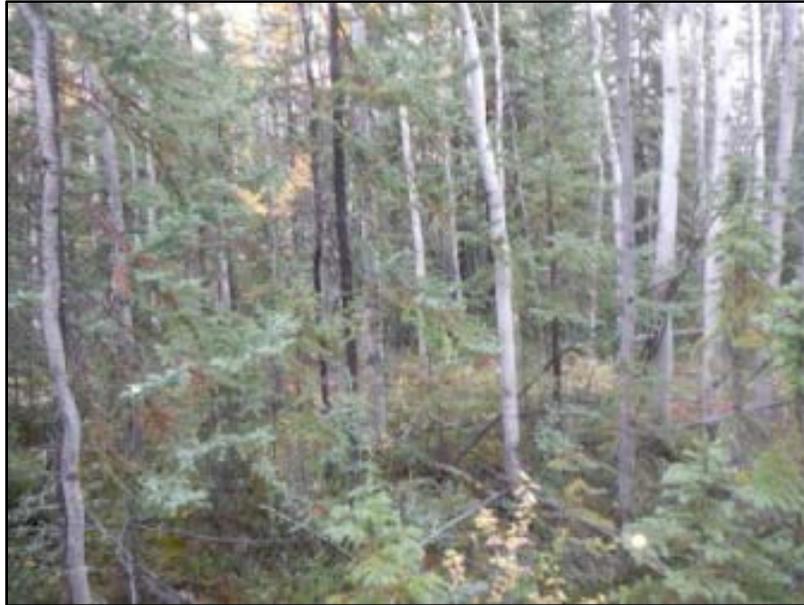
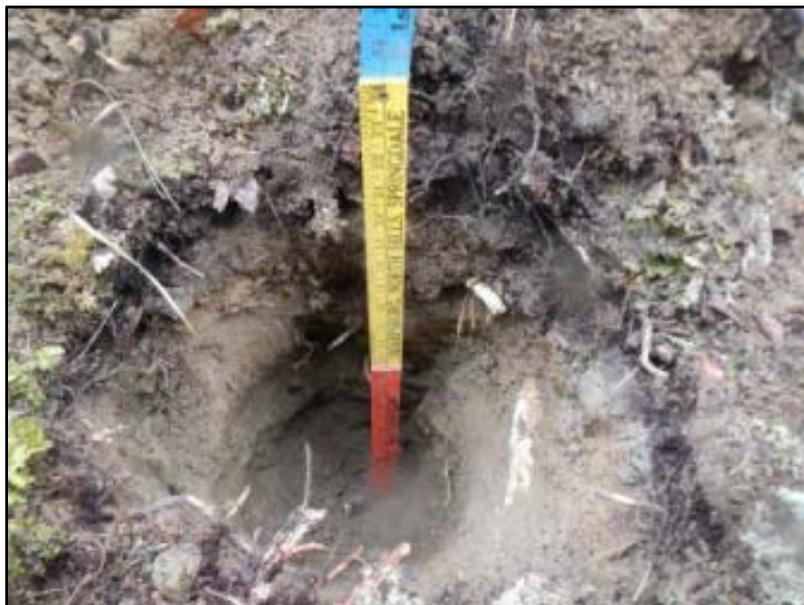
| <b>Site Number: 29<br/>Date: 09/11/2013</b> | <b>Notes:</b> | Quaking aspen ( <i>Populus tremuloides</i> ) and white spruce ( <i>Picea glauca</i> ) forested flat bench area leading to a steep slope heading towards a creek. |

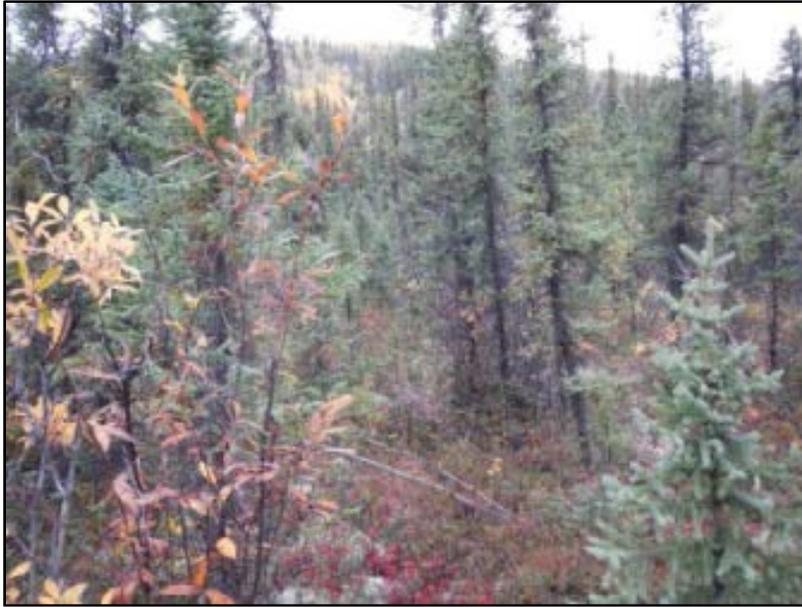
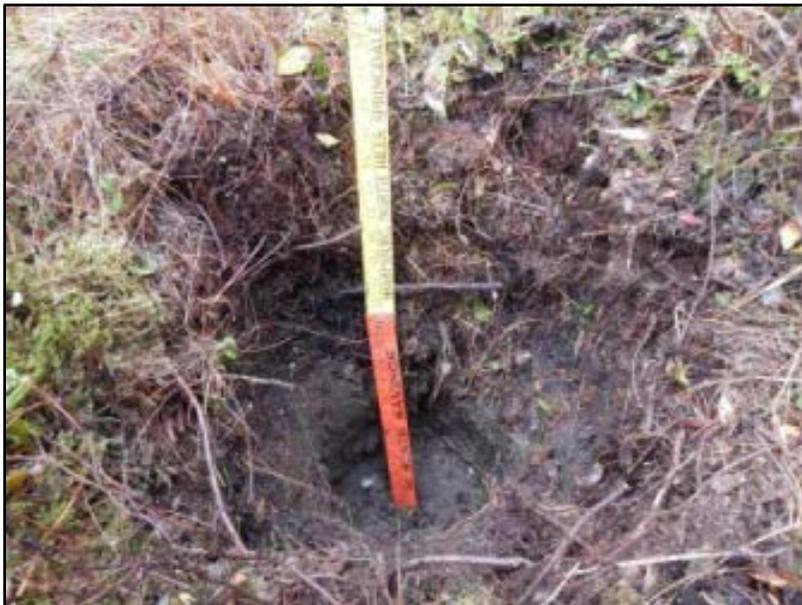
| <b>Site Number:</b> 30<br><b>Date:</b> 09/11/2013 | <b>Notes:</b> | Black spruce ( <i>Picea mariana</i> ) and Barclay's willow ( <i>Salix barclayi</i> ) on saturated toe slope leading to upland approximately 150 feet away. |

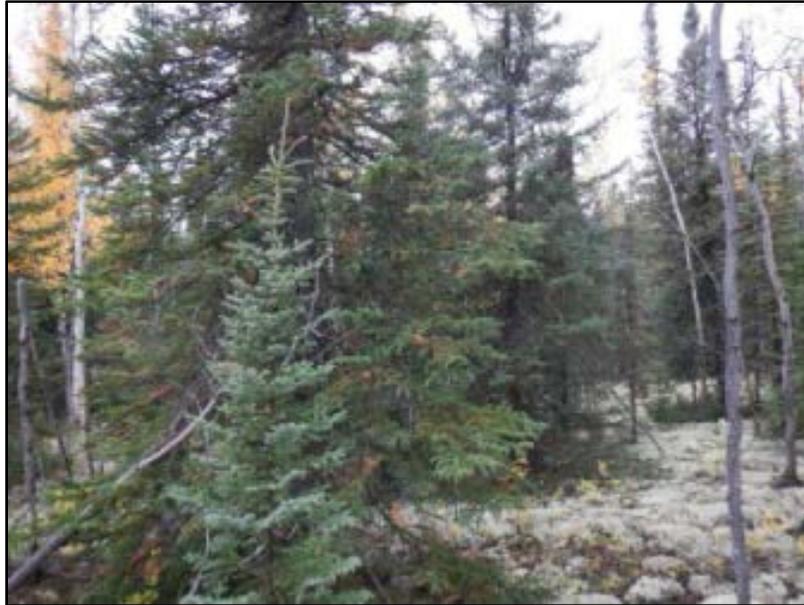
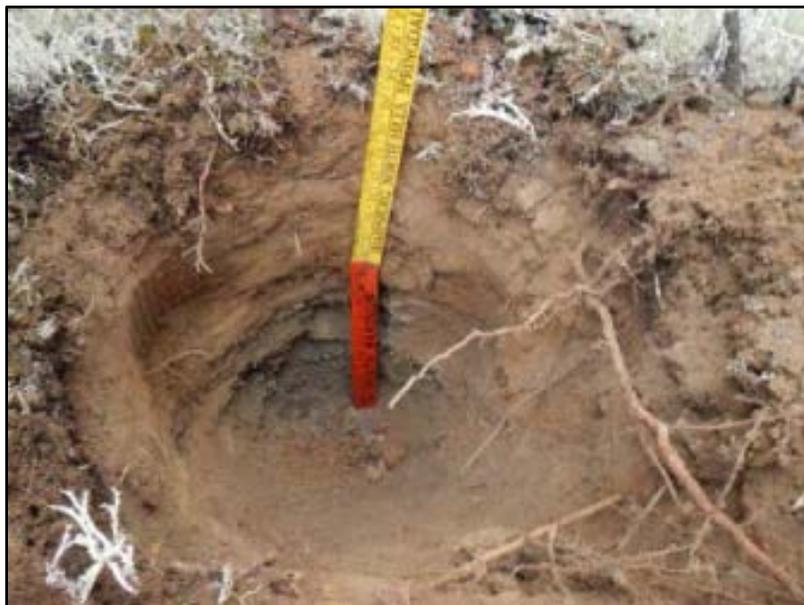
| <b>Site Number:</b> 32<br><b>Date:</b> 09/11/2013 | <b>Notes:</b> | Sample point 32 consisted of mature resin birch ( <i>Betula neoalaskana</i> ) and white spruce ( <i>Picea glauca</i> ) forest located on a toeslope. |

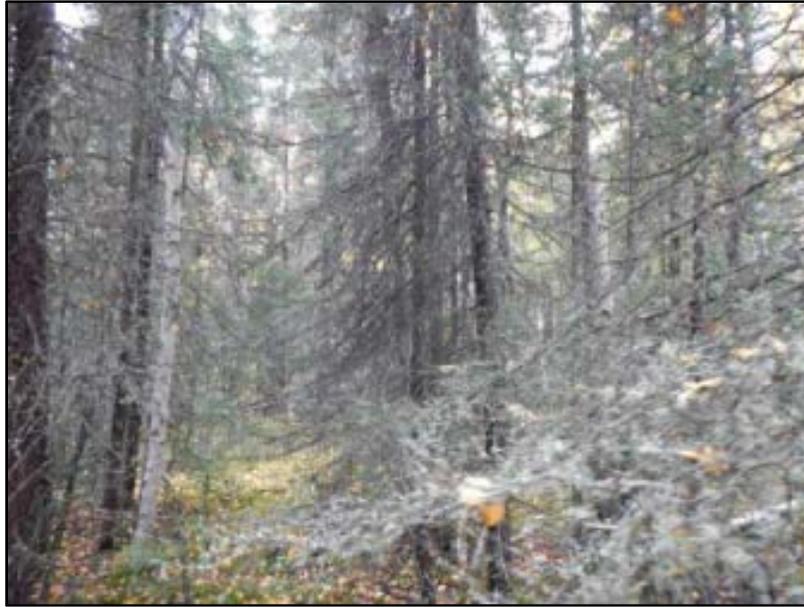
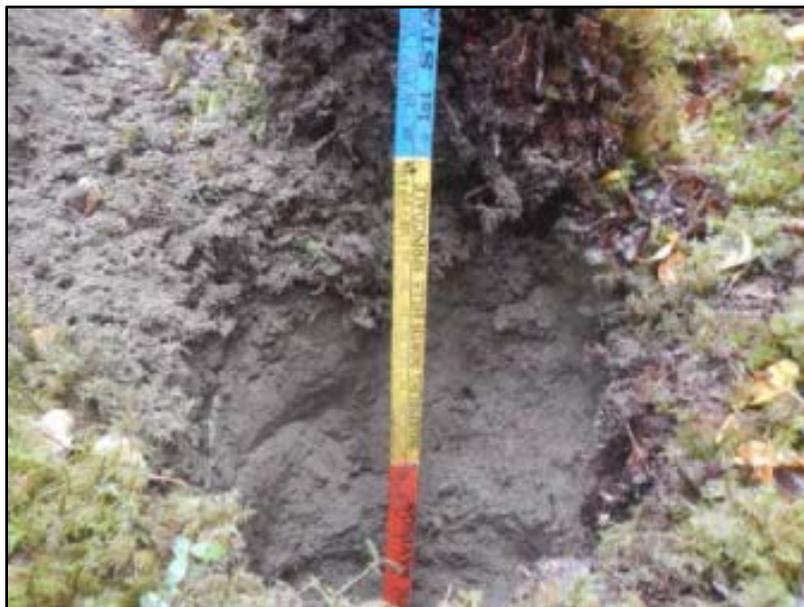
| <b>Site Number:</b> 33<br><b>Date:</b> 09/11/2013 | <b>Notes:</b> | Quaking aspen ( <i>Populus tremuloides</i> ) and white spruce ( <i>Picea glauca</i> ) forested hillside with evidence of fire previously in area observed. |

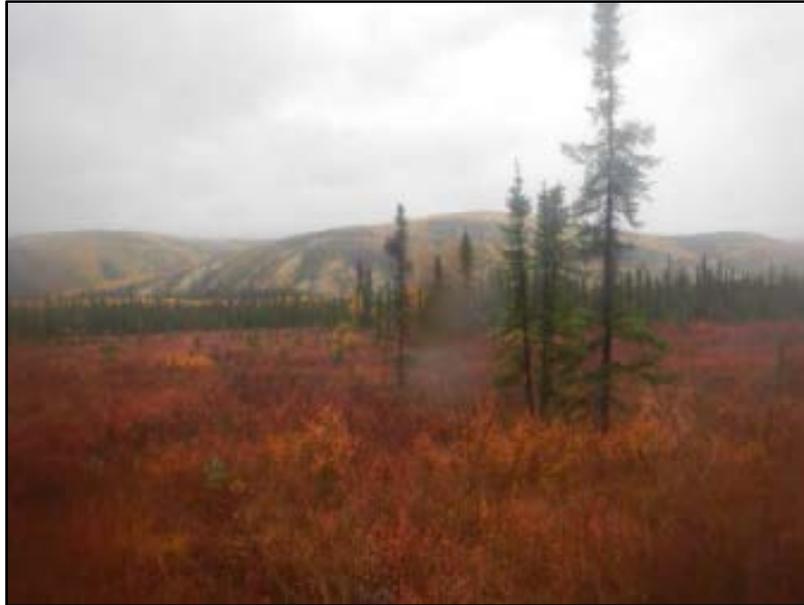
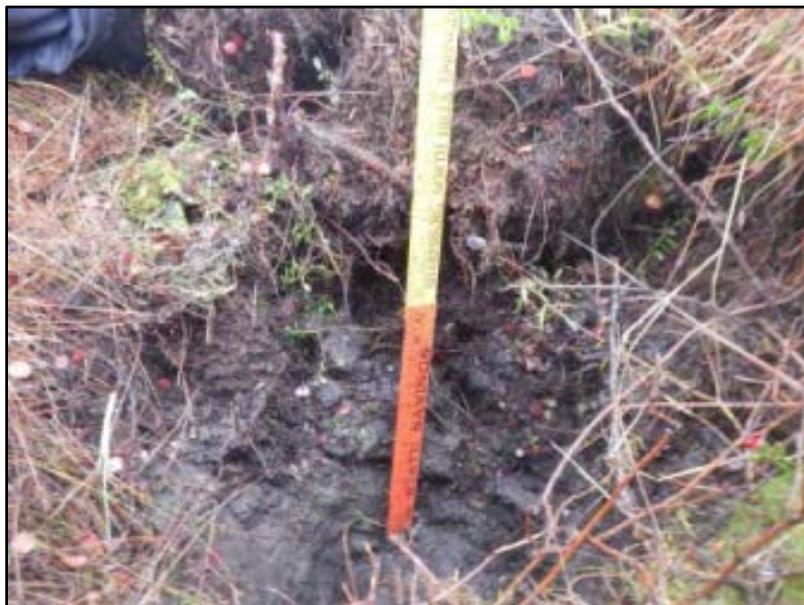
| <b>Site Number:</b> 34<br><b>Date:</b> 09/11/2013 | <b>Notes:</b> | Creek observed between points 34 and 35. The creek is recessed 5 feet below terrace. |

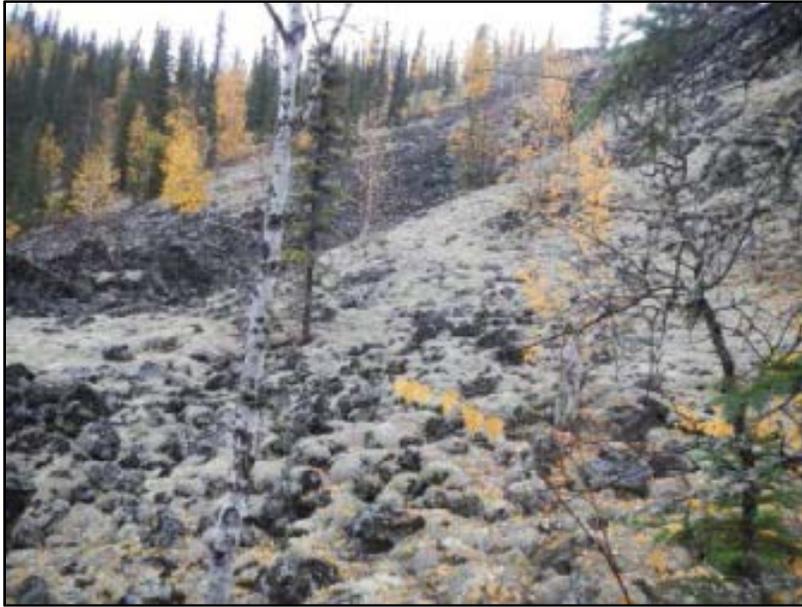
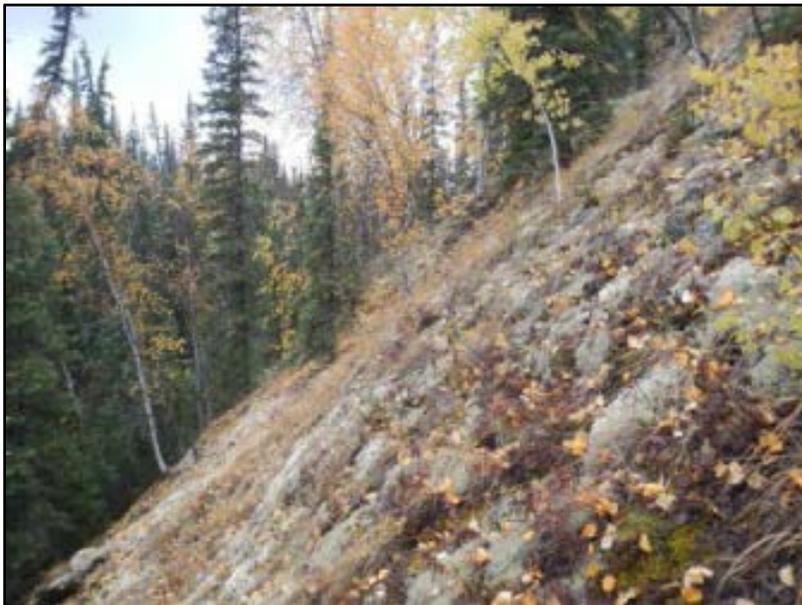
| <b>Site Number:</b> 36<br><b>Date:</b> 09/11/2013 | <b>Notes:</b> | Sample point located on a steep lichen slope dominated by black spruce ( <i>Picea mariana</i> ), resin birch ( <i>Betula neolaskana</i> ) and green alder ( <i>Alnus viridis</i> ). Surface water present in small creek channel. |

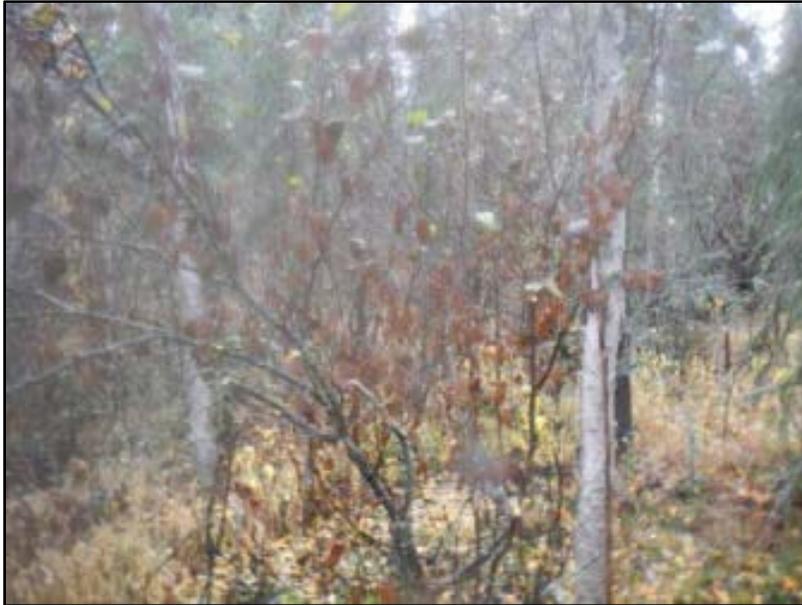
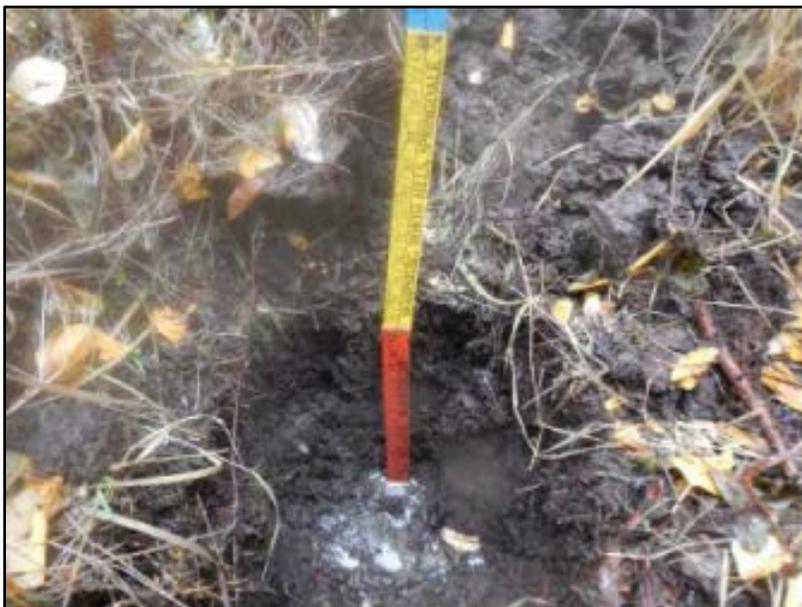
| <b>Site Number:</b> 37<br><b>Date:</b> 09/12/2013 | <b>Notes:</b> | Black spruce ( <i>Picea mariana</i> ) and bebb willow ( <i>Salix bebbiana</i> ) swale with drainage patterns present all over the sample area. |

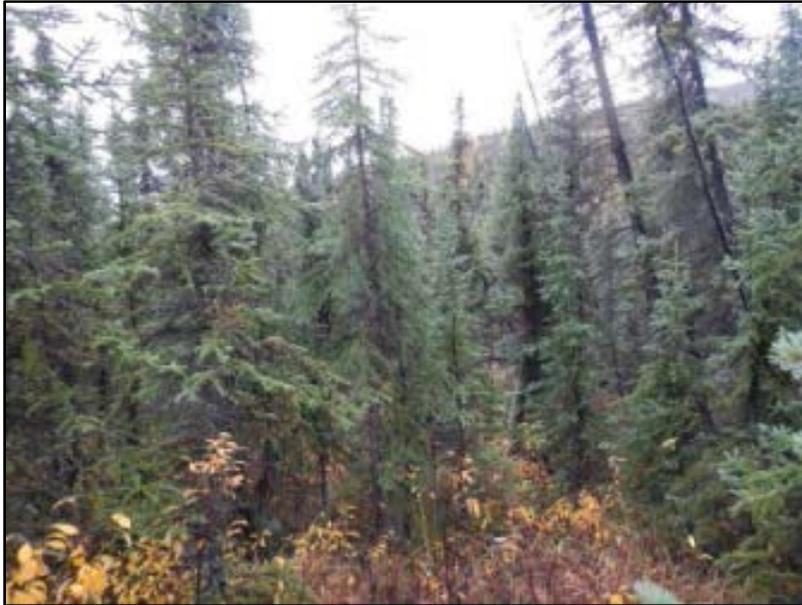
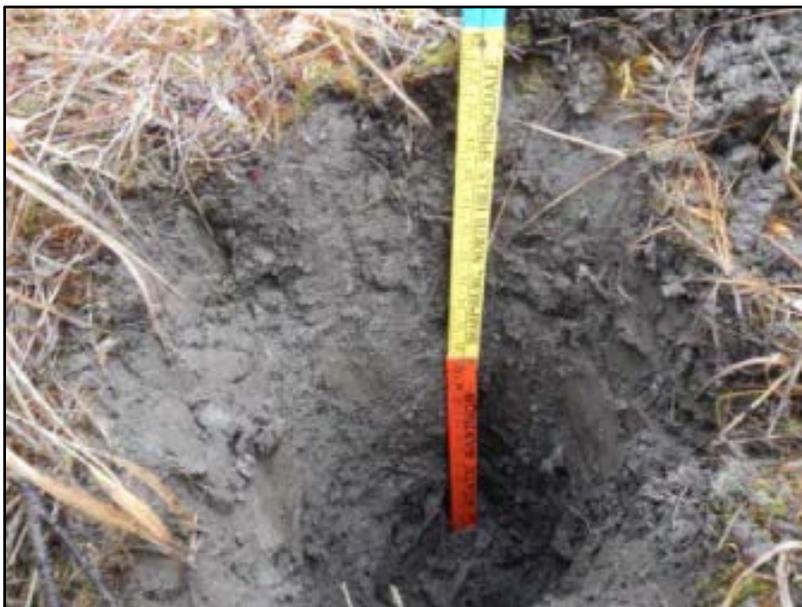
| <b>Site Number:</b> 37<br><b>Date:</b> 09/12/2013 | <b>Notes:</b> | Drainage ditch and sediment deposits within wetland area at sample point 37. |

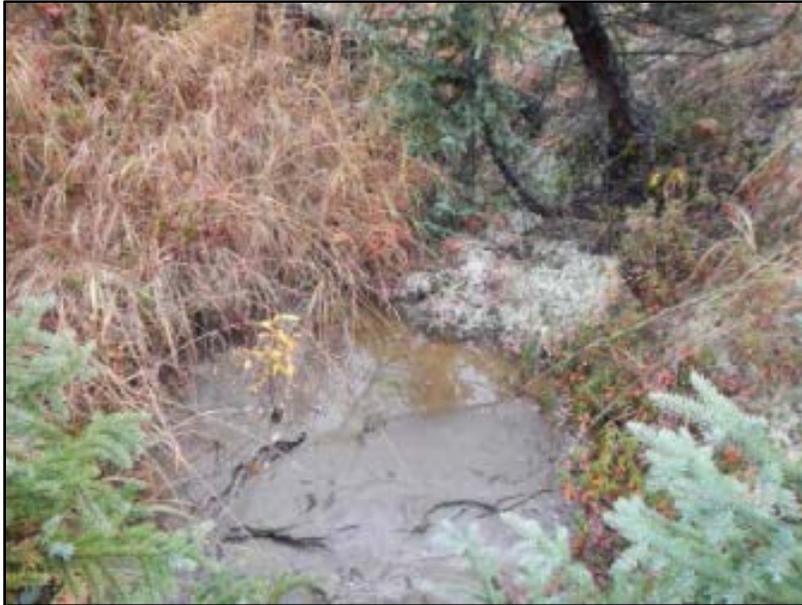
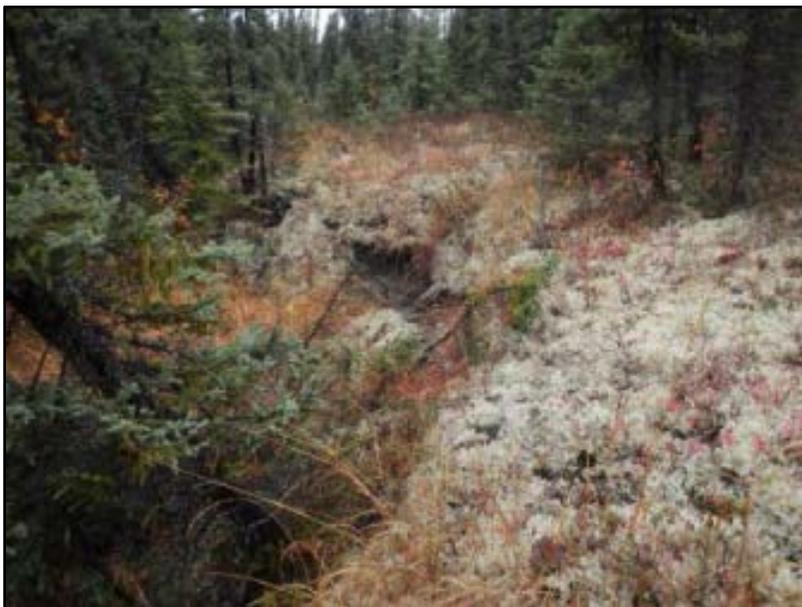
| <b>Site Number:</b> 38<br><b>Date:</b> 09/12/2013 | <b>Notes:</b> | Sample point consisted of mostly black spruce ( <i>Picea mariana</i> ) with small benches and large hummocks present. |

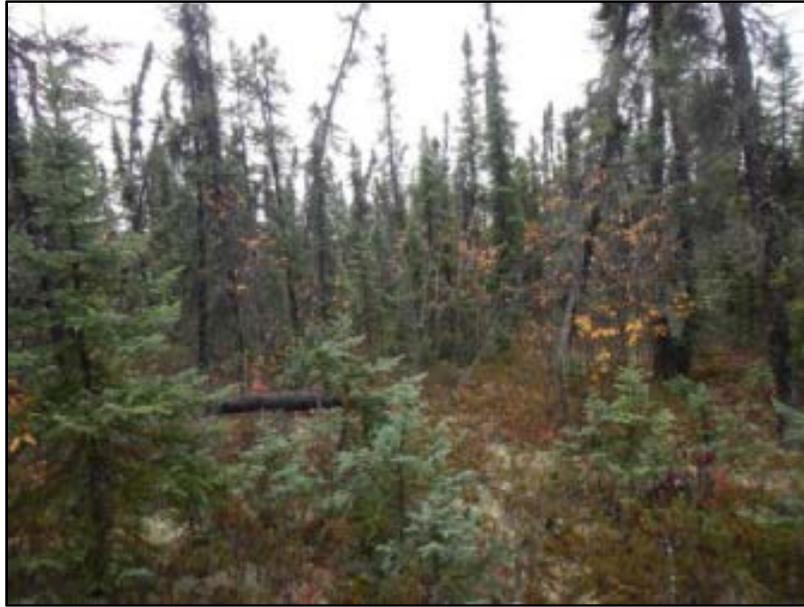
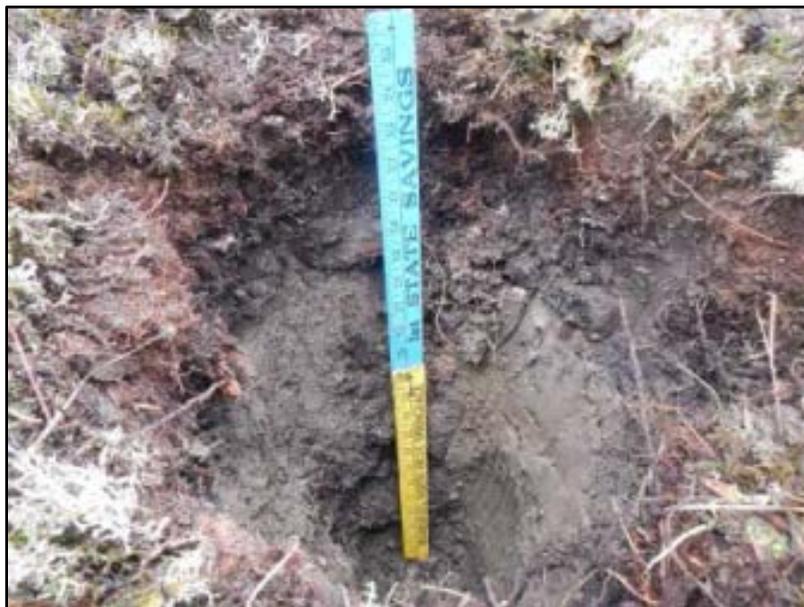
| <b>Site Number:</b> 39<br><b>Date:</b> 09/12/2013 | <b>Notes:</b> | Sample point 39 was taken at the edge of a very wet black spruce ( <i>Picea mariana</i> ) bog with surface water present. Saturated black spruce groves. |

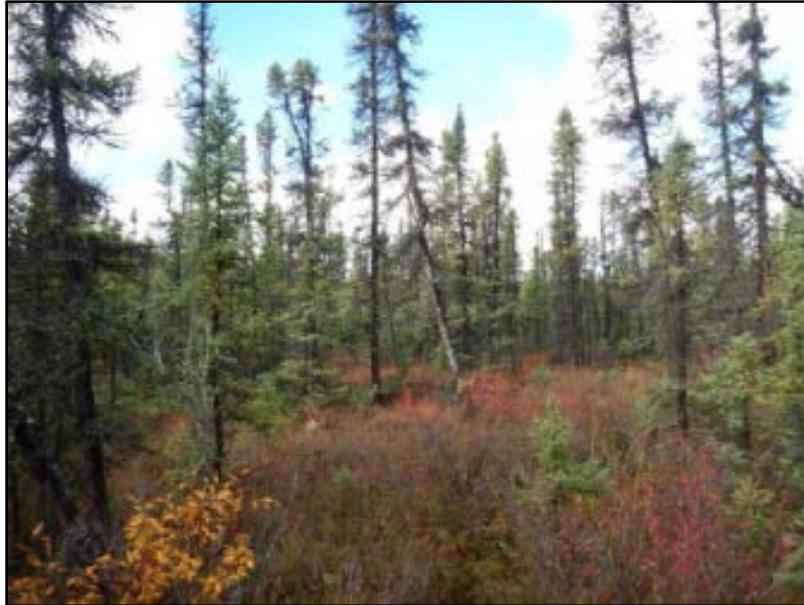
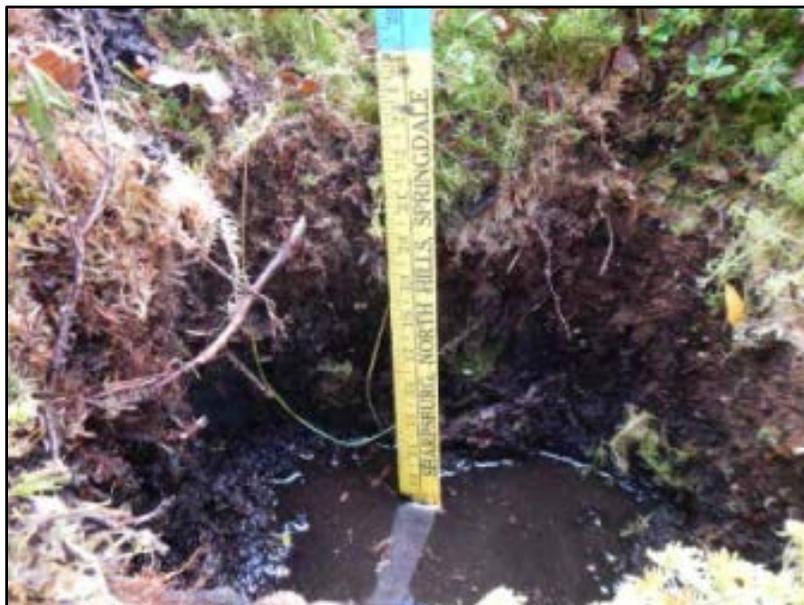
| <b>Site Number:</b> 40<br><b>Date:</b> 09/12/2013 | <b>Notes:</b> | Flat area with stunted black spruce ( <i>Picea mariana</i> ) and hummocks near a creek. Perched water table present. |

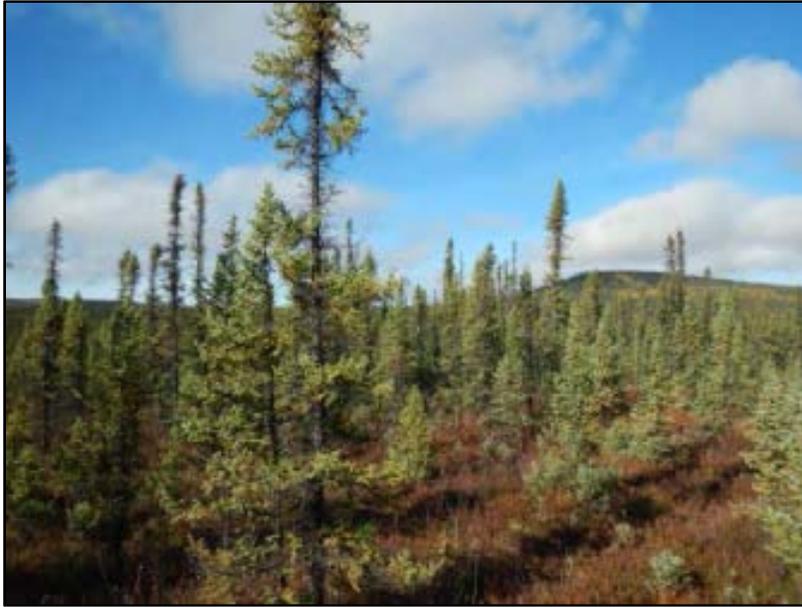
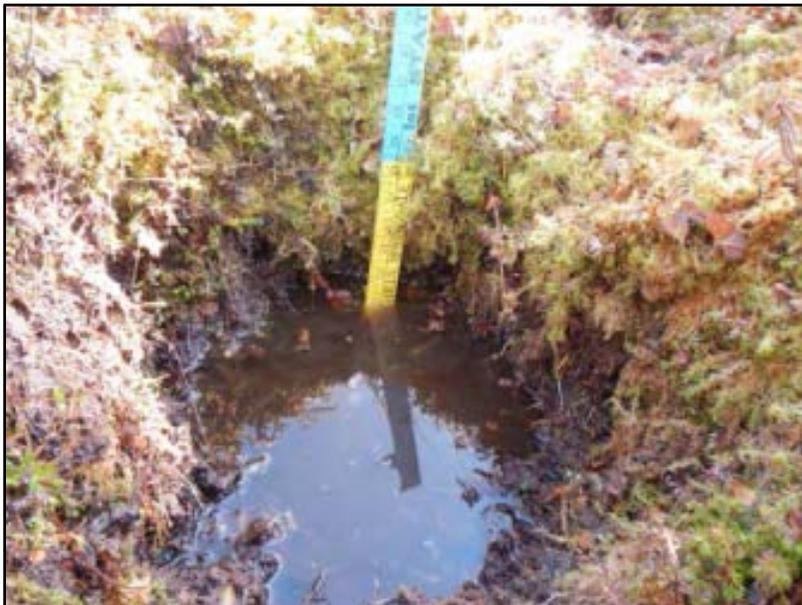
| <b>Site Number:</b> 41<br><b>Date:</b> 09/12/2013 | <b>Notes:</b> | Black spruce ( <i>Picea mariana</i> ) and willow ( <i>Salix</i> ) area with lichen and tussocks understory. Willows heavily browsed by moose. |
