# Preliminary Wetlands Delineation and Functions and Values Assessment

Dalton Highway Mileposts 0 to 9

**PRELIMINARY WETLANDS DELINEATION  
AND  
FUNCTIONS AND VALUES ASSESSMENT  
DALTON HIGHWAY MILEPOSTS 0 TO 9 RECONSTRUCTION**

Department of Transportation and Public Facilities Project No.: 60911  
Federal Project No.: STP-0652(16)

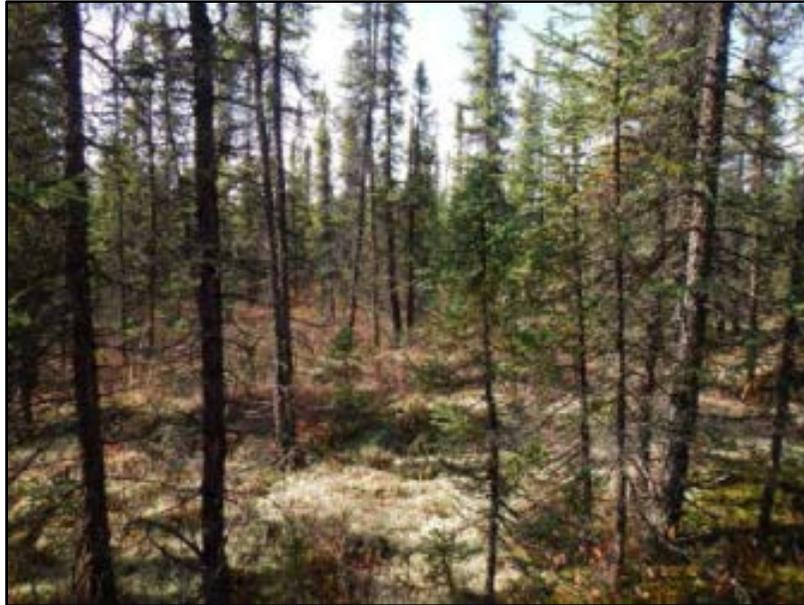
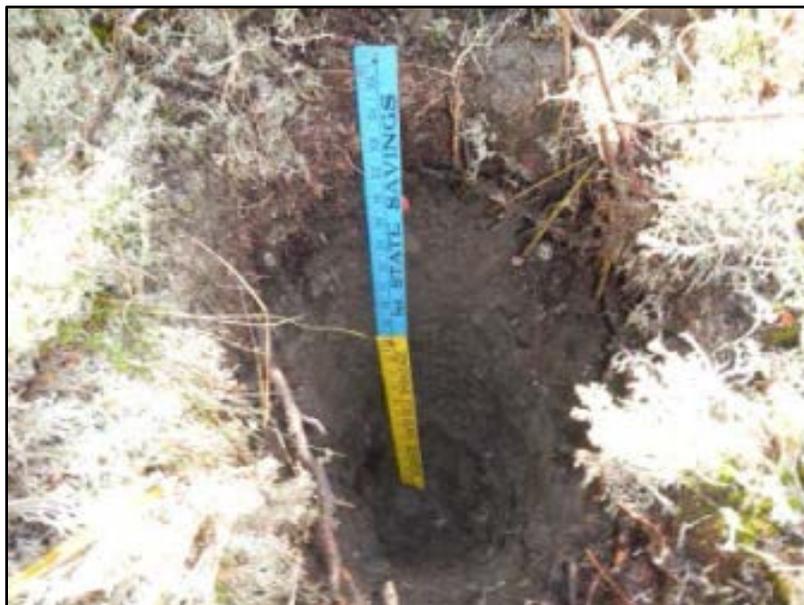
| <b>Site Number: 41<br/>Date: 09/12/2013</b> | <b>Notes:</b> Surface water observed between sample points 41 and 42. | |

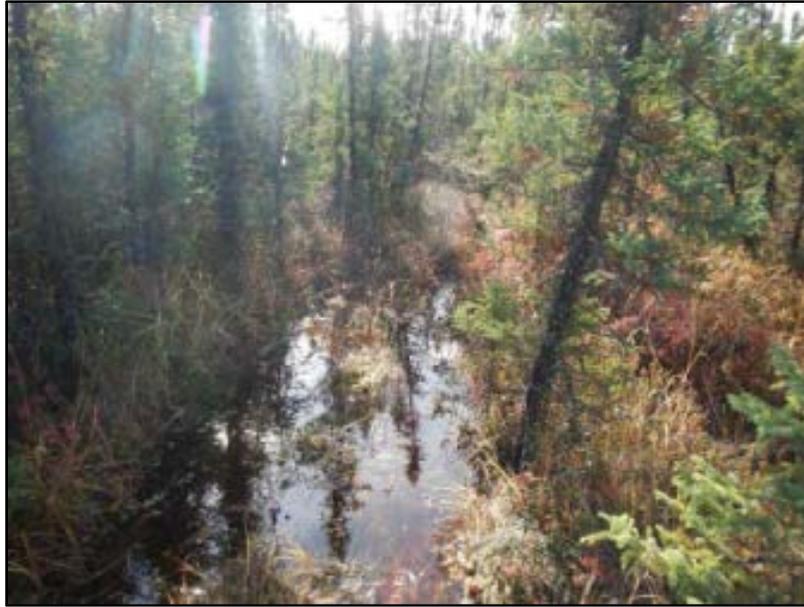
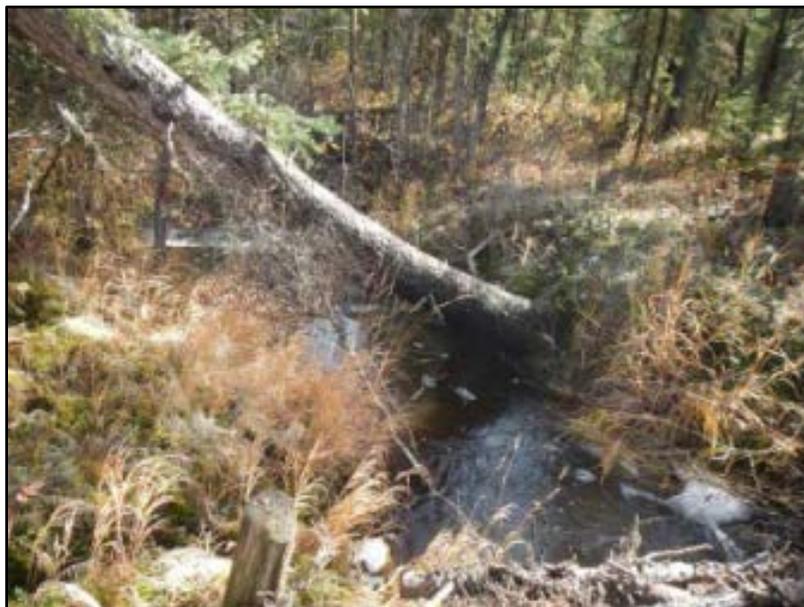
| <b>Site Number:</b> 42<br><b>Date:</b> 09/12/2013 | <b>Notes:</b> | White spruce ( <i>Picea glauca</i> ) and balsam poplar ( <i>Populus balsamifera</i> ) upland. Transition point with wetland on other side of river. |

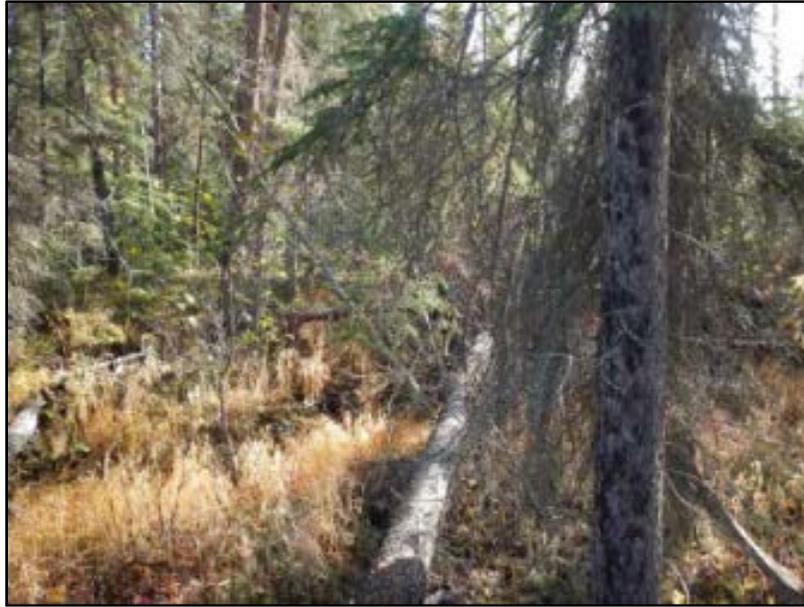
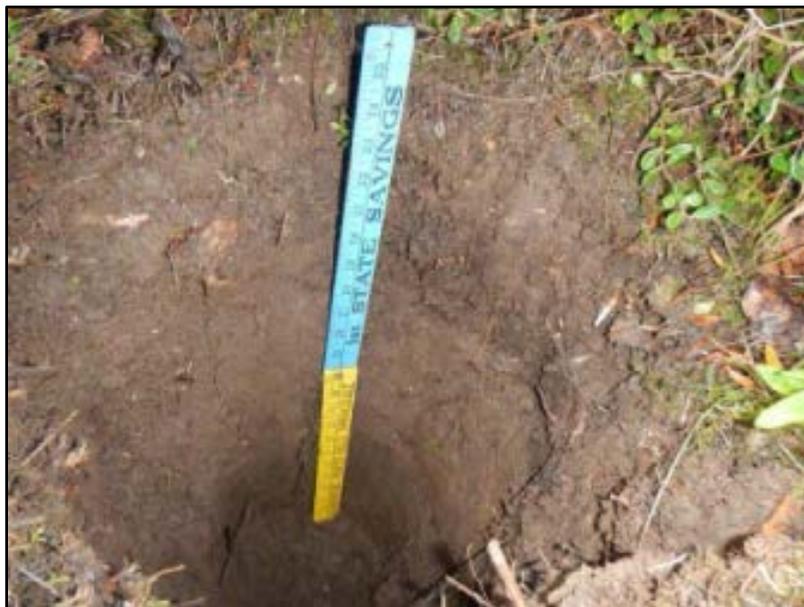
| <b>Site Number:</b> 43<br><b>Date:</b> 09/12/2013 | <b>Notes:</b> | Sample point is located downslope of road with an ATV trail 30 feet to the east. Black spruce ( <i>Picea mariana</i> ) is dominant vegetation species. |

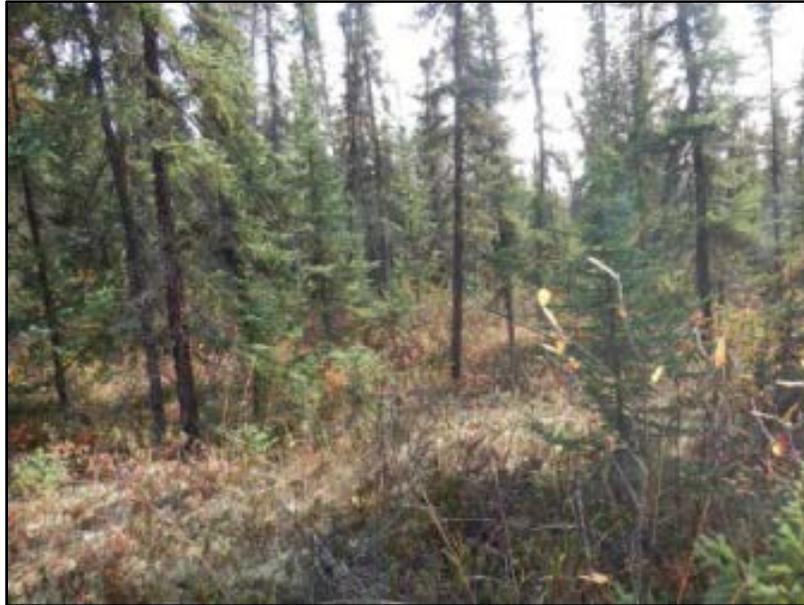
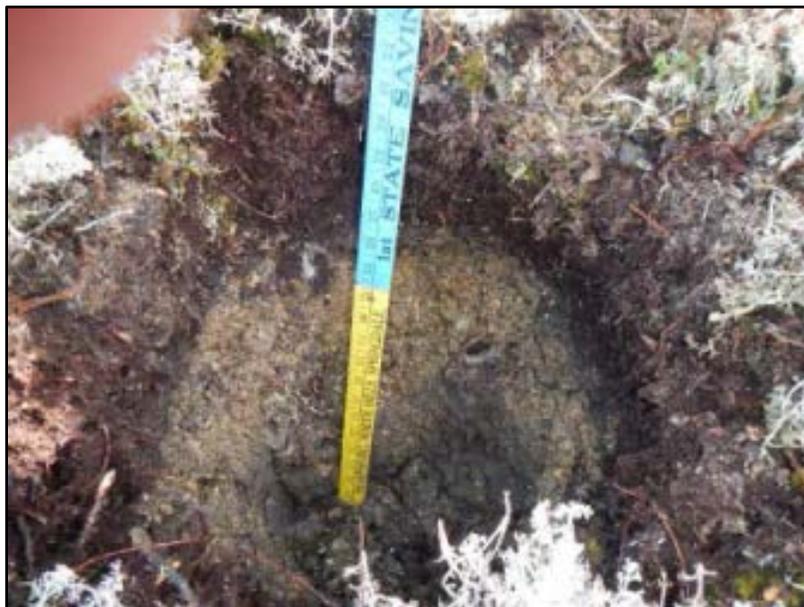
| <b>Site Number: 44<br/>Date: 09/12/2013</b> | <b>Notes:</b> | Black spruce ( <i>Picea mariana</i> ) forested upland with some birch mixed in and lots of lichen present. |

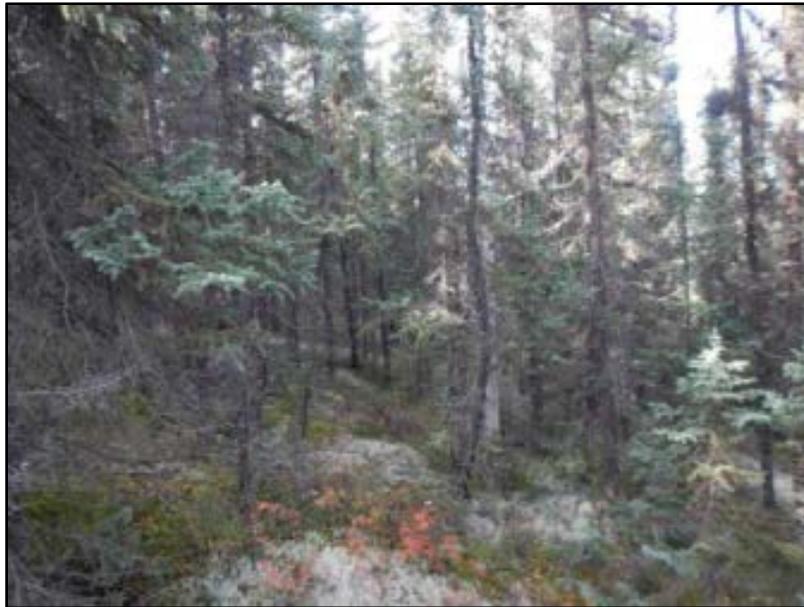
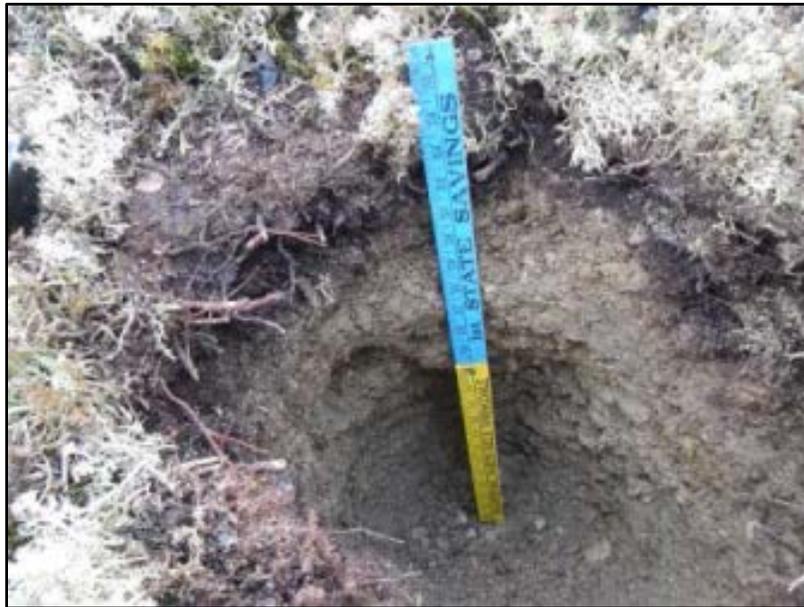
| <b>Site Number:</b> 45<br><b>Date:</b> 09/12/2013 | <b>Notes:</b> | Steep black spruce ( <i>Picea mariana</i> ) forested slope with stunted spruce present and some surface water and tussocks observed. |

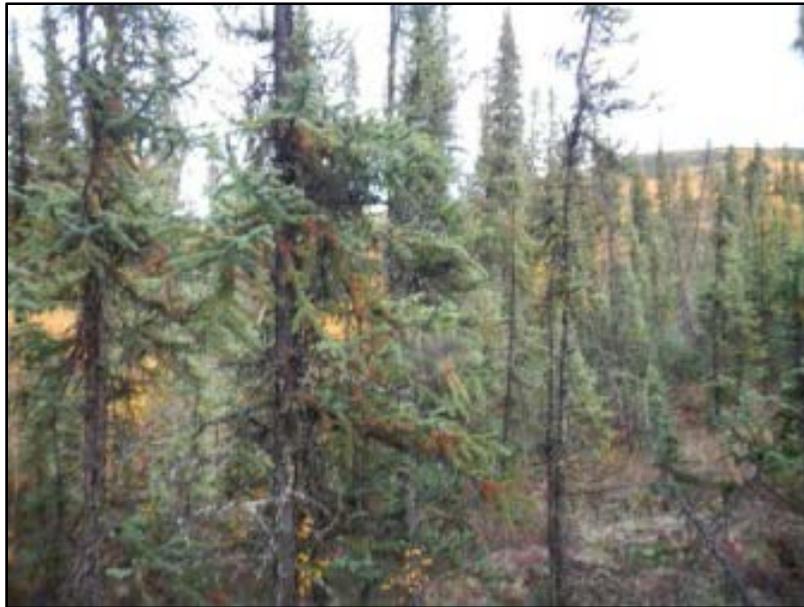
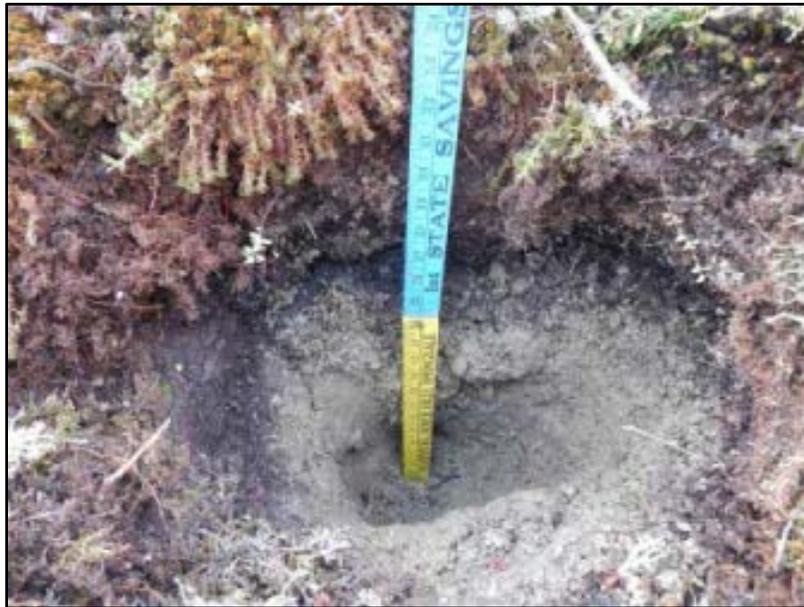
| <b>Site Number: 46<br/>Date: 09/12/2013</b> | <b>Notes:</b> | Road is upslope of sample point and there is a creek present downslope. Stunted black spruce ( <i>Picea mariana</i> ) and tussocks were observed. |

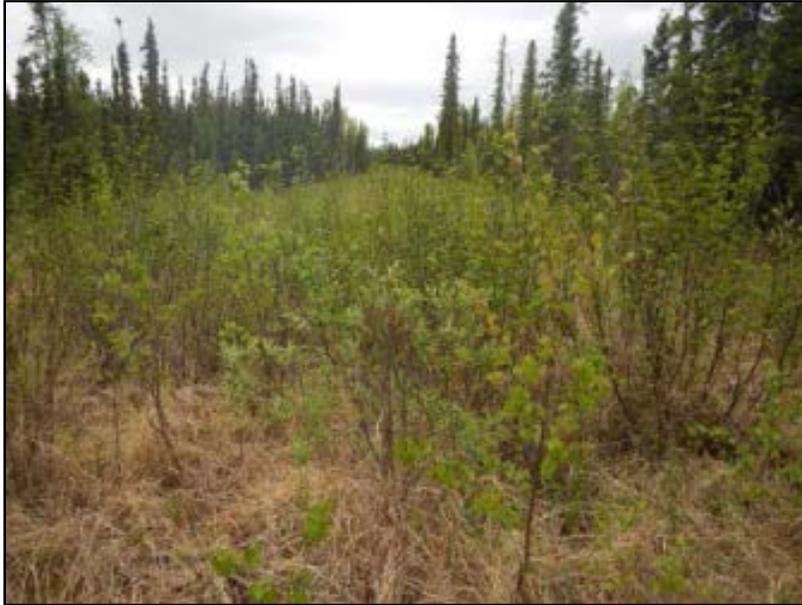
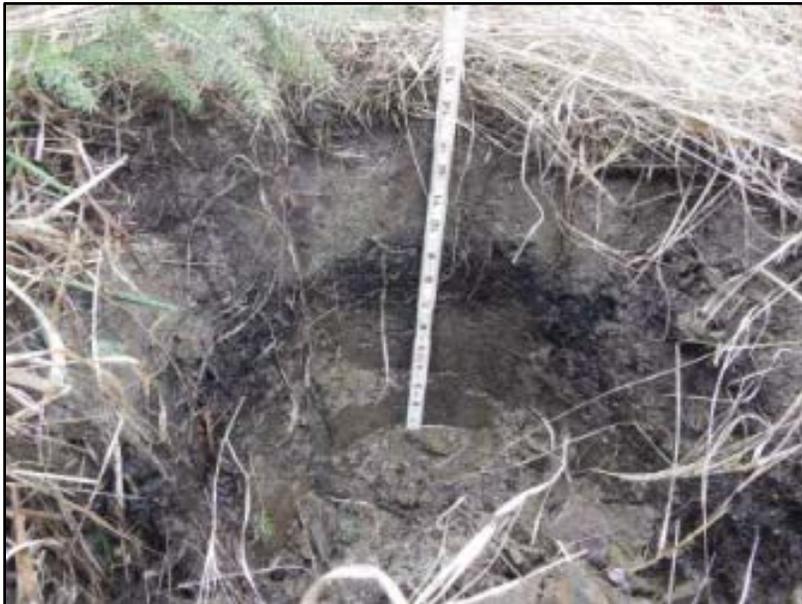
Sample location taken within clearcut utility corridor with 6 foot tall shrub layer. Vegetation dominated by *Alnus crispa* and *Calamagrostis canadensis*. Observation view point is oriented to the west.

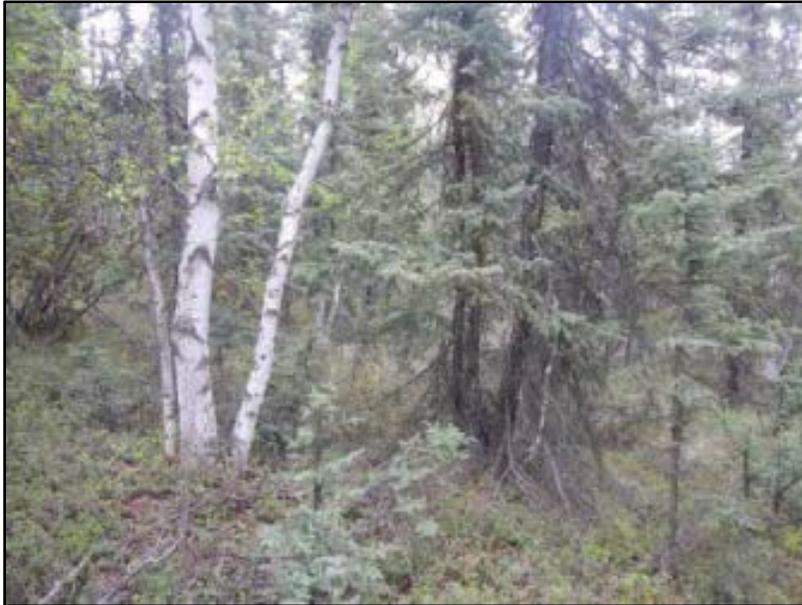
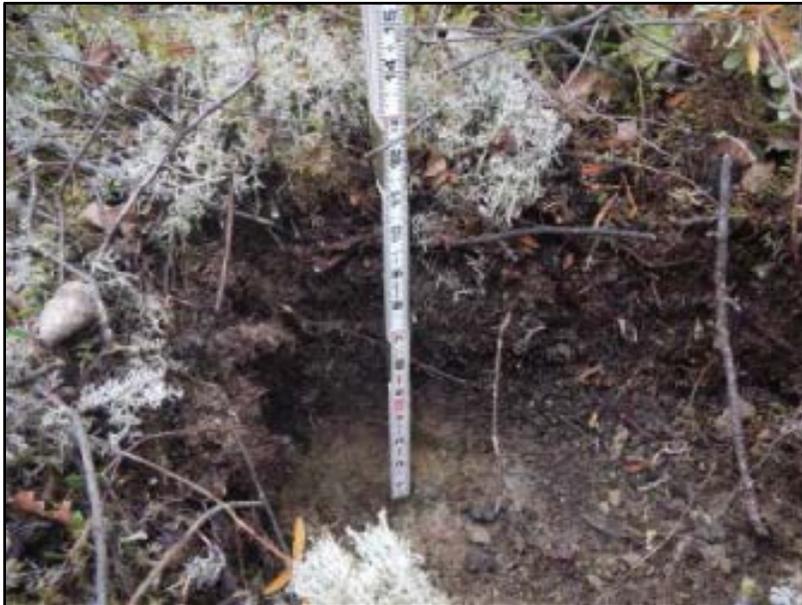
Sample point taken in an upland with vegetation dominated by *Picea mariana* in the tree layer, *Rhododendron groenlandicum* in the shrub layer and *Poa palustris* in the herbaceous layer. Observation view point is oriented to the east.

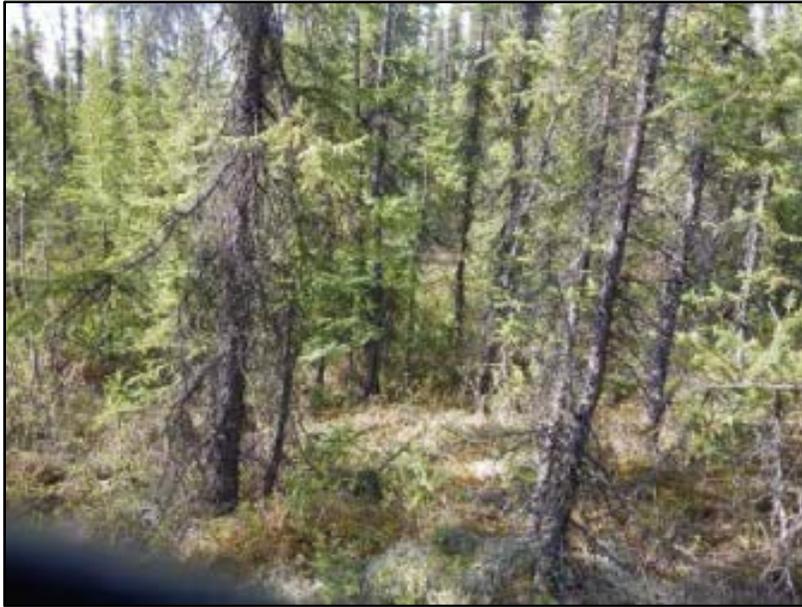
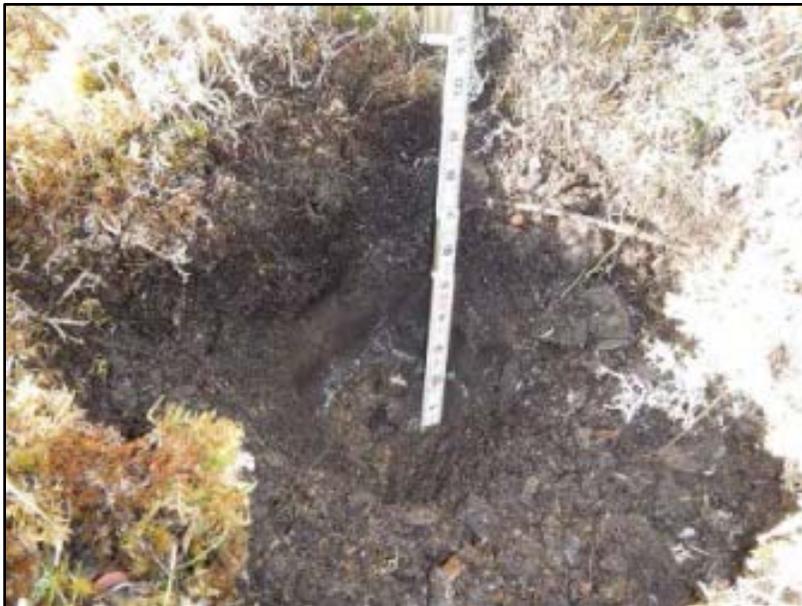
Sample point taken within a scrub shrub wetland with vegetation dominated by *Picea mariana* in the tree layer and shrub layer and *Glyceria grandis* in the herbaceous layer. Observation view point is oriented to the south.

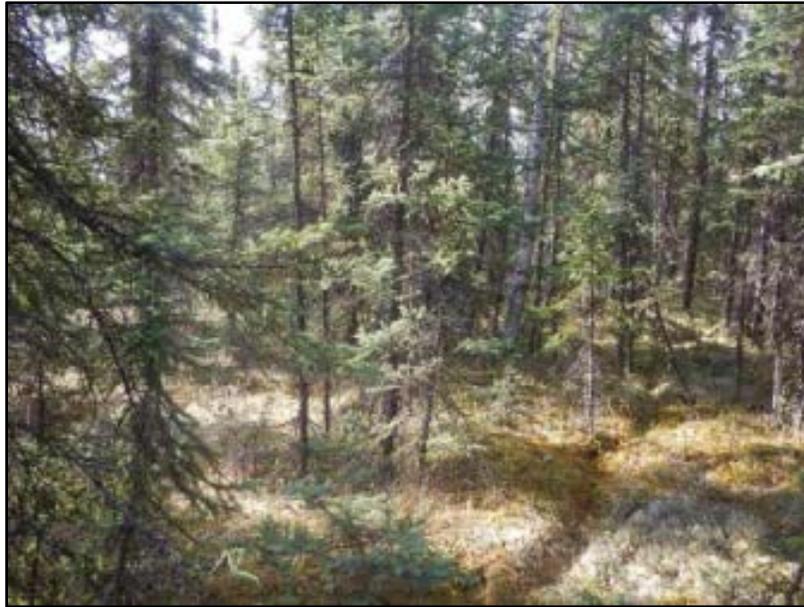
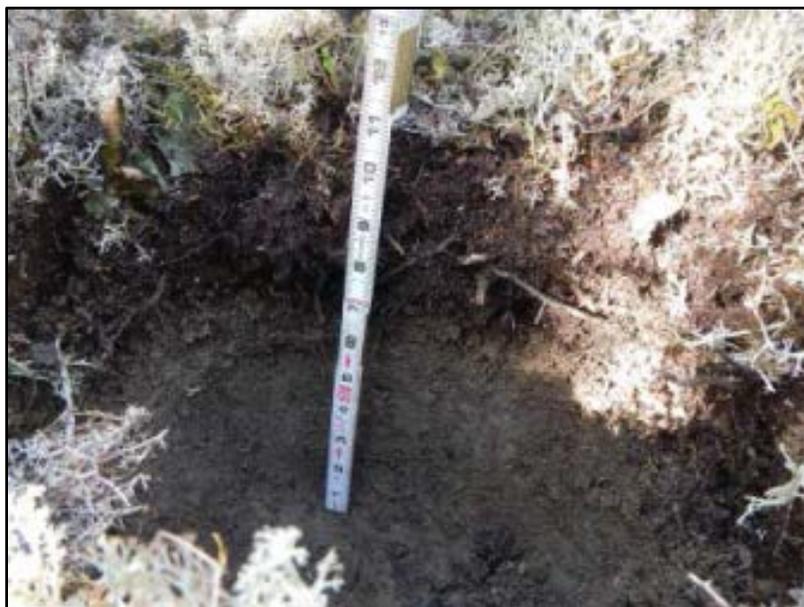
| <b>Site Number:</b> 106<br><b>Date:</b> 6/3/2014 | <b>Notes:</b> | Sample point taken within an upland dominated in the tree layer by <i>Picea mariana</i> , the shrub layer by <i>Vaccinium vitis-idaea</i> , and the herbaceous layer by <i>Cornus canadensis</i> and <i>Carex rostrata</i> . Observation view point is oriented to the south. |

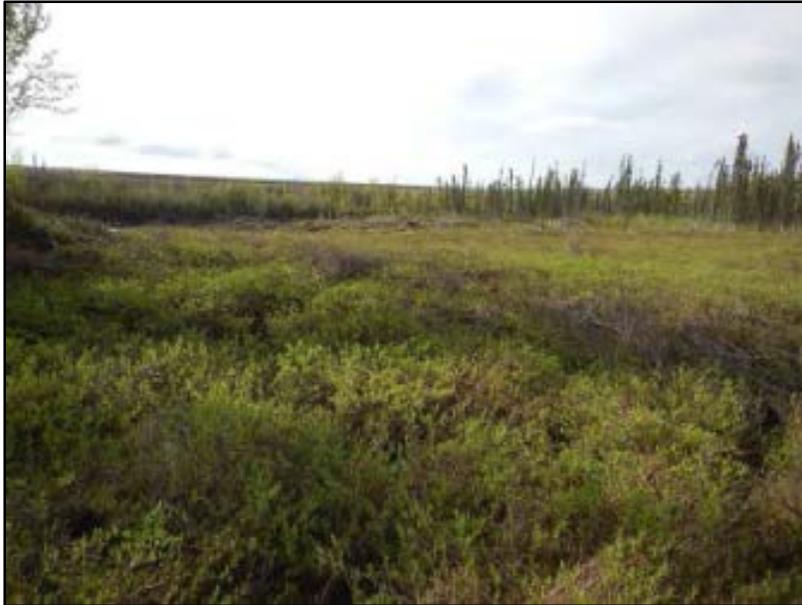
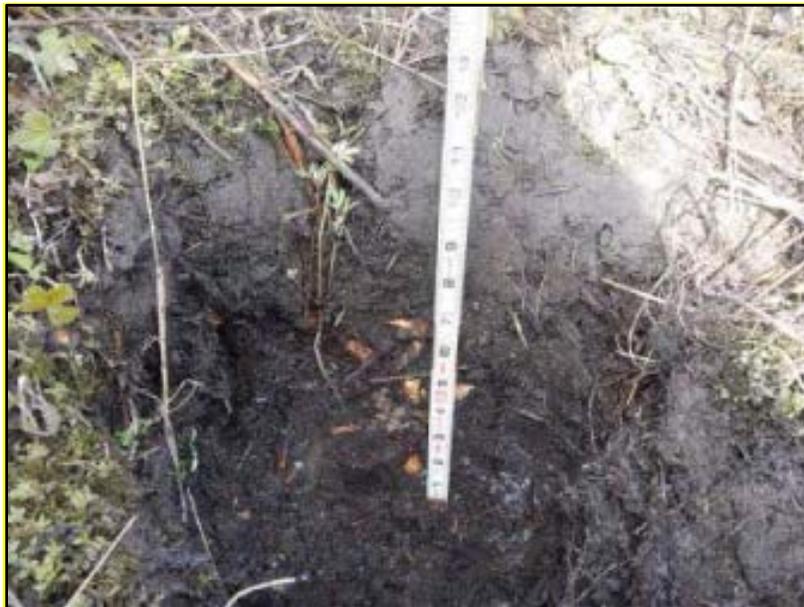
Sample point taken within a scrub shrub wetland with vegetation dominated by *Salix barclayi* in the shrub layer and *Calamagrostis canadensis* in the herbaceous layer. Observation view point is oriented to the south.

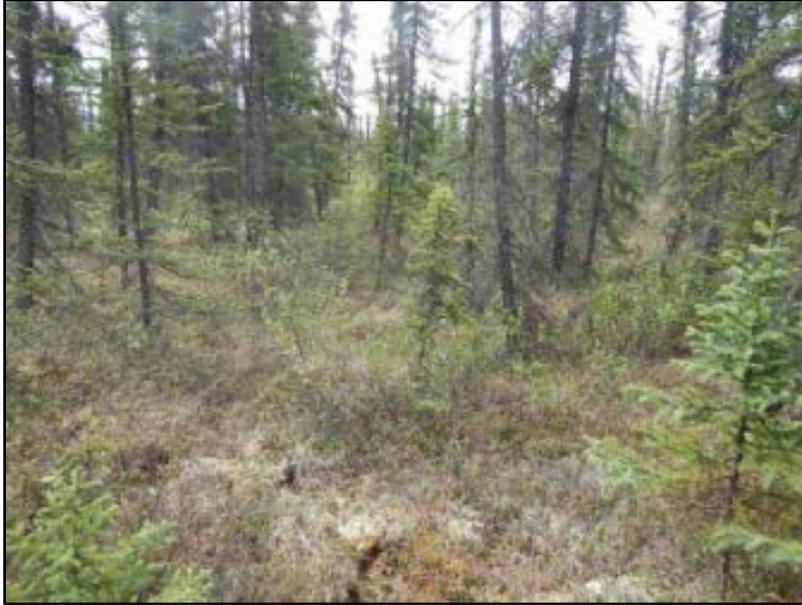
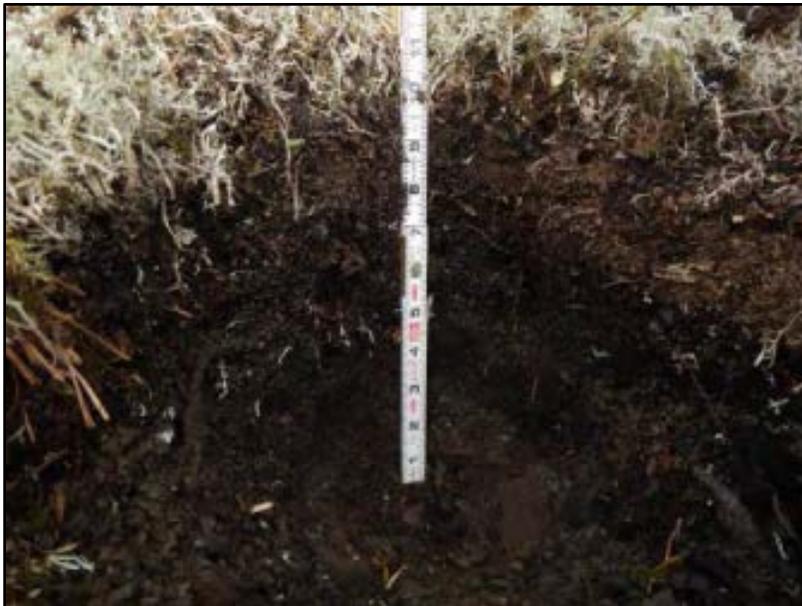
Sample location taken in a hummocky scrub shrub wetland. Vegetation was dominated by *Picea mariana* in the tree layer, *Vaccinium vitis-idaea* in the shrub layer and *Eriophorum vaginatum* in the herbaceous layer. Observation view point is oriented to the south.

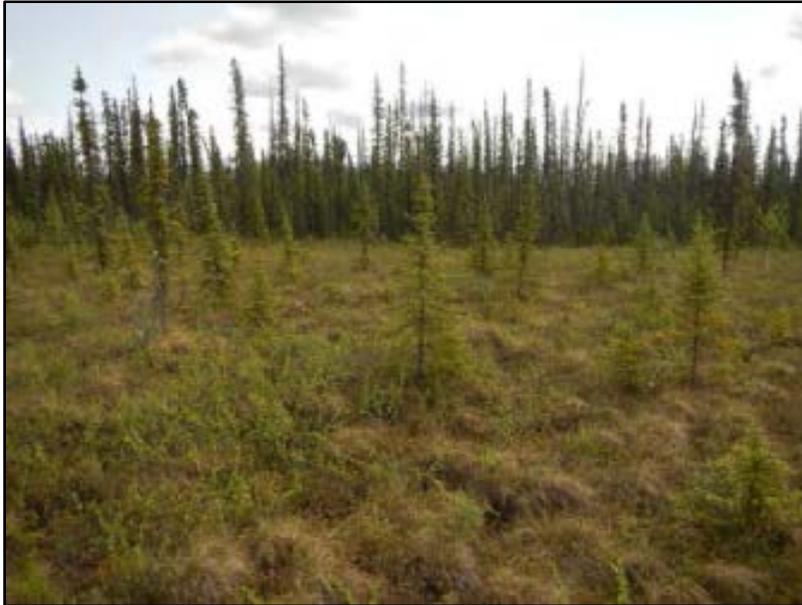
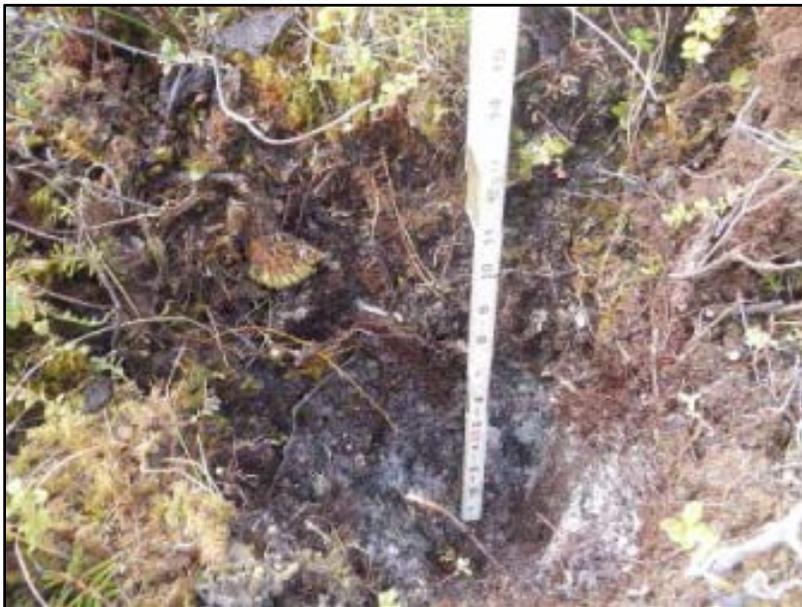
| <b>Site Number:</b> 112<br><b>Date:</b> 6/3/2014 | <b>Notes:</b> | Sample point taken within a scrub shrub wetland with hummocks 9-12 inches tall by 12 inches wide. Vegetation dominated by <i>Betula nana</i> and <i>Rhododendron tomentosum</i> in the shrub layer and <i>Eriophorum vaginatum</i> in the herbaceous layer. Observation view point is oriented to the east. |
