SUPPLEMENTAL MATERIAL SITE REPORT

PARKS HWY MP 194 BROAD PASS RAILROAD CROSSING

FEDERAL PROJECT NO. REH-HHE-OA4-3(16) / STATE PROJECT NO. 61277

JULY 2008

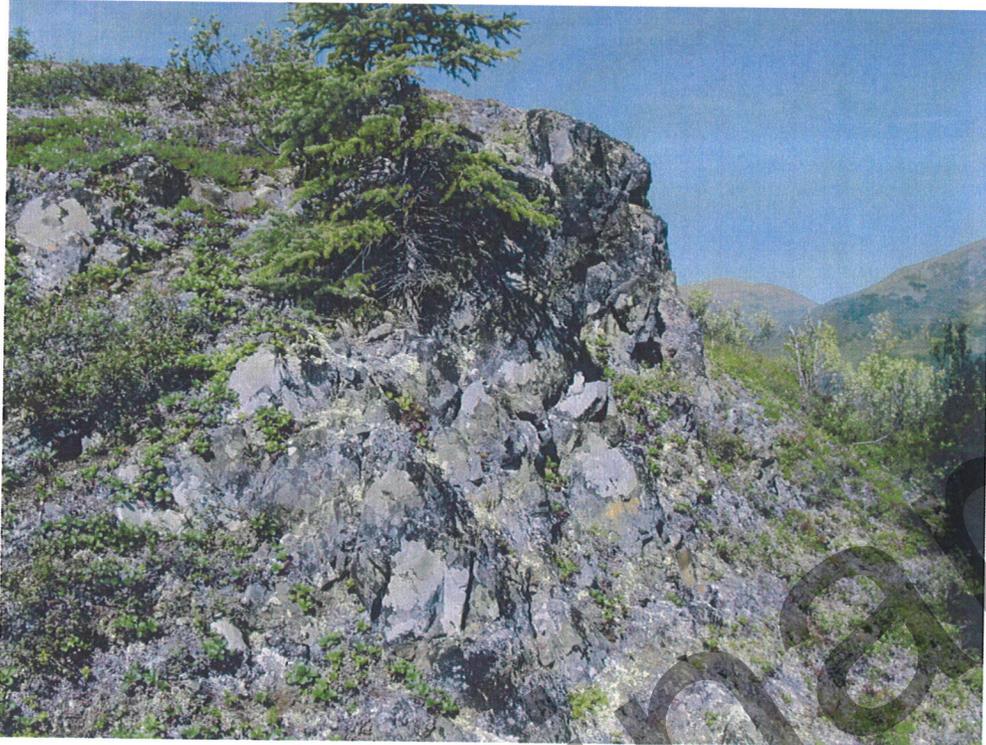
Figure 2. Cliff face of basalt bedrock exposed in the eastern portion of MS 52-2-035-2.

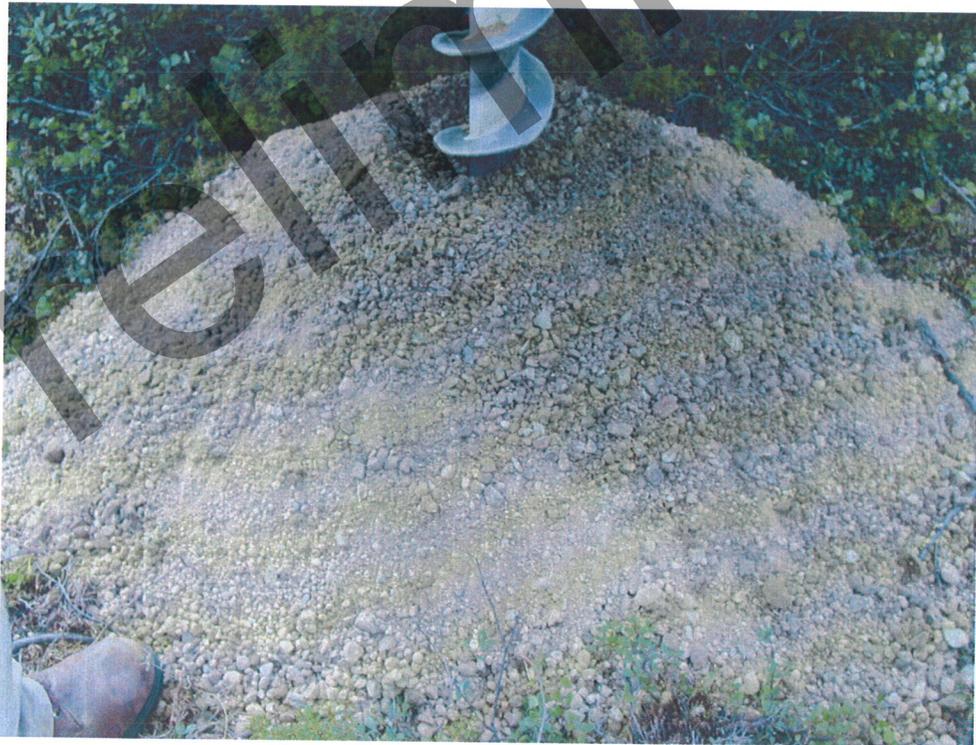
Figure 3. Completely weathered sedimentary bedrock in the western portion of MS 52-2-035-2 (TH07-1602).

- 1) Two different areas of bedrock exist in this site, i.e., soft sedimentary rock to the west and hard igneous rock to the east. Not enough quantity of the sedimentary rock was recovered for quality testing; however, based on the overburden depth, and the overall fractured and soft character of this rock, we do not recommend its use for crushed aggregates and base course.

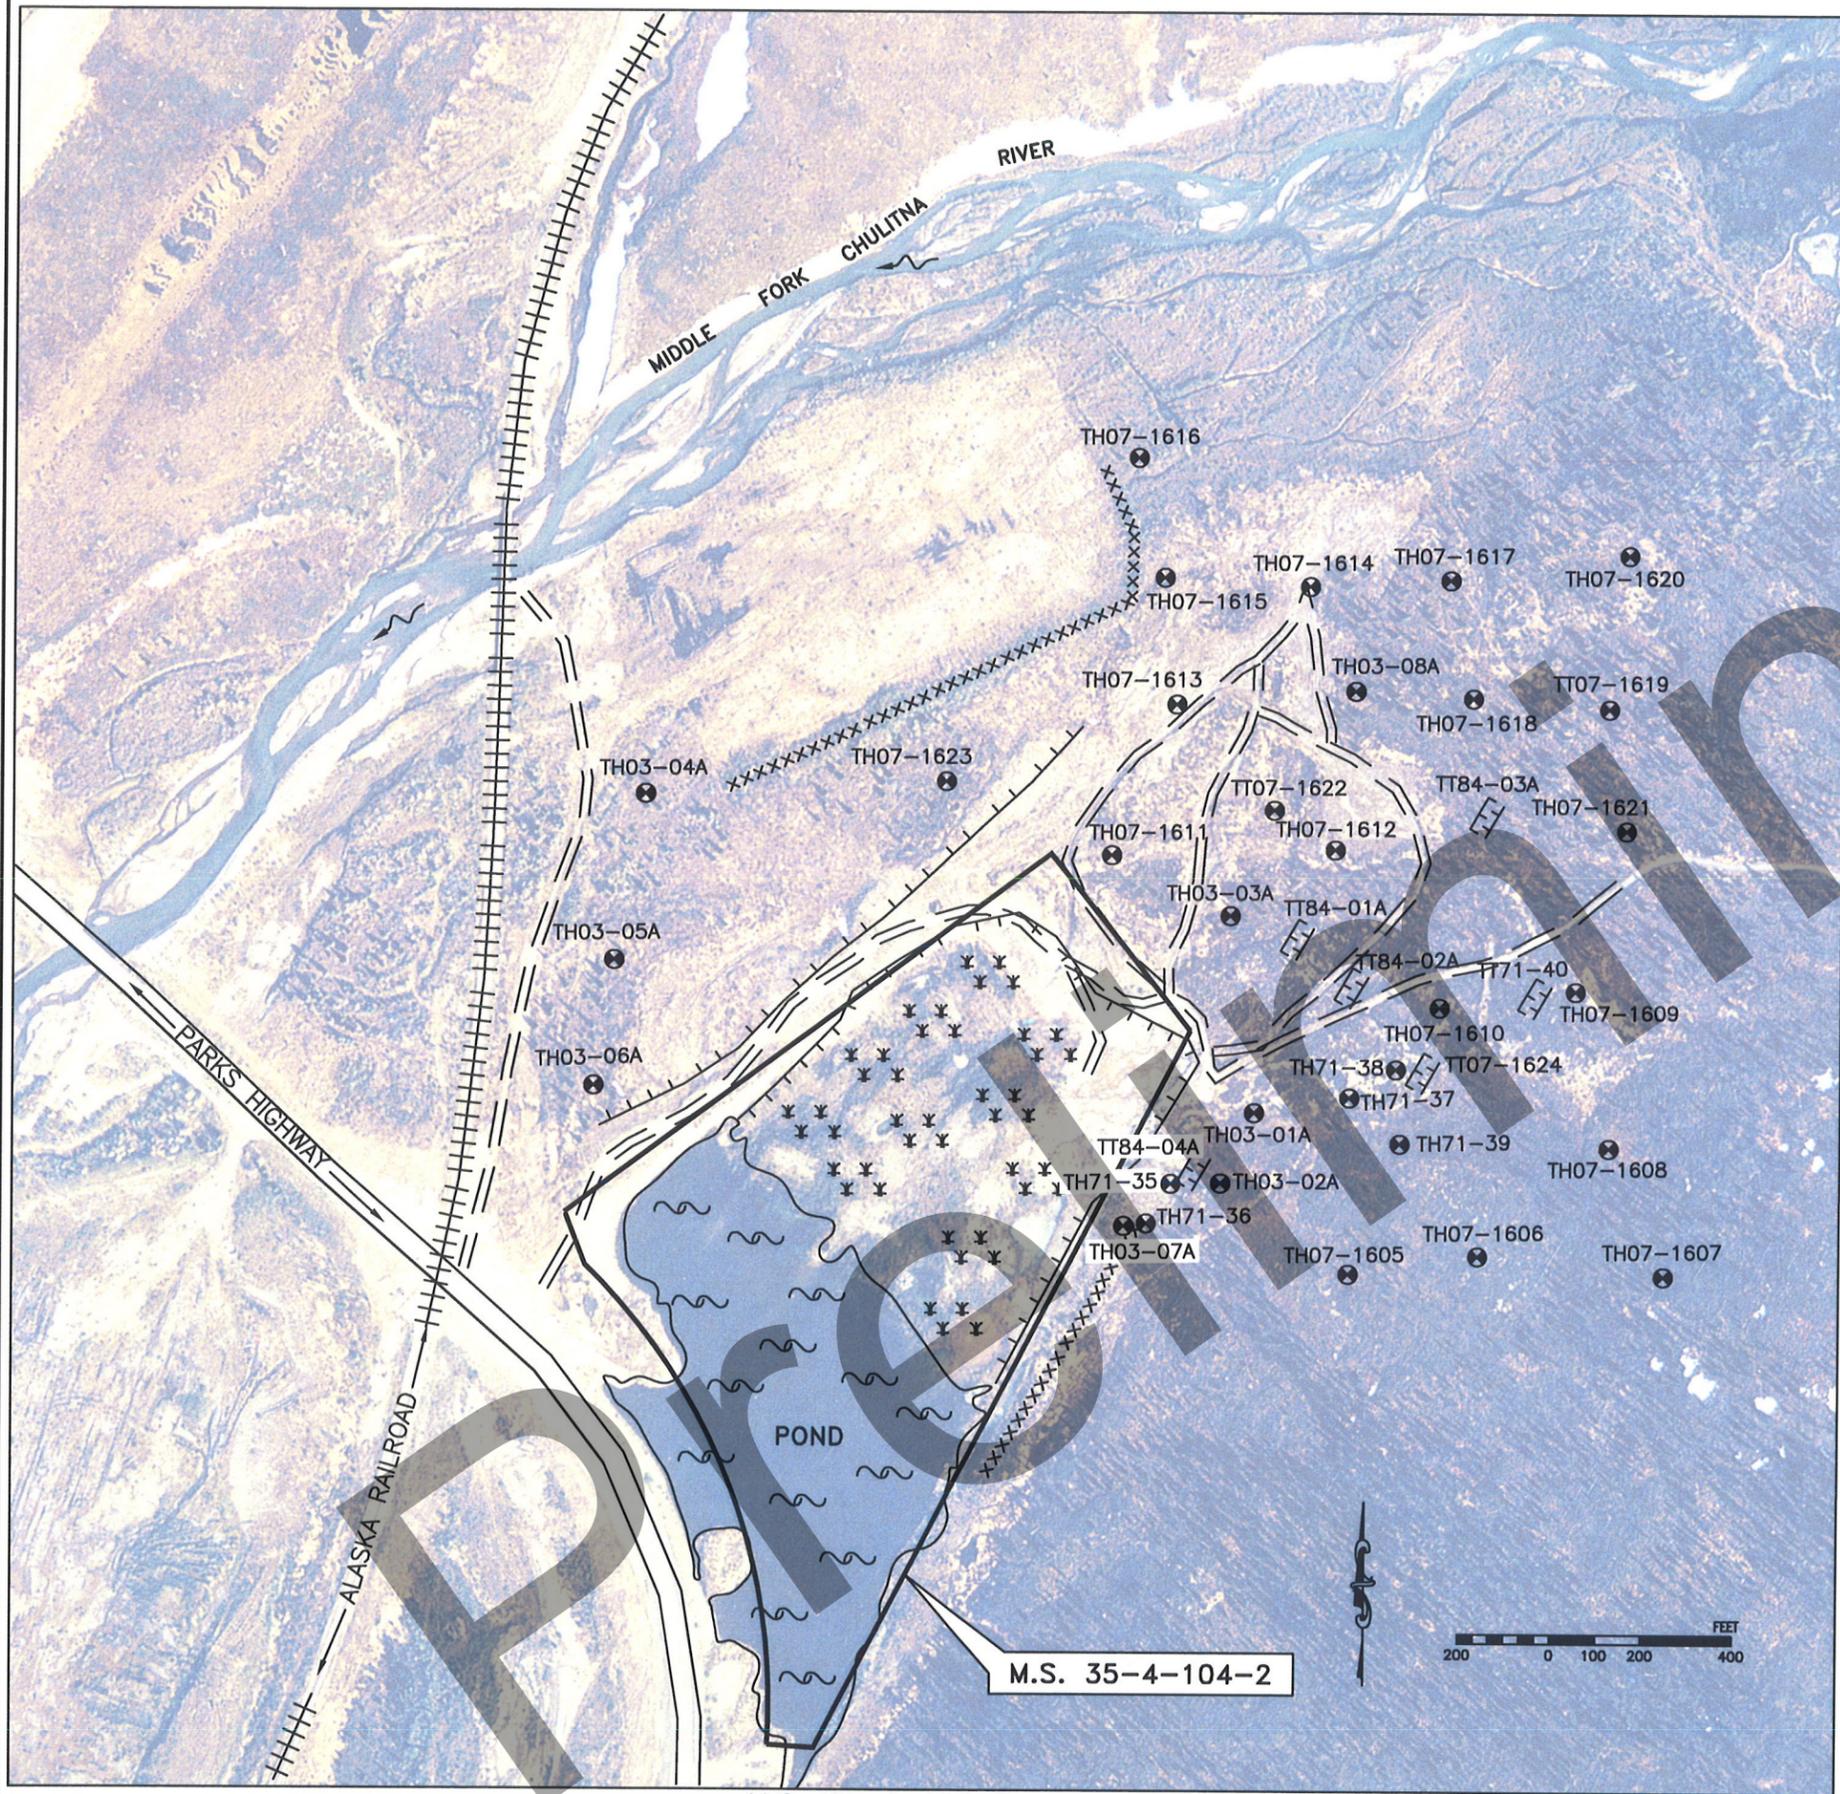
M.S. 35-4-104-2
 LOCATED W/IN SEC. 22, T19S, R9W
 FAIRBANKS MERIDIAN

- 3) Four test holes intercepted sandy silt, elastic silt, and/or coal beneath gravel. Depth to silty soil or coal varied from 11 ft to 18 ft.
- 4) Production of adequate quantities may require mining from below the water table.

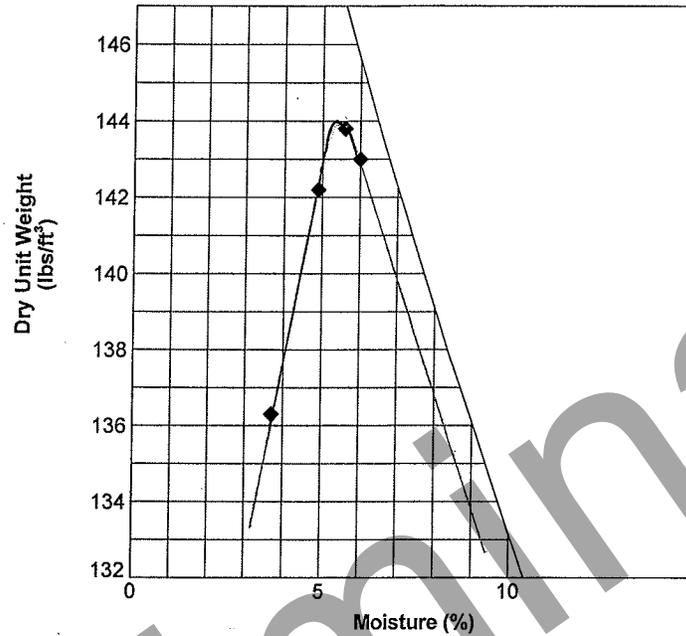
MOISTURE / DENSITY RELATIONSHIP

Dry Unit Wt	1	2	3	4	5	6
lbs/ft ³	136.3	142.2	143.8	143.0		
kg/m ³	2183	2278	2303	2291		
% Moisture	3.7	4.9	5.6	6.0

ASTM D-1557 AASHTO T-180D	Regional Lab.		Field
	lbs/ft ³	kg/m ³	
Max. Density	144.0		
Opt. Moisture	5.4

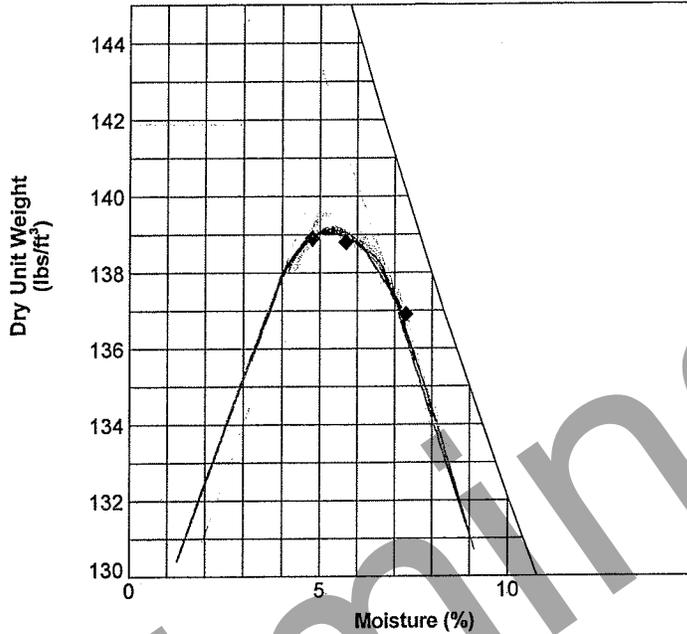
MOISTURE / DENSITY RELATIONSHIP

Dry Unit Wt	1	2	3	4	5	6
lbs/ft ³	138.9	138.8	136.9			
kg/m ³	2225	2223	2193			
% Moisture	4.8	5.7	7.3

ASTM D-1557 AASHTO T-180D	Regional Lab.		Field
	lbs/ft ³	kg/m ³	
Max. Density	139.0		
Opt. Moisture	5.2

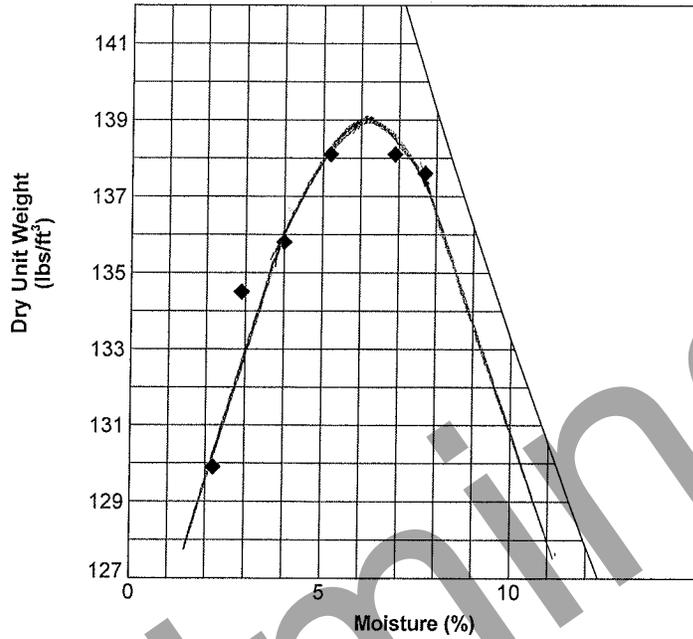
MOISTURE / DENSITY RELATIONSHIP

Dry Unit Wt	1	2	3	4	5	6
lbs/ft ³	129.9	134.5	135.8	138.1	138.1	137.6
kg/m ³	2081	2154	2175	2212	2212	2204
% Moisture	2.2	2.9	4.0	5.2	6.9	7.7

ASTM D-1557 AASHTO T-180D	Regional Lab.		Field
	lbs/ft ³	kg/m ³	
Max. Density	139.0		
Opt. Moisture	6.1

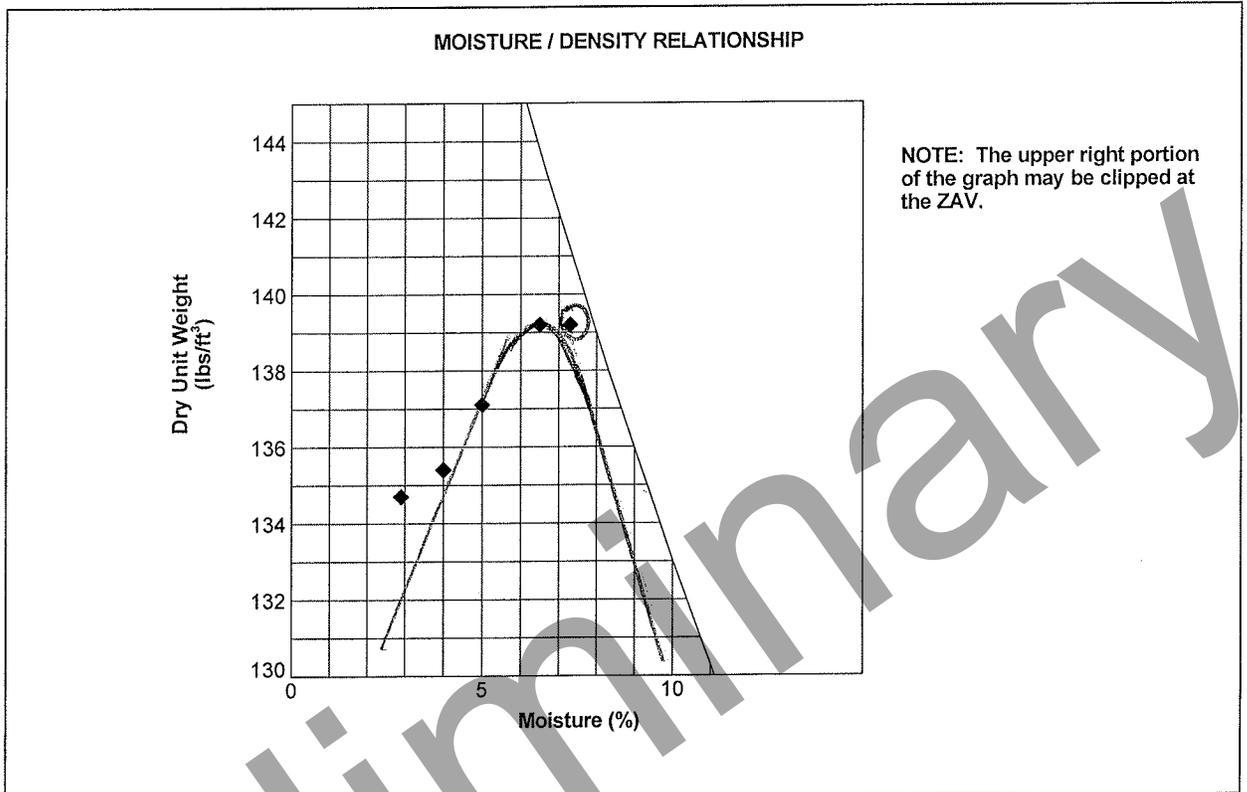
Test Hole: 07-1624

Dry Unit Wt	1	2	3	4	5	6
lbs/ft ³	134.7	135.4	137.1	139.2	139.2	
kg/m ³	2158	2169	2196	2230	2230	
% Moisture	2.9	4.0	5.0	6.5	7.3

ASTM D-1557 AASHTO T-180D	Regional Lab.		Field
	lbs/ft ³	kg/m ³	
Max. Density	139.2		
Opt. Moisture	6.5

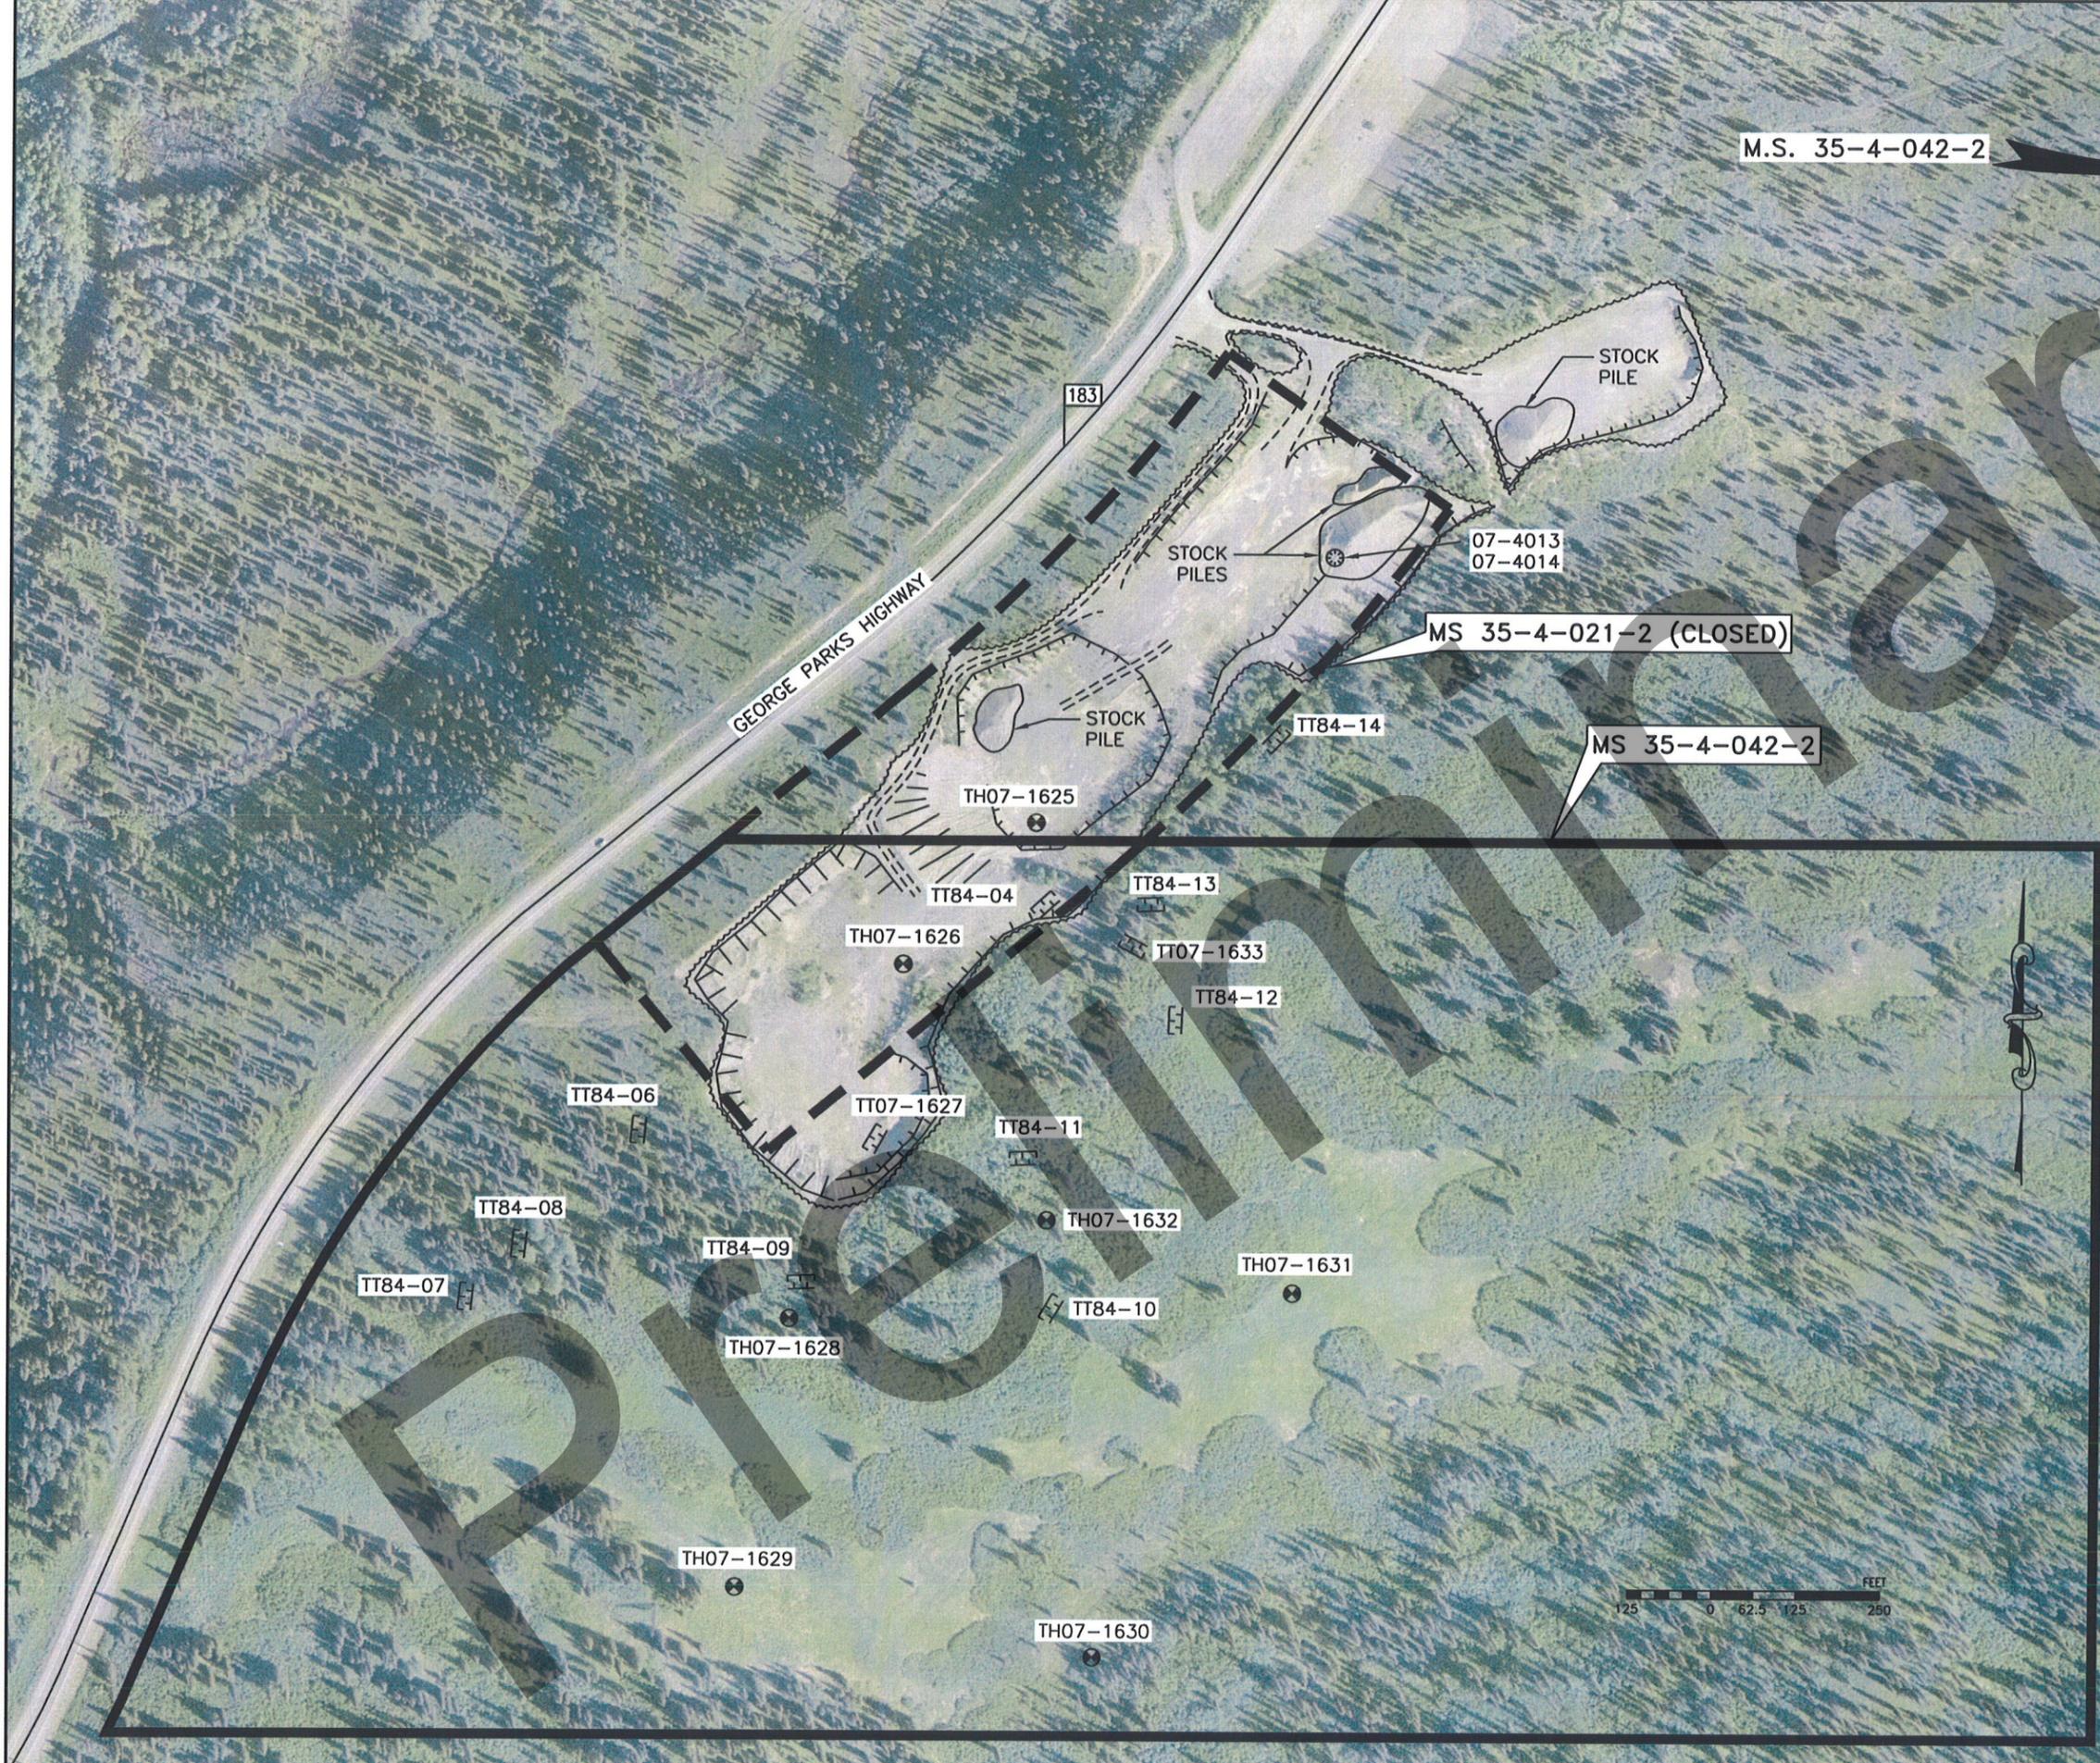
Jul 22, 2008 - 8:40am - Tab: MS21-42

07-4013 16 MAY (STOCKPILE) WG GRAVEL w/Si & So GW-GM, 5.0% -200 LA 18, DEG 50 SSc 2, SSf 3	07-4014 16 MAY (STOCKPILE) WG SAND w/Si & Gr SW-SM, 7.8% -200 LA 21, DEG 48 SSc 5, SSf 6
--	--

- 1) The borings located within the existing pit demonstrated the presence of gravel and/or sand with silt to at least 48.5 ft below the pit floor. As no water table was present in any of these borings, the existing excavation in MS 35-4-042-2 can be deepened considerably, limited only by its areal extent and backslopes necessary to stay within the permitted area.
- 2) Results from the 2007 and 1984 explorations indicate that the southern portion of the existing excavation can be expanded into MS 35-4-042-2 to the south, southwest, and southeast. Expansion to the south and southeast will require moving the existing waste berms.
- 3) Degradation results from laboratory testing indicate that some of the material coming from this site does not meet the Standard Specifications for use as crushed aggregates, base course, and subbase products.

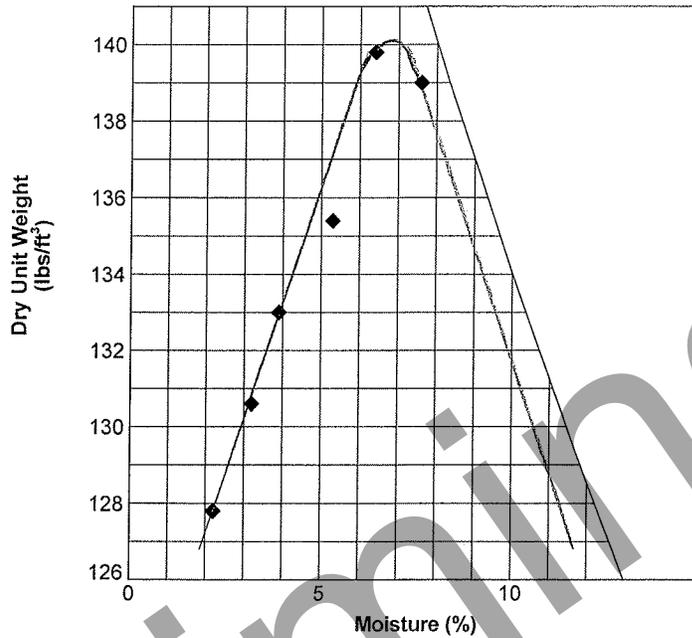
MOISTURE / DENSITY RELATIONSHIP

Dry Unit Wt	1	2	3	4	5	6
lbs/ft ³	127.8	130.6	133.0	135.4	139.8	139.0
kg/m ³	2047	2092	2130	2169	2239	2227
% Moisture	2.2	3.2	3.9	5.3	6.4	7.6

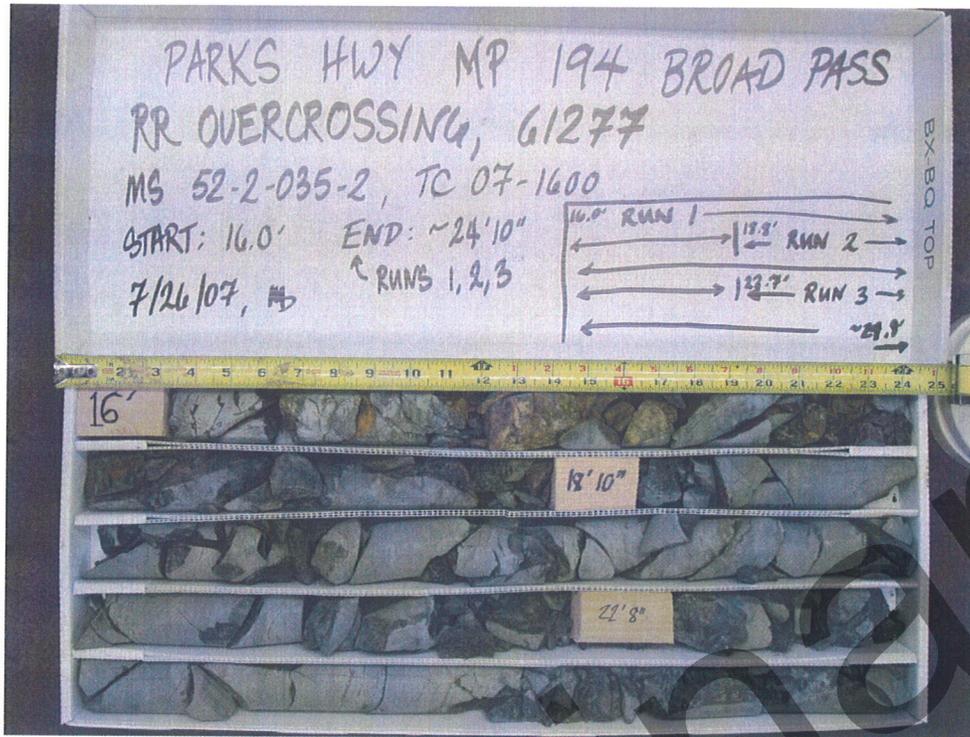
Figure B-1. Photograph of core taken from TC07-1600, in MS 52-2-035-2. Core in photograph was taken from between 16.0 ft and ~22.8 ft below the surface.

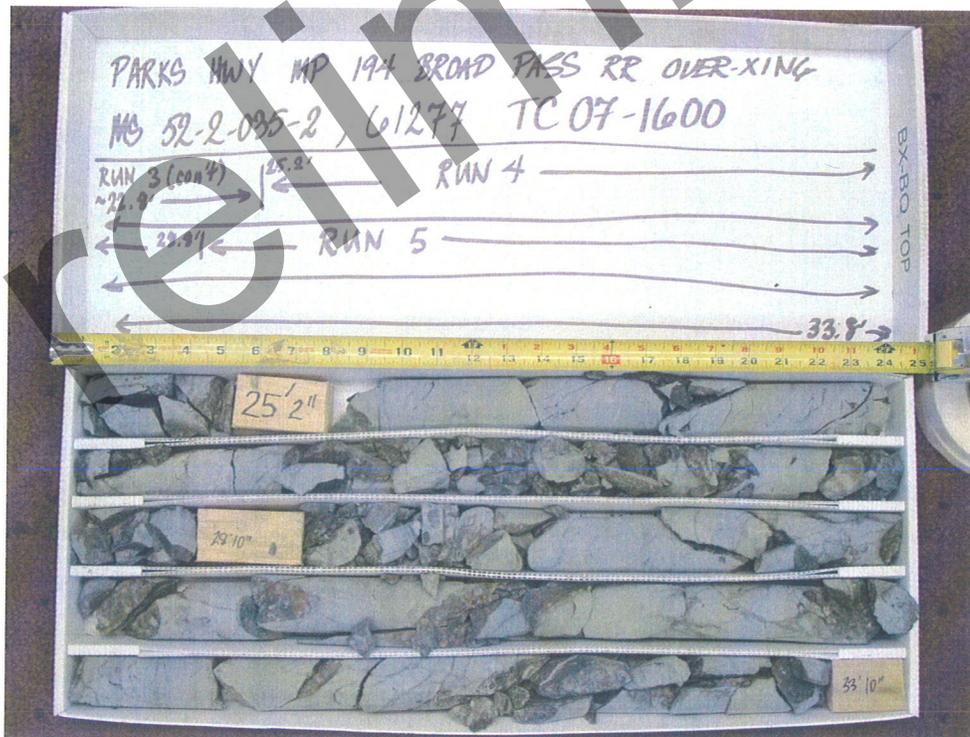
Figure B-2. Photograph of core taken from TC07-1600, in MS 52-2-035-2. Core in photograph was taken from between ~22.8 ft and 33.8 ft below the surface.

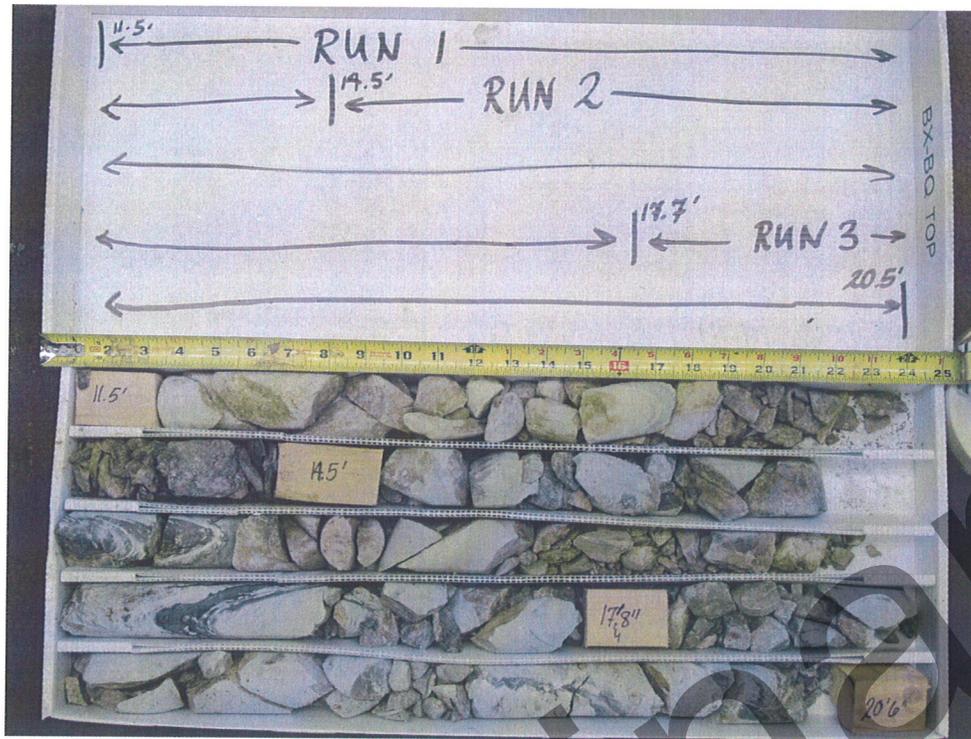
Figure B-3. Photograph of core taken from TC07-1601, in MS 52-2-035-2. Core in photograph was taken from between 11.5 ft and 20.5 ft below the surface.

In 2007, we drilled one core hole (TC07-1601) into the sedimentary rock, which consisted of highly fractured, interbedded siltstone, sandstone, shale, limestone, and chert. The Rock Quality Designation (RQD) from this test core ranged from 0 to 46, with an average RQD of 19 and the longest piece length of 7.5 in. We drilled core holes at two different locations into the igneous rock, which we identified as basalt. At the first location (TC07-1600), drilling rates indicated the bedrock was soft between 12.5 ft and 16.0 ft, becoming hard below 16.0 ft. The bedrock was highly fractured, with iron staining on joint faces and infilling in joints up to ¼-in. thick. The RQD varied from 13 to 52, with an average RQD of 35 and the longest piece length of 6.5 in. At the second of these locations, we had difficulty in seating the casing due to the shallow soil depth. We made three attempts (TC07-1603, TH07-1604, and TC07-1604b), and were successful on the third try. Drilling rates indicated that the basalt bedrock at this location was hard. It was highly fractured, with the RQD ranging from 0 to 50, with an average RQD of 30 and the longest piece length of 8 in.

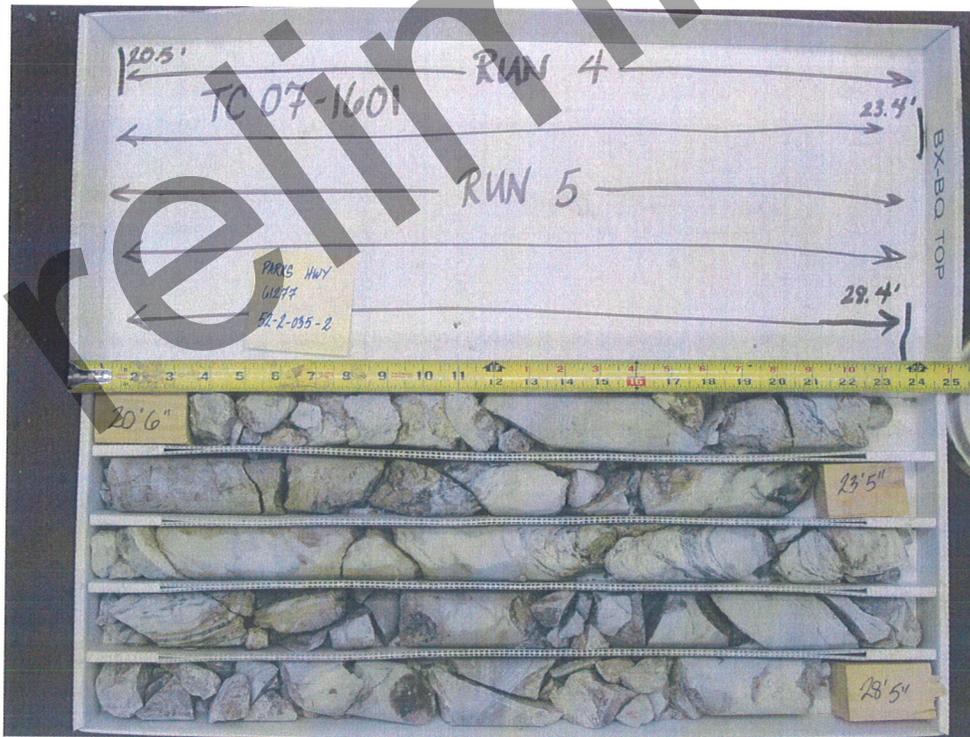
Figure B-4. Photograph of core taken from TC07-1601, in MS 52-2-035-2. Core in photograph was taken from between 20.5 ft and 28.4 ft below the surface.

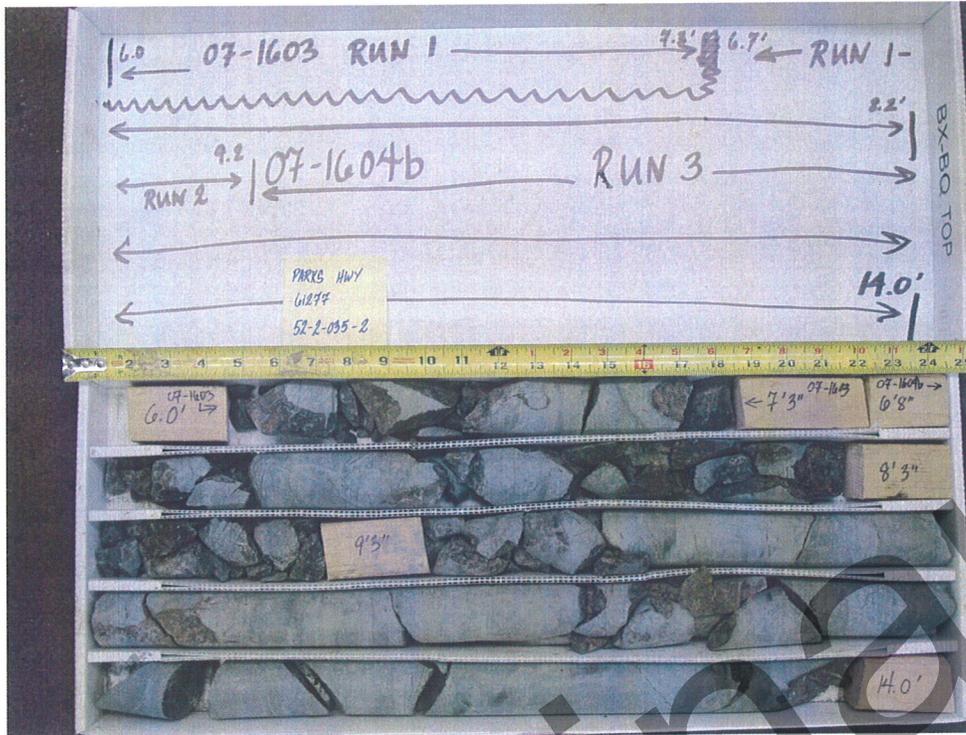
Figure B-5. Photograph of core taken from TC07-1603 and TC07-1604b, in MS 52-2-035-2. Core in photograph was taken from between 6.0 ft and 7.3 ft below the surface in TC07-1603, and between 6.7 ft and 14.0 ft below the surface in TC07-1604b.

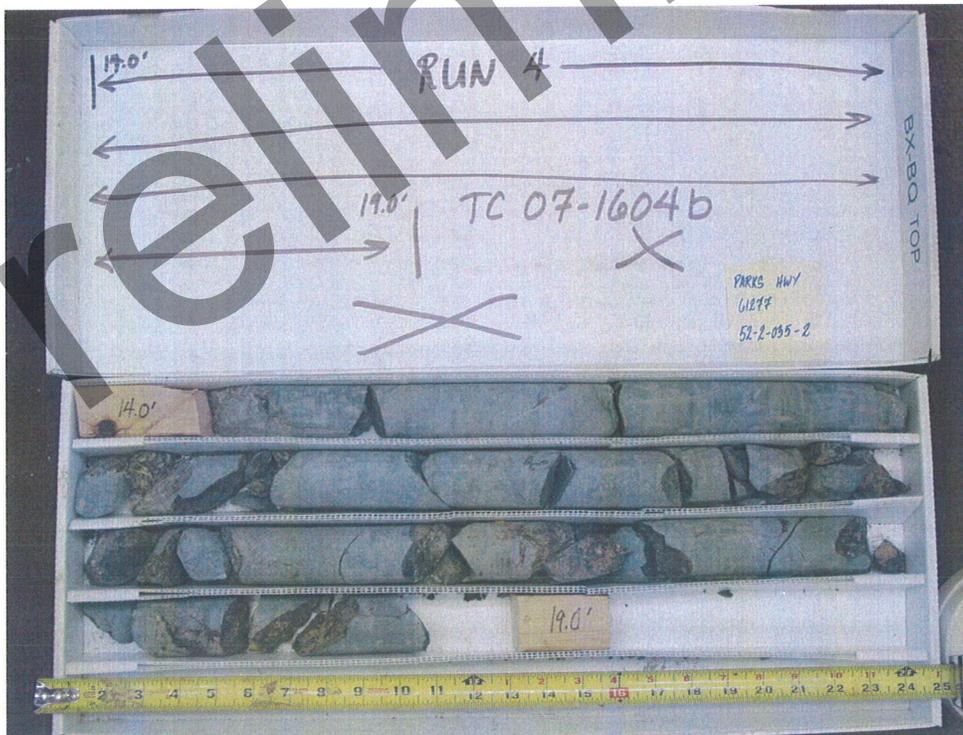
Figure B-6. Photograph of core taken from TC07-1604b, in MS 52-2-035-2. Core in photograph was taken from between 14.0 ft and 19.0 ft below the surface.
